14<sup>TH</sup> CANADIAN MASONRY SYMPOSIUM  
MONTREAL, CANADA  
MAY 16<sup>TH</sup> – MAY 20<sup>TH</sup>, 2021

**ALTERNATIVE SHEAR REINFORCEMENT FOR NARROW MASONRY CONCRETE  
BEAMS**

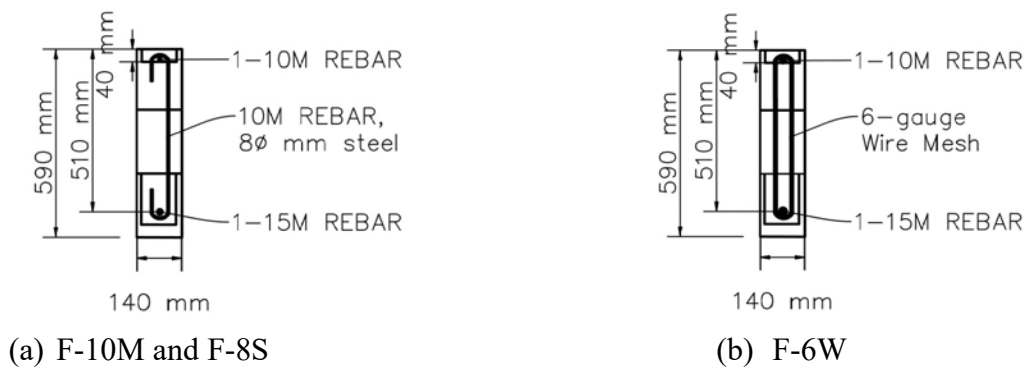
**Figure 4: Cross-sections of masonry beams**

The prisms and beams were fully grouted with type S mortar and normal strength fine grout, which was used in accordance with the performance specification of the CSA A179 [11]. Figure 4 displays the cross-sections of the various masonry beam specimens having shear reinforcement placed in every cell of the beam at a spacing of 200 mm. An additional 10M rebar was established within the compression zone to serve as anchorage for the stirrups as stated in CSA S304 standard [10]. The usage of the wire mesh reinforcement resulted in a marginally smaller spacing due to the presence of the 2-wires in each leg (double-legged shear reinforcement), which filled the entirety of cell length as presented in Figure 5b. Also, comprehensive details and dimensions of the masonry beam specimens were shown in Figure 5.

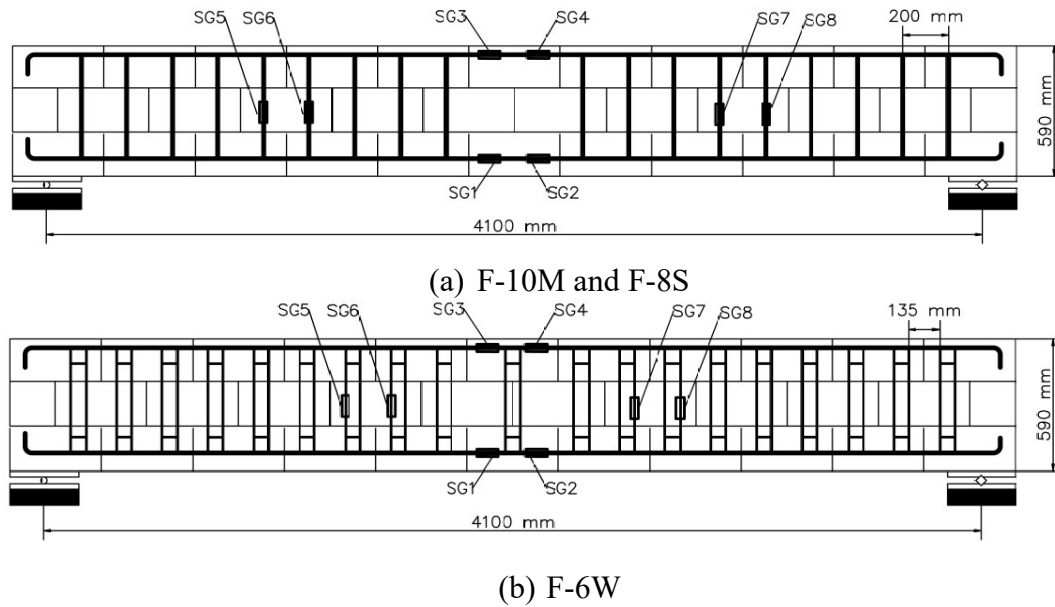
**Figure 5: Reinforcement details of masonry beams**

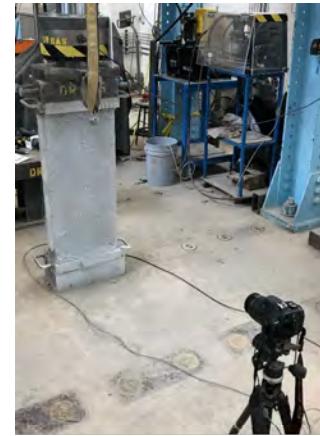
(a) Beam specimen

(b) Prism specimen

**Figure 6: Test set-up for specimens**

The experimental setup was similar for all beam samples, as presented in Figure 6a. Strain gauges were installed on the reinforcements prior to the construction of the beams. Two cameras were positioned at the speckle pattern surface of the beam specimens for DIC application. The four 100 mm stroke Linear Variable Displacement Transducers (LVDT), three load cells and eight strain gauges were connected to the computerized data acquisition (DAQ) system for obtaining experimental data.

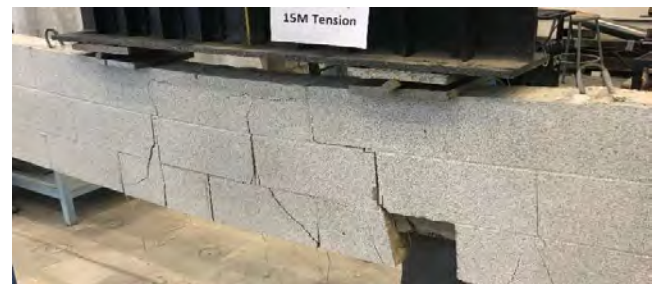
**Figure 7: Failure mode of specimen F-10M**

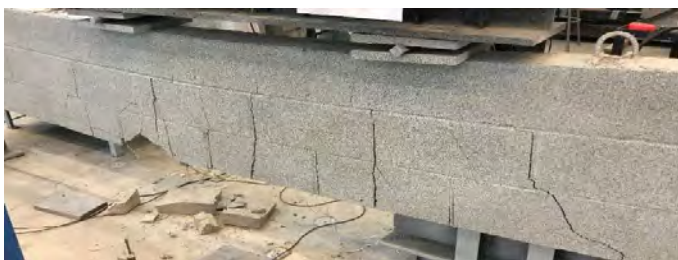
**Figure 9: Failure mode of specimen F-8S**

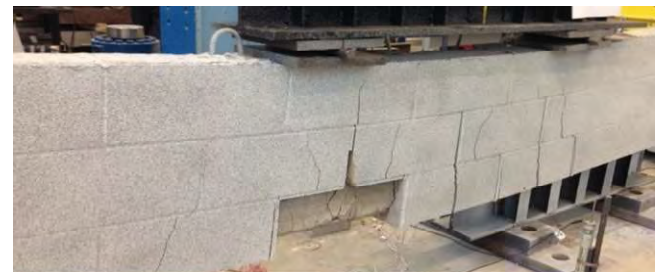
**Figure 11: Failure mode of specimen F-6W**

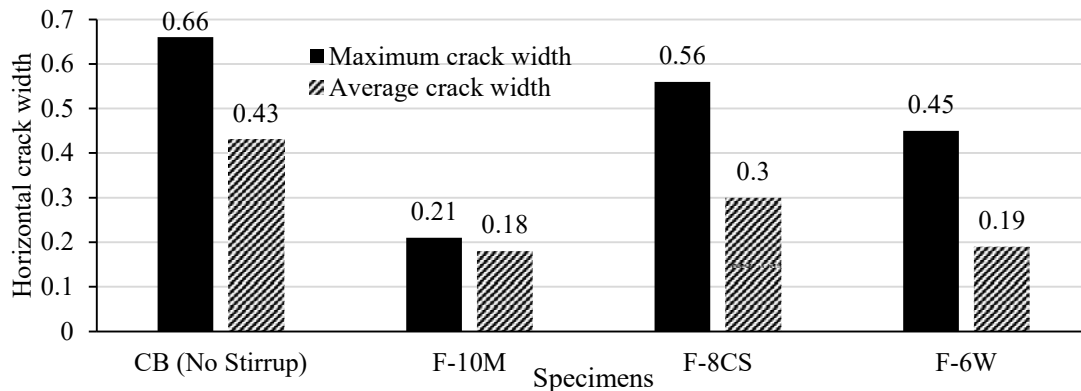
**Figure 14: Horizontal crack width comparison of the beam specimens**

The crack widths and crack patterns were acquired using Digital Image Correlation (DIC) technique [8], [15]. The crack pattern of the beam without and with stirrups are presented in Figures 12 and 13. It was observed that significant cracks in the shear span propagated in a stepwise manner. Figure 14 illustrates the comparison of crack widths in the masonry beam specimens.

Performance of the masonry beam specimens based on the maximum crack width shows that specimen F-10M exhibited better resistance than beams built with alternative shear reinforcement (F-8S and F-6W). The average width of the horizontal cracks was 0.18 mm, 0.30 mm, and 0.19 mm for specimen F-10M, F-8S and F-6W, respectively. Specimens F-10M and F-6W had slightly identical average horizontal crack width which is due to beam F-10M having 56% more area of shear reinforcement than specimen F-6W. Also, it was observed that the 8 mm bar was not as efficient at decreasing the average horizontal shear crack compared to the standard rebar and 6 mm wire. This weak performance is attributed to the smooth texture of the 8 mm bar which provides inadequate bonding action with the grout.

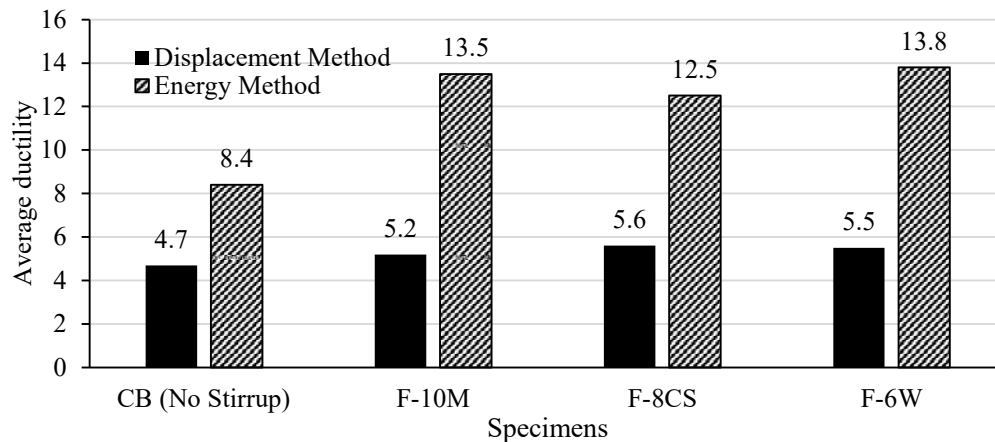
**Figure 15: Beam ductility (displacement and energy method)**

In this research, the ductility ( $\mu$ ) was measured by displacement ratio ( $\mu_{\Delta}$ ) and energy ratio ( $\mu_E$ ), which have been used by others [14], [15]. The ductility values using these two methods are shown in Figure 15. It can be observed that beams with shear reinforcement (F-10M, F-8S, and F-6W) showed higher ductility in relation to the beam without shear reinforcement. The average ductility for the beams with shear reinforcement were 15% and 57% higher than the control beam using displacement and energy method, respectively. The result revealed that ductility values of the beam specimen F-6W were slightly higher than other beam specimens having shear reinforcement (8 mm rebar and standard rebar).

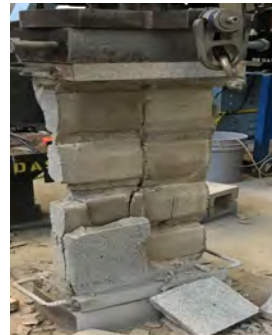
**(a): Loading applied normal to bed joint**

**(b): Loading applied parallel to bed joint**

**Figure 16: Failure modes of prism specimens**

The failure mode of the prisms compressed normal and parallel to the bed was similar, as shown in Figure 16a and Figure 16b. It was observed that the grout had undergone substantial lateral expansion during loading, which led to the pushout of the blocks shell causing tension in the outer face of the prism. In addition, leading to the damage of the grout and separation of the blocks from the grout, as depicted in Figure 16.
