14TH CANADIAN MASONRY SYMPOSIUM
MONTREAL, CANADA
MAY 16TH – MAY 20TH, 2021

**STRUCTURAL PERFORMANCE OF SHELF ANGLE FOR BRICK MASONRY VENEER
USED IN WOOD-FRAMED BUILDING**

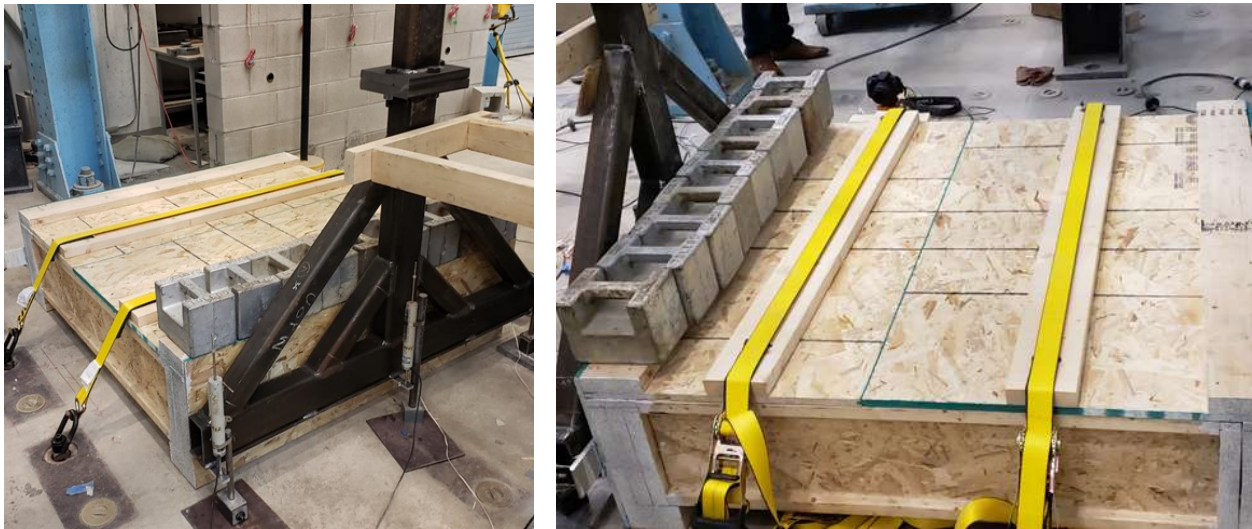
Figure 3: (a) Application of axial and gravity loads, (b) Straps used for anchoring the specimen

The weight of the brick veneer was simulated by applying an axial load to the shelf angle attached to the floor specimen. The loading continued until a complete failure was achieved. A hydraulic loading actuator of 500 kN capacity was used to apply the axial load on the shelf angle. Gravity load on the rim board was also applied using distributed heavy steel blocks. The gravity load represented the floor load acting on the wood studs of the support wall on the edge of the floor system from a roof load only. This helped in preventing rotation of rim boards. The load on the shelf angle was applied using a steel loading truss made using 5 in. (~126 mm) x 3 in. x 1/4 in. (~127 mm x 76 mm x 6.4 m) HSS sections as shown in Figure 2 to simulate a uniformly distributed load on the shelf angle due to the self-weight of the brick cladding. The base of HSS section was welded to a 3 1/2 in. (~89 mm) wide plate to imitate the load applied by a 3 1/2 in. (~89 mm) wide brick veneer. To prevent the overturning of the specimen during testing, the specimen was strapped at the strong floor as shown in Figure 3.

A loading actuator was used to apply uniformly distributed axial load on the shelf angle. Load cells attached to the loading actuator measured the load applied. A total of three linear variable differential transformer (LVDTs) were used to measure the vertical deflections at various locations at the underneath of the shelf angle. Two LVDTs were used to capture the vertical deflection of the shelf angle, one at the mid-span and one at the end. One LVDT was also attached perpendicular to the shelf angle at the distance of $3\frac{1}{4}$ in. (~ 83 mm) from the heel of the shelf angle to measure horizontal displacement of the vertical leg of the shelf angle. The values obtained from this LVDT was used to determine the rotation of the shelf angle. All the experimentation data was collected using a computerized data acquisition system connected to all the instruments. A camera was positioned at each end of the specimen to capture and understand the failure mechanism.

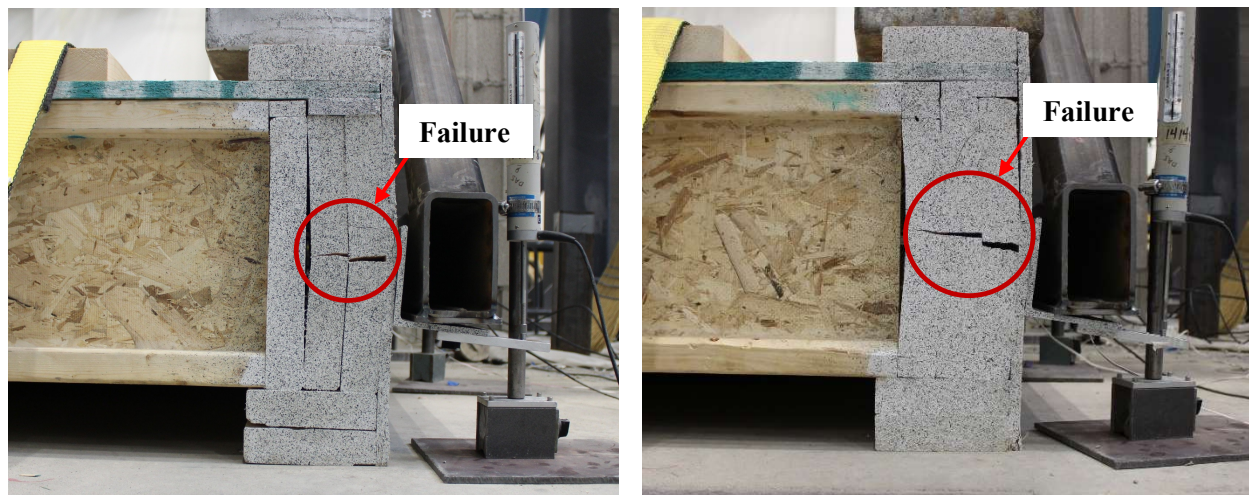
Figure 7: Splitting failure of the specimens built using (a) lag screws and (b) through-bolts

The service and design loads for this specimen are 5 kN/m and 8 kN/m, respectively. However, the first sign of obvious failure was observed at about 63 kN (44.3 kN/m) which is more than five times of the design load (8 kN/m). The exterior most rim board began developing crack at this load and the crack propagated to the center ply of the rim board when the load reached about 69 kN (48.5 kN/m). It should be noted that the rim board had 3 plies (see Figures 1 and 2). Interestingly, the crack propagated only up to the embedment length of the lag screw (see Figure 7(a)). It is obvious that the gravity loads applied on the rim board helped preventing the rim boards from rotating, and the failure was due to the perpendicular-to-grain splitting of the rim board (SPF).

observed at about 52 kN (36.5 kN/m) which is much higher than the design load of 8 kN/m. Thus, first obvious sign of failure in this specimen (specimen 2) was observed a bit earlier than the specimen 1. At this load (52 kN or 36.5 kN/m), the exterior rim board began to split. It was further observed that the center rim board (the middle ply) began to split at 62 kN (43.6 kN/m). Unlike specimen 1, the splitting in specimen 2 propagated to the interior ply of the rim board (thus all three plies of the rim board developed the crack) and it occurred at a load of about 83 kN (53.4 kN/m). The higher capacity obtained from specimen 2 (built with through bolts) can be attributed to the fact that the through-bolts were embedded into the all three plies of the SPF rim board assembly and hence, all three plies contributed in load sharing. Nonetheless, like specimen 1 (built with lag screws), the failure in specimen 2 (built with through-bolts) was also due to perpendicular-to-grain splitting of the rim board.

The shelf angle experienced a deflection of 32.5 mm when the specimen exhibited the maximum load carrying capacity (see Figure 5(a) and it is shown by an open circle). The reason for this larger deflection can be attributed to the fact that all three plies of the rim board system in specimen 2 were engaged, however, for specimen 1 (built with lag screws) only two plies of the rim board were probably engaged in load sharing. The maximum rotation for specimen 2 was found to be 7.6 degrees (shown by an open circle in Figure 6). The splitting of the rim board is shown in Figure 7(b).
