14<sup>TH</sup> CANADIAN MASONRY SYMPOSIUM  
MONTREAL, CANADA  
MAY 16<sup>TH</sup> – MAY 20<sup>TH</sup>, 2021

**EXPERIMENTAL TESTS OF STRENGTHENED SMALL MASONRY WALLS MADE OF HORIZONTALLY-HOLLOW BRICKS (“PANDERETA”) IN SEISMIC ZONES**

**Tarque, Nicola<sup>1</sup> and Quiun, Daniel<sup>2</sup>**

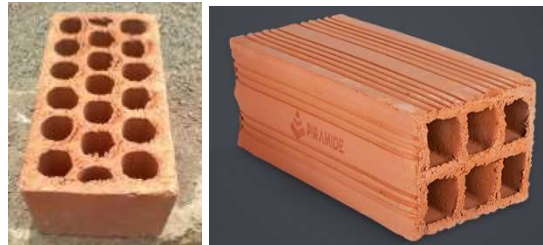
**Figure 1: Industrial perforated brick and industrial horizontally-hollow brick**

Confined masonry dwellings are very popular in Peru and other Latin American countries. In Peru, despite having a standard for earthquake-resistant design and construction with masonry, there are many non-engineered dwellings in which perforated bricks, horizontally-hollow (*tubular* in Spanish, Fig. 1) or hand-made bricks are used, which are not suitable for bearing walls [1]. The Peruvian standard [2] requires the use of solid bricks (with a bedding area of at least 70% of the gross area) for the construction of structural walls. Then, perforated and tubular bricks should be used only for constructing partition non-structural walls. Also, hand-made bricks are only allowed for walls up to two-stories, but due to the lack of control, buildings up to four and five-story are entirely built with hand-made bricks (Fig. 2). A typical constructive error is seen in Fig 2, where tubular bricks are also used in upper floors without confinement elements. In case of an earthquake, those walls are the first to suffer overturning.

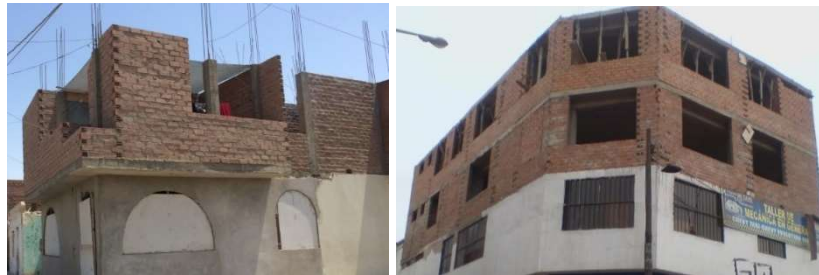
**Figure 2: Popular informal buildings have walls made of horizontally-hollow bricks**

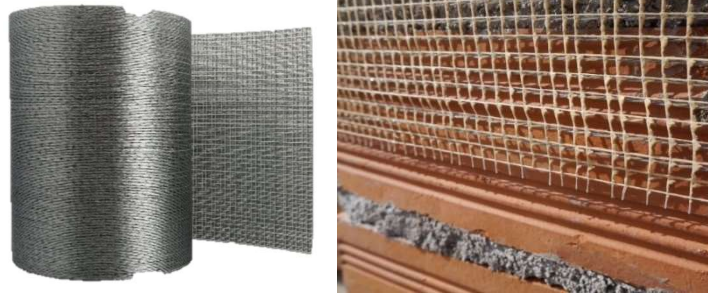
The Steel Reinforced Grout (SRG) system is included within the TRM set. These steel fibers are one-directional since they result from twisting two wires around three straight wires (Fig. 3). Perpendicular plastic fiber filaments connect them to form a textile. These fibers are called Ultra High Tensile Strength Steel (UHTSS) with a yield strength of 2800 MPa. Besides, the mortar that acts as a binder is made of lime with type resistance M15 according to EN 998-2 and type R1 according to EN 1504-3 [7].

**Figure 3: Steel Reinforced Grout (SRG)**

The SRG has an easy installation on the wall surfaces, which means that it could be directly used by the owners. However, different aspects must be taken into account before the application of the SRG, such as the preparation of the wall surface and to guarantee a good adhesion between textile and mortar. Thus, after treating the surface by removing the dust and moistening it, the first layer of 5 mm thick mortar is applied. Then, the SRG is placed on the fresh mortar and is finished with a second layer of 5 mm thick mortar. Finally, unlike the other types of reinforcement, it is cured for 7 days.

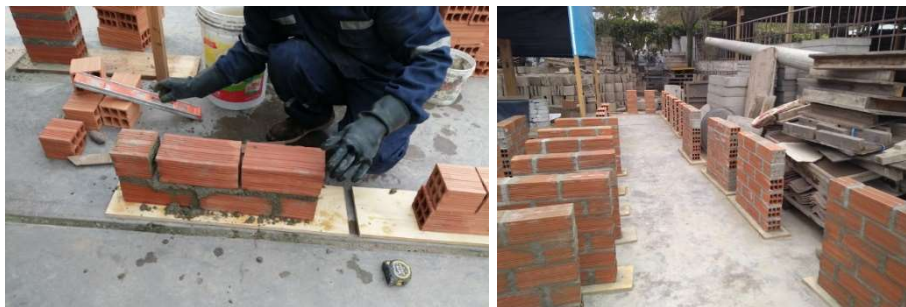
A total of 9 masonry small walls were built at the Structural Laboratory of the PUCP. Three of them to be tested without any strengthening system, 3 with welded mesh and the other 3 with SRG. The small walls were square with a side length of 600 mm. The thickness of the small walls was 110 mm. The mortar's thickness was kept close to 15 mm. Figure 4 shows the construction stage.

The construction of the small walls started by cleaning the dust from the units; and then, wetting the clay bricks to control water's absorption from the mortar. The mortar had a proportion of cement:sand of 1:4. Since the units have horizontal cells, the bricks at two opposite corners were filled with mortar by approximately 200 mm in length. These corners are those in which the compression equipment grips the specimens and applies the diagonal compression load. In previous research, it was observed that those corners need to be solid as possible to avoid local failures (crushing) during the tests.

**Figure 4: Construction of small walls**

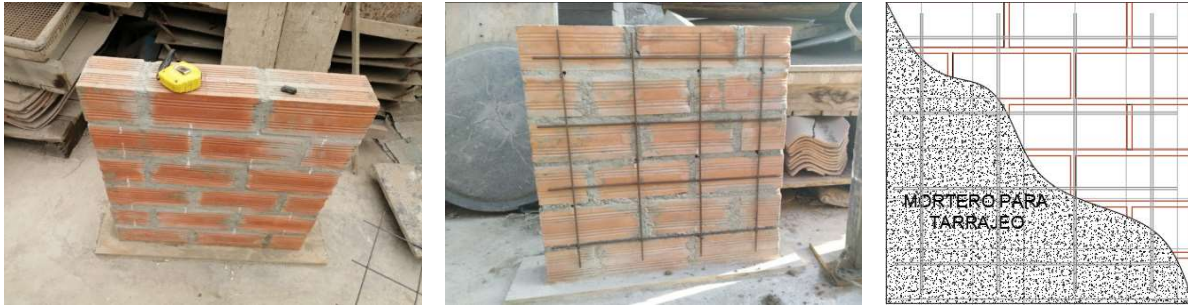
Several points were marked in the mortar joints of three specimens, prior to the reinforcement with the wire mesh. Using these marks, holes were drilled across the specimen, keeping the bricks without damage. A 1.6 mm wire was inserted into each hole with enough length to tie the

wire mesh to the wall; then, the crossing wire was bent and fixed to the masonry (Fig. 5). Afterwards, mortar 20 mm thick was used to cover the wall surface including the reinforcing wire mesh. The gross thickness of these reinforced walls was then 140 mm.

**Figure 5. Wall specimen strengthened with welded wire mesh**

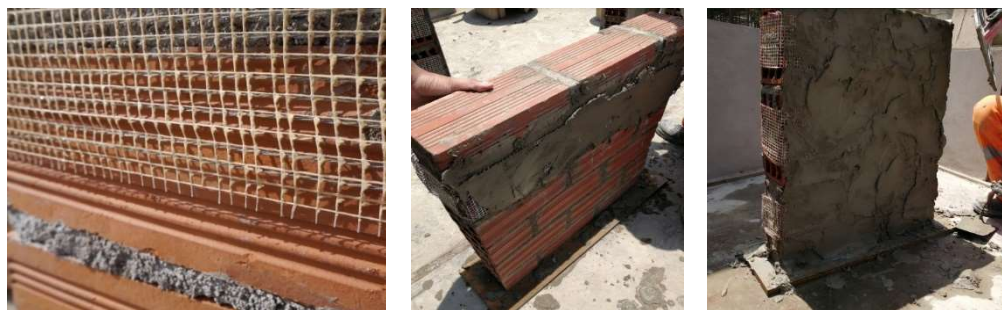
As in the previous case, the 3 specimens were strengthened after 28 days. The fiber application was following the recommendations given by the manufacturer Kerakoll [8]. Special attention was done to remove all dust from the specimens. The strengthening system consisted of 3 bands of 100 mm height and 1620 mm length for each small wall. The bands are placed around the small wall considering also a 200 mm overlapping. First, the surface where the band is to be placed was wetted. Then, a mortar layer from 3 to 5 mm thickness was placed. The band was placed and pressed, leaving the mortar flow over the apertures of the bands; this is to guarantee a good bond behavior between the masonry and the steel bands. At this step, the band should go around the small wall acting as a hoop. Finally, a second mortar layer was applied, pressing again the mortar to guarantee the bonding. The curing of the mortar was done (twice a day, by wetting) during the first 7 days after strengthening. The 3 bands were placed along with the height of the small walls and equally separated (Fig. 6).

**Figure 6: Small wall specimen reinforced with SRG**

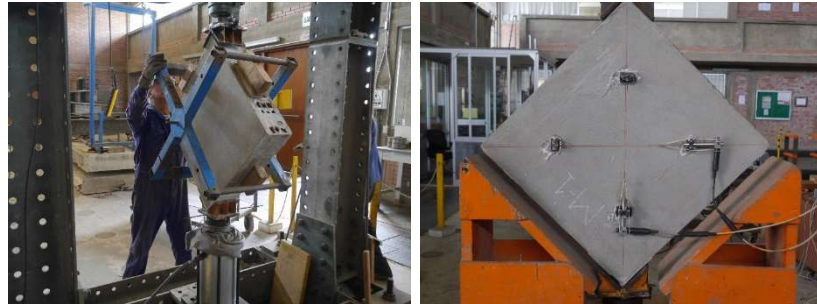
All the wall specimens were carefully moved from the construction yard to the laboratory. At the corners, where the small walls were fixed to the loading equipment, a layer of gypsum was applied to level the corner's surfaces. This was needed to have a better load distribution from the

equipment to each specimen and to avoid local failure as much as possible. Also, two Linear Variable Displacement Transducers (LVDT) were placed in each small wall, along the wall's diagonals. The length of each LVDT was 400 mm. Both LVDT served to measure the deformation in each specimen and to compute the shear modulus (Fig. 7).

**Figure 7: Test setup of the diagonal compression tests**

The diagonal compression load was applied with a hydraulic jack of 200 kN capacity, and with a 10 kN/min as velocity. Special attention was taken at the beginning of the load, giving time to the equipment heads to adapt to the load conditions. The LVDTs were removed (around at 100 kN load) before each specimen failed to avoid any damage to them. The scope of the tests was to record the elastic behavior, and as much as possible, the inelastic stage with the LVDTs. But when those were removed, the vertical displacement at one diagonal continued to be measured by the instrument at the equipment head. Each test lasted about 15 min.

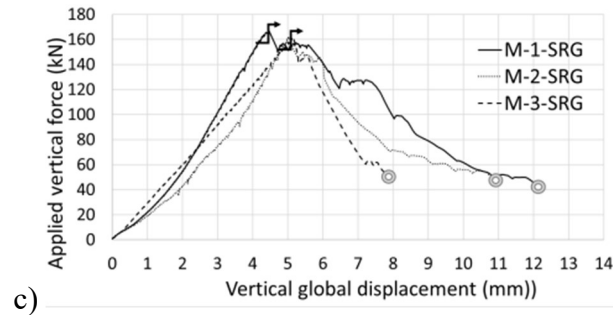
In Fig. 11 a comparison of all Force vs Global Displacements is shown. Here it was marked the point of maximum load and maximum displacement of each curve. To infer in a ductility value, just the inelastic displacements were analyzed and written in Table 5. It is observed that small walls without strengthening had a brittle behavior and with almost no displacement ductility. This displacement ratio is given as unity in Table 5.

**Figure 11: Vertical force vs Global vertical displacement plots, a) small walls without strengthening; b) strengthened with welded mesh and c) with SRG**

**Figure 11: (continuation): Vertical force vs Global vertical displacement plots, a) small walls without strengthening; b) strengthened with welded mesh and c) with SRG**

To evaluate the relative displacement ductility among all the small walls, the plots of vertical force vs global vertical displacements (head machine) were analyzed. These records are related to the vertical displacement of the head of the hydraulic jack. It is known that to compute the displacement ductility, all data in the LVDTs should be recorded, but these were removed from the small walls around 70% of the maximum load. Then, a solution to obtain the ductility of each specimen was to measure the displacement capacity of each specimen after reaching its maximum load capacity, and comparing to the end of the elastic range.

The small walls with steel welded mesh had a greater load capacity but at failure the units broke, the load decreased to around 30% of the maximum load, and then the strengthening worked and transferred ductility to the small walls. The ductility ratio was 8.4 times more than the previous small walls. The last group of strengthened small walls seemed to have better behavior. The steel bands were perfectly bonded to the masonry units, and allowed a smooth decrease in the capacity and with more energy dissipation. Also, the displacement ductility ratio was around 7.80.
