14<sup>TH</sup> CANADIAN MASONRY SYMPOSIUM  
MONTREAL, CANADA  
MAY 16<sup>TH</sup> – MAY 20<sup>TH</sup>, 2021

SHAKE-TABLE TESTS ON COLLAPSE RESISTANCE OF REINFORCED MASONRY  
WALL SYSTEMS

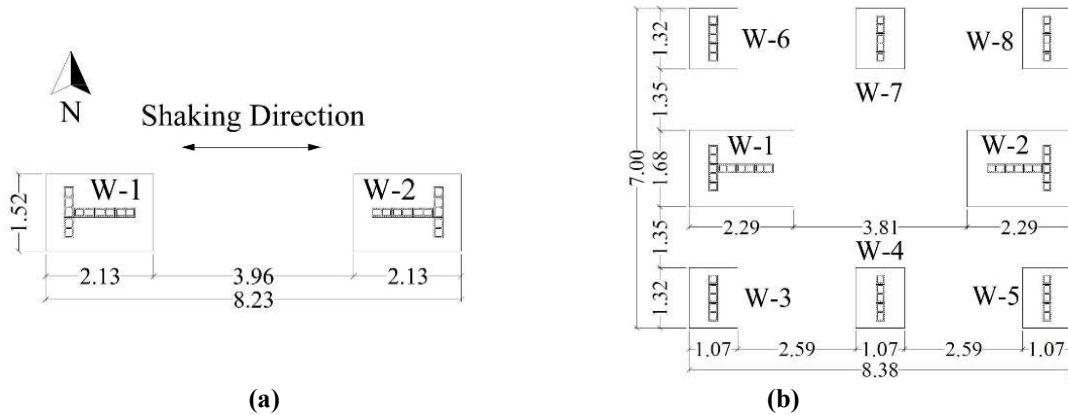
**Figure 1: Plan views of footing and wall layout (in meters): (a) Specimen 1; (b) Specimen 2**

Figure 1 shows the plan layouts of the two RM shear wall systems designed and tested under unidirectional motions on the outdoor shake table in the NHERI (Natural Hazards Engineering Research Infrastructure) facility at the University of California San Diego. Each specimen had two T-walls as the main seismic force resisting system. Specimen 2 had six additional rectangular walls with their planes oriented perpendicular to the direction of the shake-table motion. They are

This section presents the major observations and the structural response obtained from the tests of the two specimens with the wall numbers identified in Figure 1. For both specimens, the roof drift ratios were calculated as the relative roof displacement divided by the wall height of 2.44 m (8 ft). The base shear was calculated as the product of the average roof acceleration along the shaking direction, measured by the accelerometers installed along the perimeter of the roof slabs, and the seismic mass consisted of the total roof mass and the masonry mass above the mid-height of the walls.

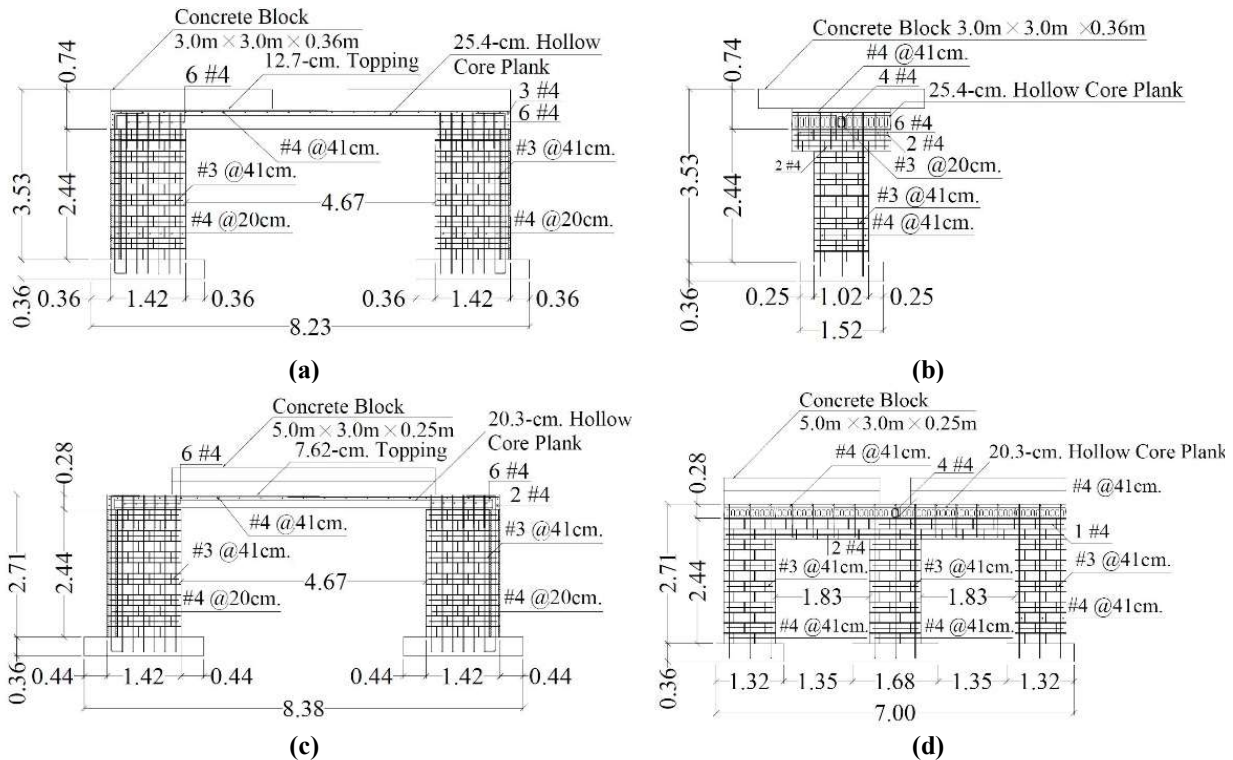
**Figure 2: Reinforcement details (in meters unless indicated): (a) South elevation view of Specimen 1; (b) West elevation view of Specimen 1; (c) South elevation view of T-walls in Specimen 2; (d) West elevation view of Specimen 2**

Figure 2 shows the reinforcement details for the two specimens. The reinforcing bars in the walls had a nominal yield strength of 414 MPa (60 ksi). Each T-wall had six No. 4 (13 mm) vertical bars spaced at 20 cm (8 in) on center in the web, and three No. 4 (13 mm) vertical bars spaced at 41 cm (16 in) in the flange. The horizontal bars in the web and the flange were No. 3's (10 mm) spaced at 41 cm (16 in) on center. In Specimen 2, each of the out-of-plane walls had No. 4 (13 mm) bars for the vertical reinforcement, and No. 3 (10 mm) bars for the horizontal reinforcement, both spaced at 41 cm (16 in) on center. The reinforcement complied with the prescriptive requirements of TMS 402/602 [1] for walls designed for high seismic areas, but the spacing of the reinforcing bars in the flanges of the T-walls slightly violated the maximum spacing requirement (which is no greater than one-third of the wall length). The vertical reinforcement ran continuously from the walls into the footings, and each bar ended with a 90-degree standard hook in the footing conforming to the ACI 318-14 specification [7] for the development of reinforcement in tension. The surface of the concrete footing underneath each wall was intentionally roughened to increase the frictional resistance.

As shown in Figure 2, the roof slab of Specimen 1 consisted of 25-cm-thick (10-in) precast prestressed hollow-core planks with a 13-cm-thick (5-inch) cast-in-place concrete topping. Two reinforced concrete slabs, each with dimensions of  $3.0 \times 3.0 \times 0.36$  m (10 ft  $\times$  10 ft  $\times$  14 in), were secured on top of the roof slab to achieve the target roof mass. For Specimen 2, the roof slab consisted of 20-cm-thick (8-in) hollow-core planks with a 7.6-cm (3-in) concrete topping. It had four additional concrete slabs, each with dimensions of  $5.0 \times 3.0 \times 0.25$  m (16.5 ft  $\times$  10 ft  $\times$  10 in), as added mass. The resulting roof weights of Specimens 1 and 2, including the added concrete slabs, were 245 kN (55.1 kips) and 601 kN (135 kips), respectively. The roof weights of the two specimens were so determined that the T-walls in the two specimens carried the same gravity load. Since the roof slabs were very stiff, the tributary roof load,  $P$ , on each wall was assumed to be

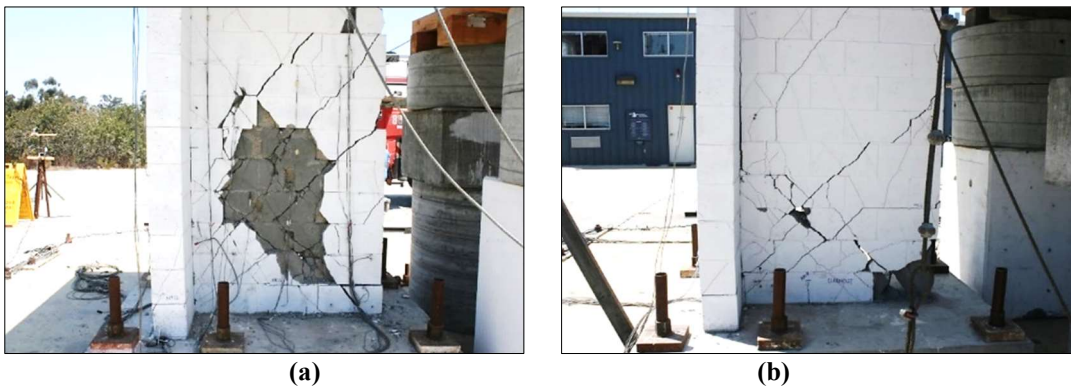
**Figure 7: Damage in Specimen 1 after MUL-133%: (a) South view of Wall-1; (b) North view of Wall-2**

The last dynamic test on Specimen 1 was conducted with a 133%-level Mulholland motion. In this test, the walls developed severe shear cracks. Figure 7 shows the severe diagonal shear cracks and the masonry spalling and crushing that developed in the webs of the T-walls. Wall-2 (East T-Wall) also showed base crushing and subsequent buckling of the extreme vertical bar in the web near the wall base. The base shear-vs.-roof drift hysteresis curves for the structure (Figure 6) shows that the peak strength of 690 kN (155 kips) was reached at a roof drift ratio of about 1% in the negative (west) direction. The peak strength of the specimen is close to the shear strength of 685 kN calculated with the formula given in TMS 402/602 [1]. The masonry compressive strength and the yield strength of the horizontal reinforcing bars used in the strength calculation were the average strengths obtained from the material sample tests. They are 20 MPa (2.9 ksi) and 521 MPa (75.6 ksi), respectively. A maximum roof drift ratio of 2.53% was reached in the west direction. At this drift level, the lateral resistance of the tested structure dropped to 340 kN (76.3 kips), which was

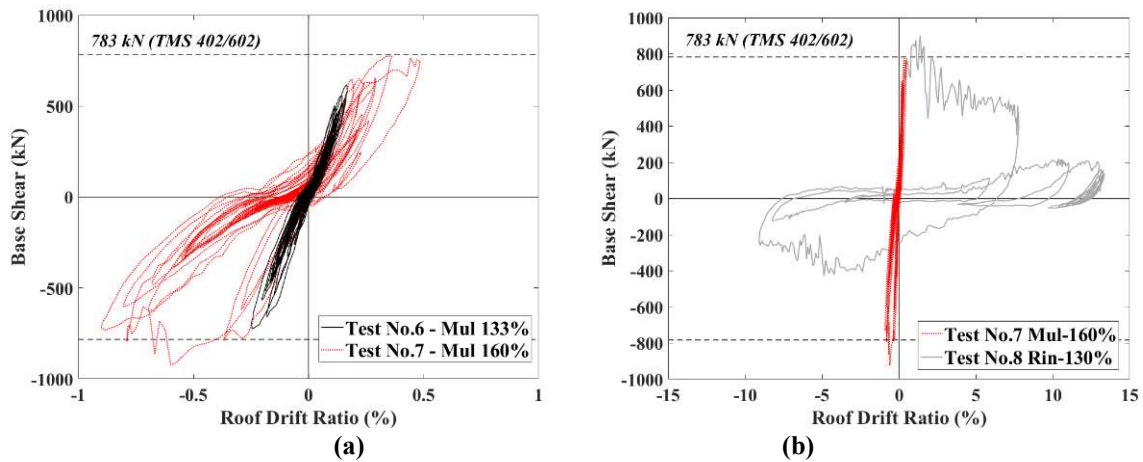
**Figure 9: Base shear-vs.-roof drift ratio curves for Specimen 2: (a) Mulholland motions; (b) last two motions**

During MUL-160%, a maximum drift ratio of 0.90% was reached. As shown in Figure 9, the base shear capacity of 925 kN (208kips) was reached at a roof drift ratio of 0.60% in the negative (west) direction. During the test, degradation of lateral resistance was relatively mild, about 22% with respect to the peak. Flexural and diagonal shear cracks occurred in the webs of the two T-walls, and toe crushing occurred in the web of Wall-2. With the initiation of diagonal cracks in the webs of the two T-walls, yielding occurred in the vertical and horizontal bars at locations intersected by diagonal shear cracks.

During RIN-130%, Specimen 2 reached verge of collapse with a maximum drift ratio of 13.4%. Severe damage was developed on the web of two T-walls. The base shear-vs.-roof drift ratio curves in Figure 9(b) show that the maximum base shear reached 902 kN (203 kips) at a drift ratio of 1.39% in the positive (east) direction. The specimen developed a residual strength of 185 kN (41.6 kips), which was about 20% of the peak strength (208 kips) reached during MUL-160%. Figure 10 shows the damage of the specimen after the test. The diagonal cracks developed during MUL-160% extended further and were accompanied by the opening of new diagonal cracks in the webs of the T-walls. As in the quasi-static test of Specimen 1, severe masonry crushing occurred in the wall webs. After this test, all the horizontal bars (except the two top bars) in the webs of the T-walls fractured at the locations along the major shear cracks. The webs and flanges of the T-walls were practically separated. The failure of the 90-degree hooks connecting the flanges and webs was observed, along with the fracture of the horizontal bars crossing the flange-web interfaces. The flanges of the T-walls exhibited severe out-of-plane bending at the elevation of the horizontal cracks that developed in motion MUL-160%. However, the roof slab remained practically intact during the test. At the end of the tests, the webs of the T-walls in both specimens had lost significant portions of the masonry due to crushing, and the roof weight was carried by the wall flanges and the out-of-plane walls.

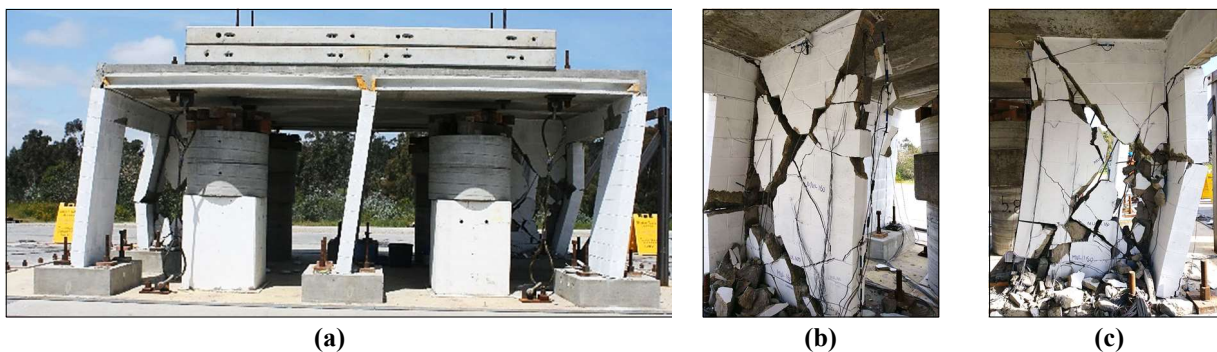
**Figure 10: Damage in Specimen 2 after RIN-130%: (a) South view of Specimen 2; (b) South view of Wall-1; (c) South view of Wall-2**
