14<sup>TH</sup> CANADIAN MASONRY SYMPOSIUM  
MONTREAL, CANADA  
MAY 16<sup>TH</sup> – MAY 20<sup>TH</sup>, 2021

## IN-PLANE SEISMIC BEHAVIOR OF SPECIAL REINFORCED FULLY GROUTED MASONRY SHEAR WALLS SUBJECTED TO HIGH AXIAL LOADS

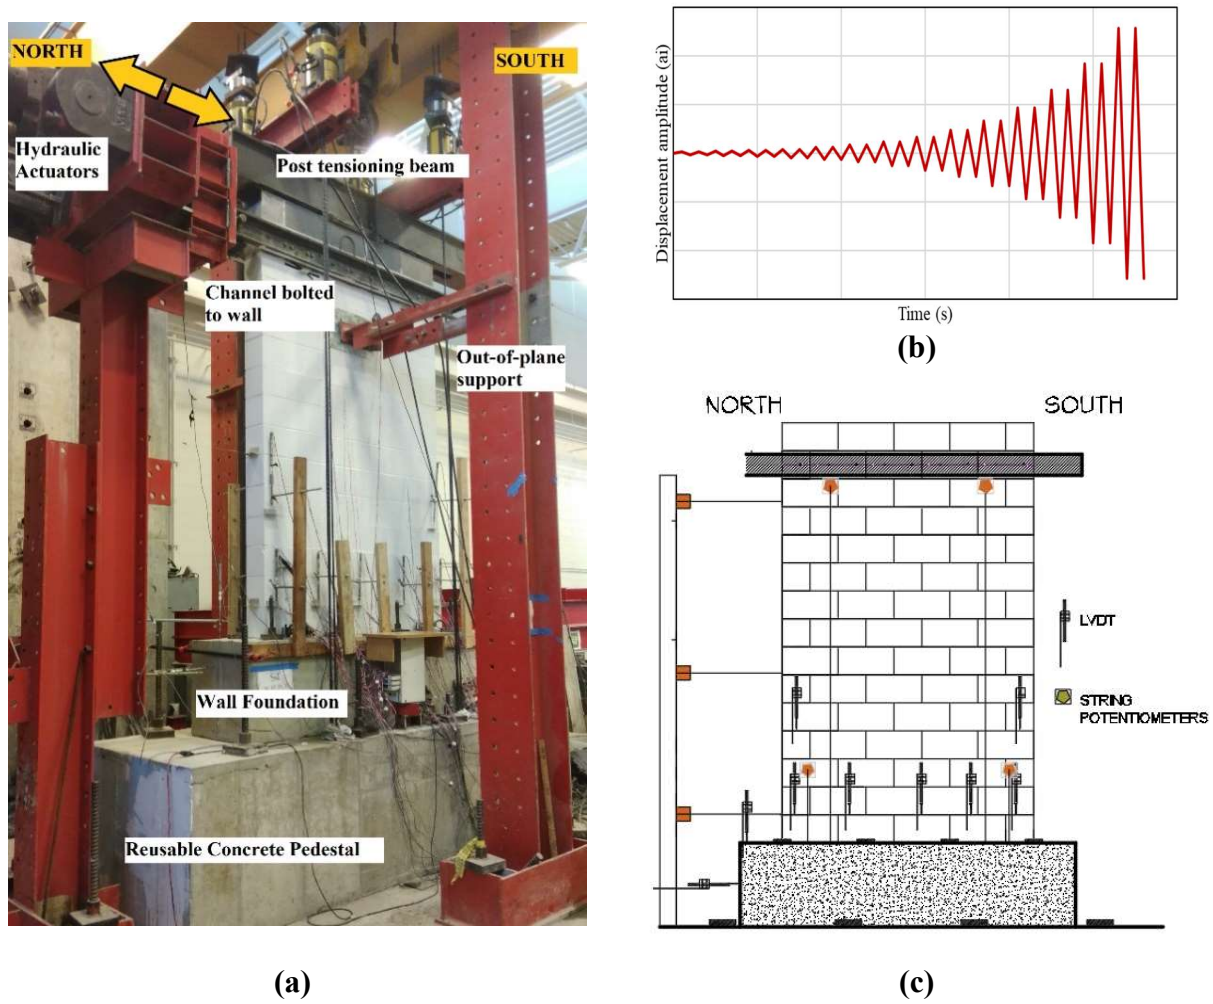
(a) (b) (c)  
**Figure 2: (a) Test Setup, (b) Loading protocol, (c) Instrumentation**

The walls were subjected to fully reversed in-plane cyclic load using two 890kN (200-kips) actuators as shown in Figure 2a. Loading protocol as per FEMA 461[6] have been used. The amplitude  $a_i$  of the stepwise increasing deformation cycles is given by the equation  $a_{i+1} = 1.4a_i$ , where  $a_i$  is the amplitude at 'i' cycle as shown in Figure 2b. The axial stress on the walls were applied with a steel loading beam equipped with load cells and high strength post tensioning strands that run through the RC pedestal. The post tensioning force on the strands were monitored thorough the load cells.

Figure 2a shows the test setup of the walls being tested. The wall foundation was post tensioned to a larger reinforced concrete pedestal with 8 Dywidag bars which in turn was post tensioned to the laboratory's strong floor. The out-of-plane bracing used is shown in Figure 2a. The out-of-plane supports had Teflon sheet in contact with wall surface to eliminate any frictional resistance between the support and the wall.

A computerized data acquisition system was used to measure the applied loads, horizontal and vertical displacements measured using several string potentiometers and LVDTs. A total of eleven LVDTs and four string potentiometers (Figure 2c) were installed along the wall length and height to monitor the vertical displacements with respect to the wall foundation. Moreover, two more LVDTs were used to separately measure the sliding and rocking of the foundation. Eleven strain gauges were attached to each vertical reinforcement bar. The strain gauges were placed in close proximity at the plastic hinge length region to accurately measure the strain profile in the plastic hinge region. Out of the eleven strain gauges, three were attached on the reinforcement inside the foundation to determine the strain penetration inside the foundation.

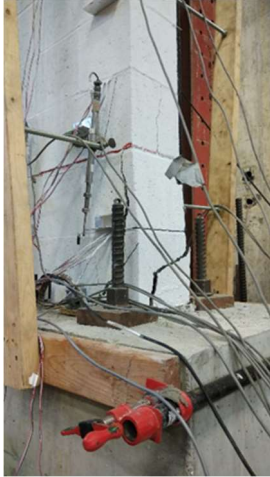
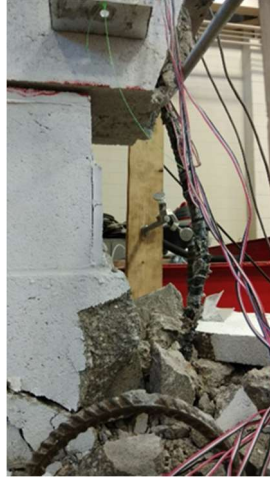
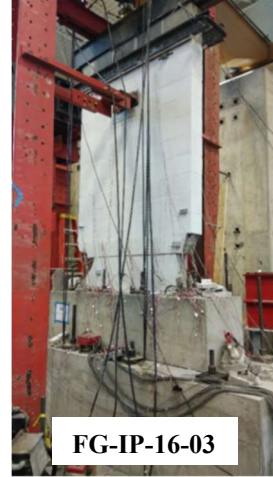
**Figure 4: Cracking and damage of wall specimen : (a) and (b) Crushing and bar buckling of FG-IP-16-03, (c) Extent of damage at end of test of FG-IP-16-03, (d) and (e) Crushing and masonry spalling of FG-IP-16-10, (f) Extent of damage at end of test of FG-IP-16-10, (g) and (h) Compression cracks and bar buckling of FG-IP-16-15, (i) Extent of damage at end of test of FG-IP-16-15.**

of yielding strain. Widening of bed joint cracks along with vertical splitting cracks at the south bottom end were observed at a drift of 0.70% which is at the onset of yielding. With drift reaching 1%, more step cracks appeared and widening of the 2nd course bed joint. At 1.75% drift level compression cracks widened with bar buckling evident as masonry up to 3rd course was bulging out with severe splitting cracks (Figure 4a and 4b) on both ends of the wall. The wall continued at this peak load of 253.5 kN (57 kips) for 2 more cycles reaching a drift of 2.6%. The load degradation observed was not rapid. The wall sustained almost 70% of the peak load in the last two cycles reaching a maximum drift of 3.50%. Maximum crack width of 18mm (0.70 inch) was recorded at this drift level. The maximum masonry strain recorded at the wall toe at failure was 0.0067. The outermost vertical rebars has gone through almost 7 times of the yielding strain and buckling of rebar revealed with masonry spalling (Figure 4b). The extent of damage at the end of the test is shown in Figure 4c.
