14TH CANADIAN MASONRY SYMPOSIUM
MONTREAL, CANADA
MAY 16TH – MAY 20TH, 2021

**QUASI-STATIC OUT-OF-PLANE TESTING OF UNREINFORCED MASONRY WALLS
INSTRUMENTED WITH OPTICAL MEASUREMENTS**

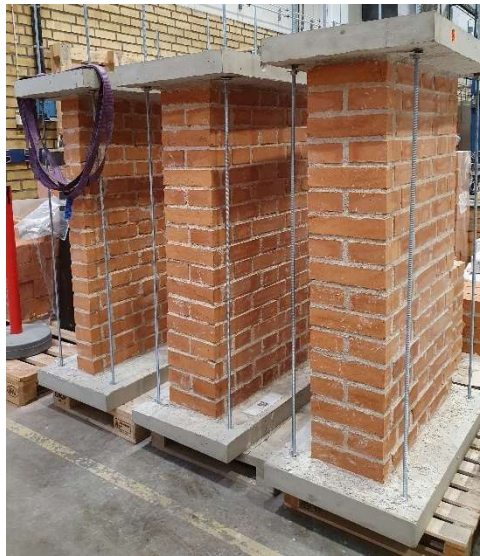
Three specimens were configured as unreinforced walls without a cavity (see Figure 1). One wall was built with one wythe and two walls with two wythes. The dimensions of the specimens were $1500 \times 780 \text{ mm}^2$ with a thickness of either 125 mm or 250 mm. Each wall was constructed between two reinforced concrete (RC) slabs ($980 \times 500 \times 75 \text{ mm}^3$) to simulate similar contact conditions to that found in existing buildings, where masonry walls are directly in contact with the RC floor slabs.

Figure 1: Exemplification of Test Specimens

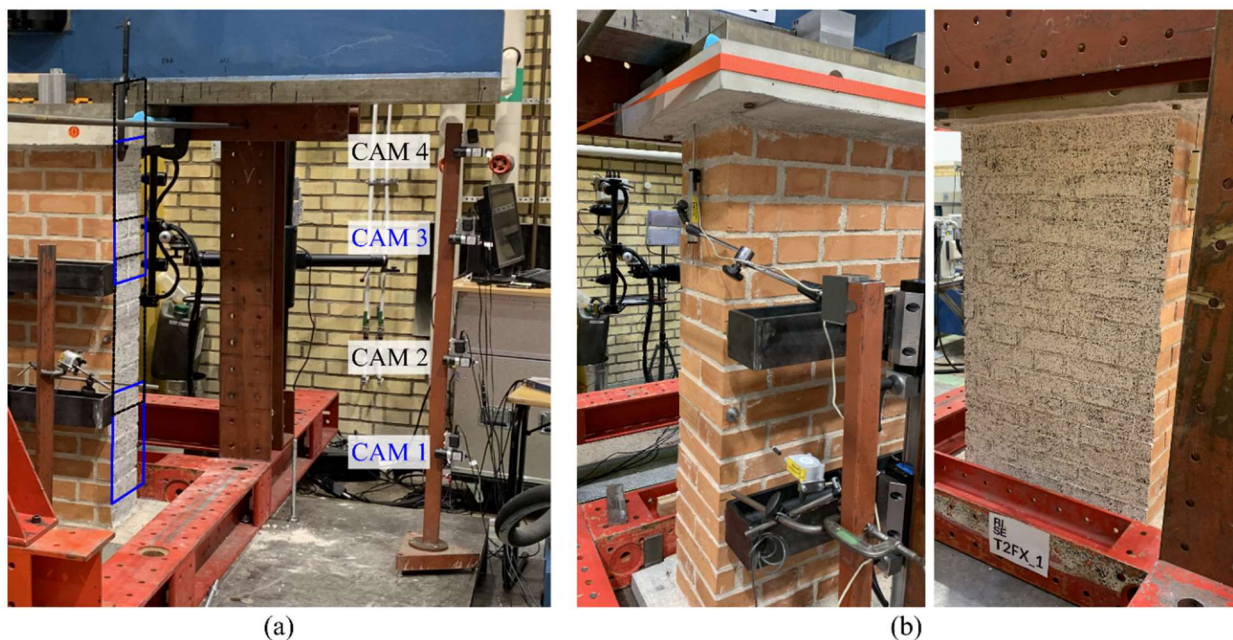
four single-camera set-up (2D DIC) and three-dimensional measurements using a stereoscopic camera set-up (3D DIC) were used, as shown in Figure 3. The basic idea of DIC is to measure the displacement of a specimen under testing by analysing the deformation of a surface speckle pattern in a series of digital images acquired during loading. This is accomplished by tracking the position of discrete pixel subsets of the speckle pattern within the images.

Figure 3: DIC Measurement Setup: 2D (a) and 3D (b)

The 3D DIC measurement was performed using the optical system ARAMIS 12M by GOM [10]. The system configuration was calibrated for a measuring volume of approximately $1500 \times 1200 \times 1200 \text{ mm}^3$, covering most of the wall surface, except a smaller area at the lower part, which were unsighted by the support beam (see Figure 3b). The images were captured with a frequency of 0.5 Hz. For this configuration, the displacement resolution was approximately 0.005 mm for both x- and y-displacement (in-plane) components and approximately 0.010 mm for z-displacement (out-of-plane), determined as the standard deviation between two static images of the specimen before loading. The out-of-plane 3D DIC measurement of the wall surface allows the visualization and determination of deformation characteristics and crack distribution, as depicted in Figure 4.

The images from the 2D DIC measurements were taken along the height of one side of the wall element, mainly to determine the crack propagation through the wall thickness (see Figure 3a). The imaging system was set up as four individual 2D measurements, with three of the cameras covering a third of the wall height each (measuring area $560 \times 470 \text{ mm}^2$), with a small overlap, and the fourth camera focusing on the upper concrete slab. The images were acquired with a frequency of 0.5 Hz and evaluated by DIC technique using the software GOM Correlate [10]. For this configuration, the displacement resolution was approximately 0.003 mm for both x- and y-displacement components (in-plane).

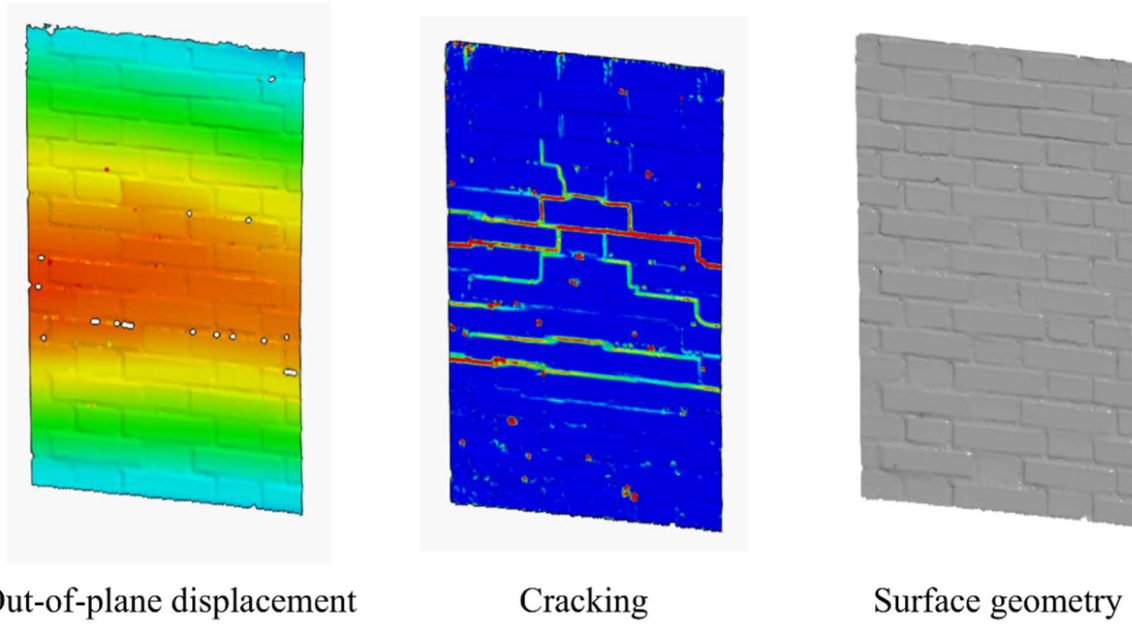
Figure 4: Exemplification of 3D DIC Measurement Results

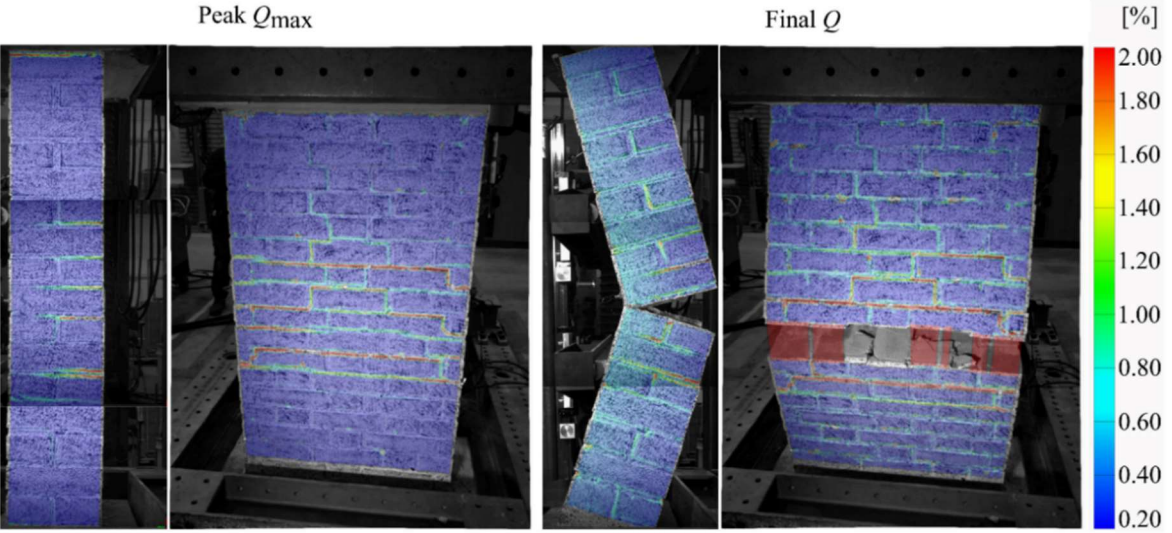
The wall experienced a three-hinge mechanism as shown in Figure 10. Two mid-cracks, located at the same distance from the supports, formed. The upper middle crack eventually closed while the lower middle crack was opened forming the middle hinge. Given the thickness of the wall, a large amount of crushing was observed. Shear sliding at the wall supports, in combination with bending, was also noted.

Figure 10: T2-2: DIC Results for Peak and Final Horizontal Loads
