SEISMIC REHABILITATION OF UNREINFORCED MASONRY SHEAR WALLS

Omer O. Erbay¹ and Daniel P. Abrams²

ABSTRACT

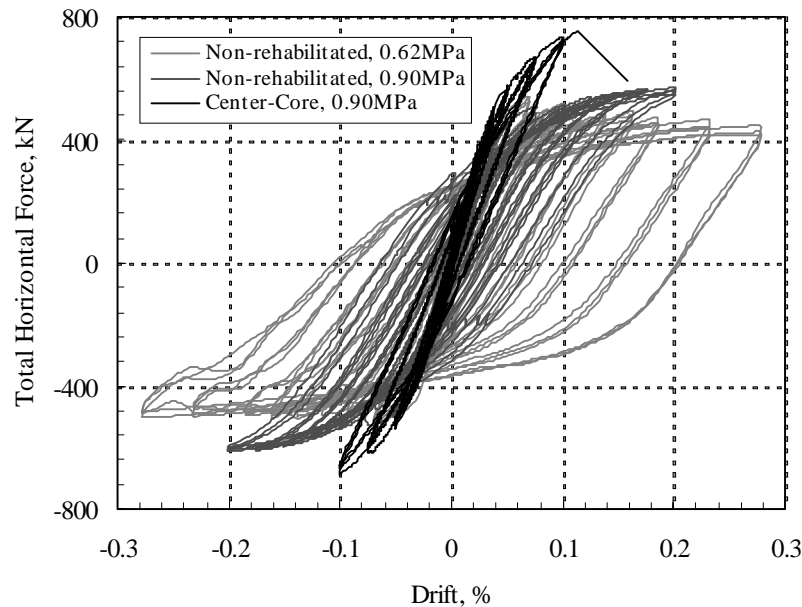
Figure 3 Measured Force-Deflection Curves for Masonry Wall Specimens

The second plain test wall, 2S, had a vertical compressive stress of 0.90MPa [130psi]. The general response behavior was very similar to the first specimen except that the higher vertical compressive stress level resulted in higher lateral force capacity, Figure 3. The initial flexural crack occurred at approximately 0.04% drift, corresponding to a lateral force level of approximately 65% of the ultimate lateral strength. Similar to the first specimen, this specimen also slid along the bottom bed-joint, Figure 4. The sliding started at a drift level of approximately 0.13%, Figure 5. As can be seen, the amount of sliding gets larger as the number of repetitions of the cycle increases for the same drift level. This indicates that the sliding surface roughness deteriorates with increasing cycle repetitions. At approximately 0.2% drift level the wall reached its limit state. The mode of failure can be represented as toe-crushing together with out-of-plane failure. The ultimate drift level is approximately five times the drift level at the initial flexural cracking took place.

3S, respectively. Similar to the initial elastic stiffness, the unloading stiffness is higher for the rehabilitated specimen, Figure 3. Early stages of the unloading response for specimens 1S and 2S reflects the small stiffness associated with the crack closing behavior. Unlike the first two specimens, the presence of cores and reinforcing bars reacted the unloading motion thus increased the unloading stiffness for specimen 3S.

Plain and rehabilitated walls had a different energy dissipation mechanism. For plain walls most of the energy was dissipated through the sliding shear mechanism. As can be seen from Figure 3, this mechanism initiated at a certain drift level and advanced further during the subsequent drift levels. Since the sliding shear capacity was greatly enhanced by the rehabilitation technique, the energy dissipation attributable to this mechanism was relatively low for the rehabilitated specimen. However, yielding in the reinforcing bars and slip at the core interface introduced other means of energy dissipation measures. Unlike the sliding shear mechanism, energy dissipation due to yielding started at an earlier drift level because drift levels smaller than drift levels resulting in sliding, generate yielding in the reinforcing bars. Different energy dissipation characteristics, loop fatness, for small drift levels can be seen in Figure 3.

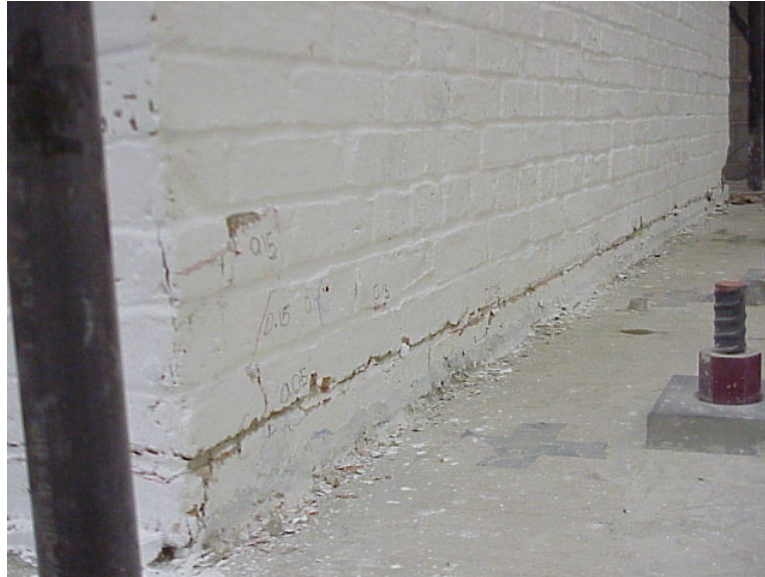
ultimate lateral force capacity of the specimen. With increasing drift levels the flexural crack extended and eventually joined with the crack developing from the other side of the base. At approximately 0.1% drift, the wall started to slide causing unrecoverable deformations along the wall base, Figure 4. Figure 3 shows the full force-displacement response history of the wall. As can be seen, sliding shear response becomes more dominant, more dissipated energy within loops, with increasing drift levels. Other than providing a good energy dissipation mechanism, the sliding shear behavior greatly enhanced the deformation capacity of the wall. Lateral drifts as large as seven times the initial flexural cracking drift, were observed without loss of lateral force capacity. High

Figure 4 Sliding Along the Bottom Bed-Joint, Specimen 2S

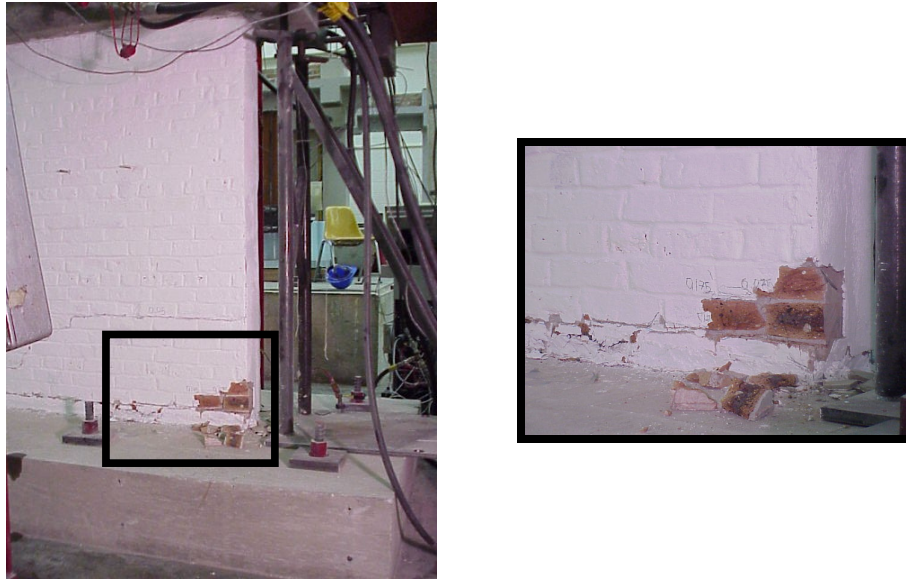
post-cracking strength is due to the friction acting along the base joint and therefore suggest that the vertical compressive force plays a significant role on ductility. The limit state was reached at a drift level of 0.3%. The limit state mode can be stated as toe-crushing together with an out-of-plane failure, Figure 6.

Figure 6 Toe-Crushing at the Ultimate Stage, Specimen 2S

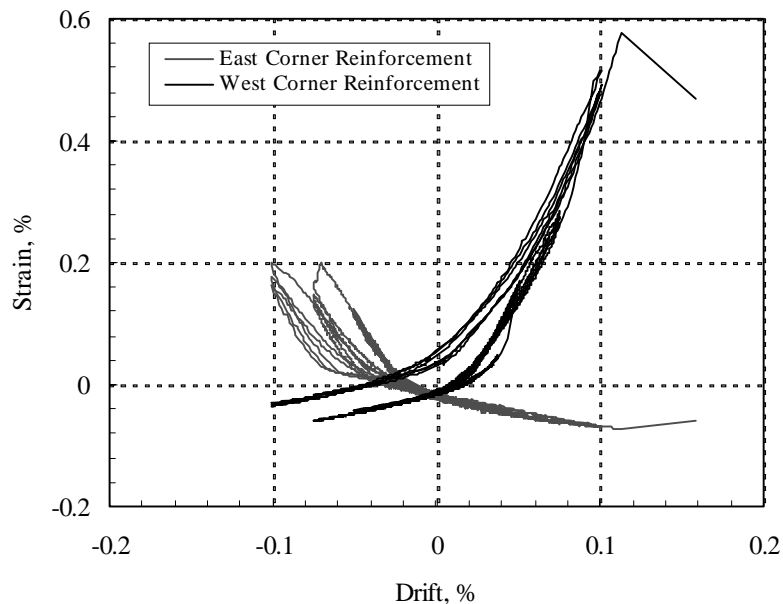
The center-core rehabilitation technique was selected to improve the sliding shear strength and the flexural capacity of the wall specimens. The vertical compressive stress was set equal to 0.90MPa [130psi] for direct comparison purposes. The specimen had an initial cracking drift that was similar to the previous specimens. The force level corresponding to this drift level was approximately 66% of the ultimate lateral strength. The outer reinforcing bars yielded at approximately 0.06% drift level, indicating that the cores were able to develop the full yield strength of the reinforcing bars, Figure 7. This suggests that the behavior of the specimen can be represented by that of a reinforced masonry wall. Examination of Figure 7 shows a horizontal offset in the curve corresponding to sliding taking place between the core and the surrounding masonry in the East corner reinforcement beyond 0.07% drift. A similar offset can be noticed for the West corner reinforcement but in the vertical direction. This indicates a permanent plastic deformation in the bar.

Figure 7 Strain Variation at Corner Reinforcements in Specimen 3S

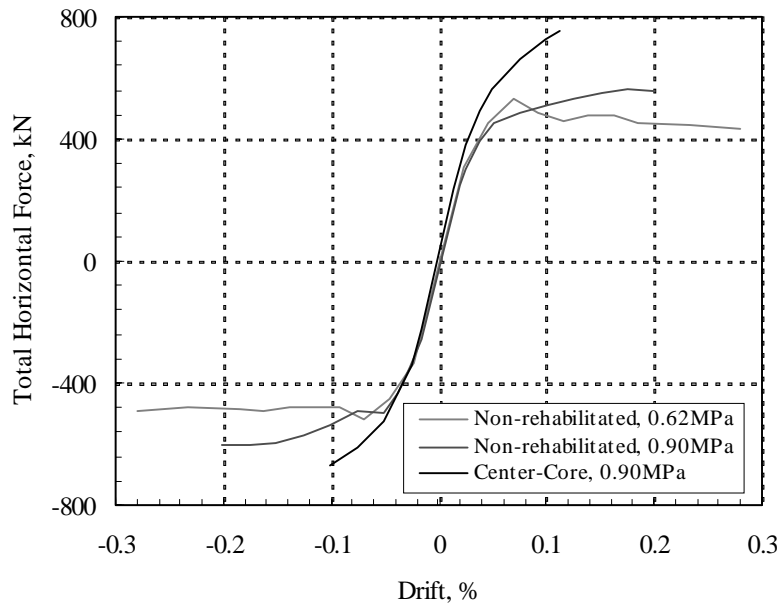
Figure 8 shows the envelope curve for each specimen. Comparison of the curves in the elastic range indicates that specimens 1S and 2S have very similar initial elastic stiffnesses. However, being reinforced and grouted with stiffer material than the surrounding masonry, the third specimen shows a higher initial elastic stiffness than the first two specimens. The initial elastic stiffnesses can be approximated as 540,000kN/m [3080kip/in], 592,000kN/m [3376kip/in], and 663,000kN/m [3780kip/in] for 1S, 2S and

Figure 8 Envelope Force-Deflection Curves for 1S, 2S and 3S
