BRICKWORK MASONRY WALLS REINFORCED BY CFRP

Roberto Capozucca¹

The aim of this paper is the analysis of the behaviour of brickwork masonry walls damaged by shear-bending loading and reinforced by Carbon Fibre Polymers.

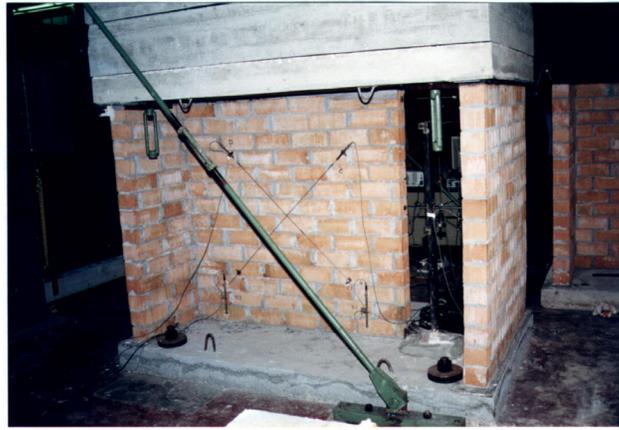
Figure 1 - Brickwork masonry model in scale 1 to 2.

The experimental brickwork masonry model with flange is shown in Figure 1. The dimensions of the hollow units are $247 \times 118 \times 95 \text{ mm}^3$. The ratio of holes on the gross area is $\phi=45\%$. The wall subjected to bending and shear has a T-shape section. The principal dimensions are (Figure 2): t (width of wall)=118mm; b (depth of flange)=1.32m; h (height) = l (length)=1.47m. The section area is $A=0.33 \text{ m}^2$; the position of the central axis from the edge of flange is $a=477 \text{ mm}$; the moment of inertia is $I=831.53 \cdot 10^8 \text{ mm}^4$.

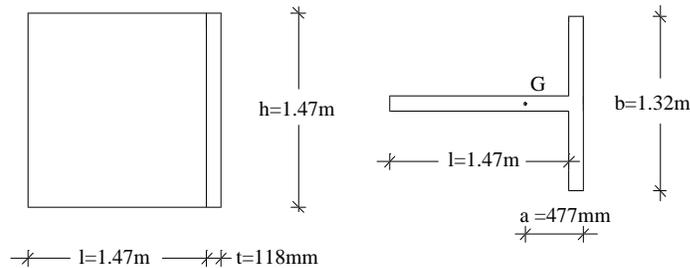
Figure 2 - Geometric dimensions of the brickwork model in scale 1 to 2.

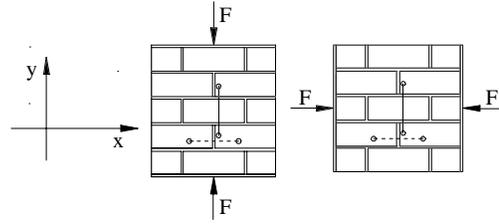
Figure 3(a) - Masonry wallets subjected to compressive tests in two directions.

The compression strength of the units in direction parallel to the holes is $f_b=22.45 \text{ N/mm}^2$. The mortar used in the wall is a high strength mortar, type M1 in compliance with Italian rules. The strength of mortar to compression is $f_m=19 \text{ N/mm}^2$. The strength of masonry is evaluated both on prisms of 5 units and wallets of $504 \times 515 \text{ mm}^2$ in two directions, as shown in Figure 3(a). By means of compressive tests on the wallets, the compression

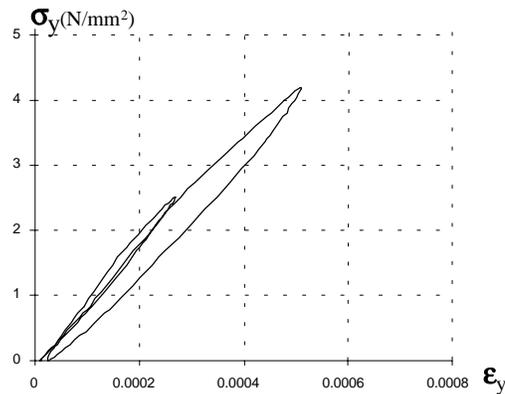
Figure 3(b) - Cyclic diagrams by compressive tests on the wallets in y direction.

strength of masonry, $f=12.86 \text{ N/mm}^2$, and the elastic modulus $E_y=8483 \text{ N/mm}^2$ by the diagram σ - ε (Figure 3b), are evaluated.

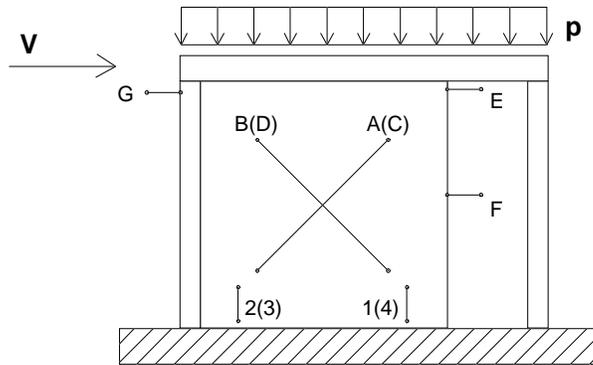
Figure 4 - Brickwork model and instruments of measure: E,F,G inductive displacement transducers; A,B,C,D inductive diagonal displacement transducers; 1,2,3,4 inductive displacement transducers at the first mortar bed joint.

During the shear-bending test on the brickwork model, a precompression load was transferred on the top by RC slabs for a total of vertical stress $\sigma_v = 0.1 \text{ N/mm}^2$. The test was cyclic and the horizontal load V was imposed by a hydraulic horizontal jack applied at the edge of slab (Figure 4).

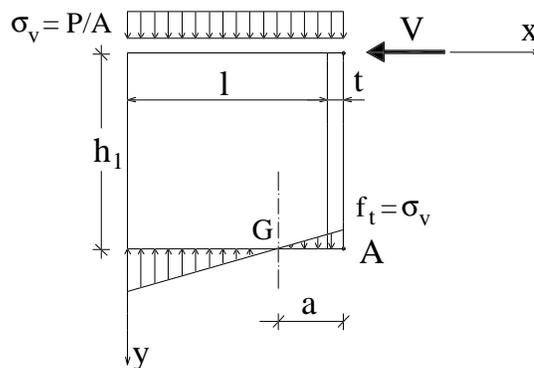
Figure 5 - Brickwork masonry scheme under loading.

The behaviour of the model under shear load applied at the top is first studied theoretically considering the scheme in Figure 5. The unreinforced brickwork masonry model was subjected to a precompression load P so that a vertical stress is present in the wall:

Under loading, the tensile stress that may be sustained at the A point, located at the height of the first mortar joint, in absence of tensile capacity of the masonry, is equal to σ_v .

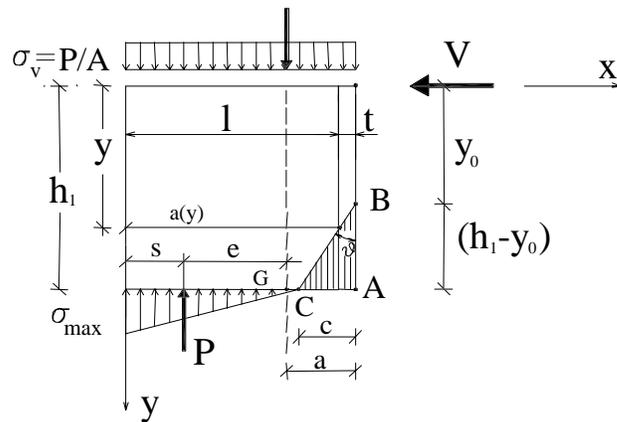
Figure 6 - Cracked brickwork masonry scheme

being $u = W_s/A$ the ratio between the resistant modulus of the entire section and the T-shape area. When the shear V is greater than V_{cr} , the section is cracked with a dead zone of the panel as indicated in Figure 6 (Epperson *et al.*, 1990).

The dead zone is limited by a straight line between the points B and C. The top of cracked zone is given by equation:

Considering the equations (7), (8), and (9), the inclination θ of straight line B-C may be evaluated. Finally for each section, at the distance $y > y_0$ from the top of wall, the non cracked zone is (Figure 6):

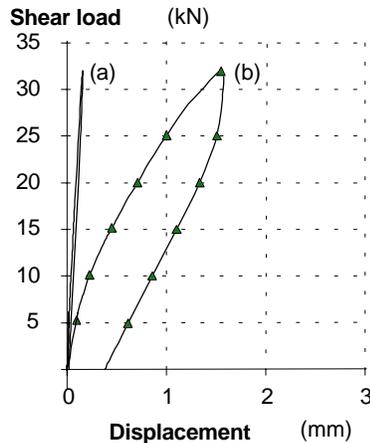
Figure 7 - Shear load vs displacement (a) by the diagonal transducers and (b) at the top.

The shear-bending test on the unreinforced model confirms the results of the theoretical analysis exemplified above. Figure 7 shows the experimental diagrams of displacements measured during the test. The diagram (a) in Figure 7 refers to the data obtained by diagonal inductive transducers used to record the strain of the wall up the first mortar joint where the cracking first appears. Diagram (b), on the other hand, shows the total displacement at the top of wall taking account the data recorded at points E and G (Figure 4). The development of this last diagram is influenced by the cracking phase in the mortar joints. About $V=11\text{kN}$, the stiffness of the wall decreases considerably and begins the cracking phase. The development of diagram (b) in Figure (7) also shows that the model sustains an increment of shear load over 25kN .

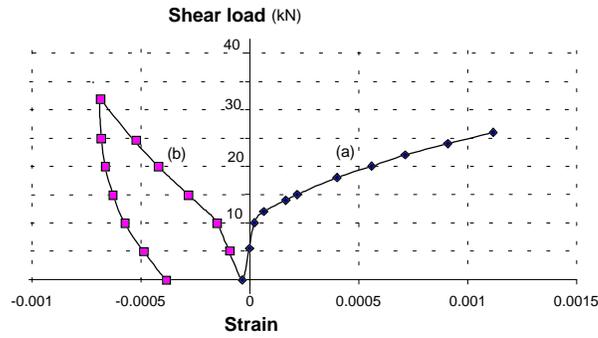
Figure 8 - Experimental diagrams (a) at the 2(3) transducers and (b) at the 1(4).

In Figure 8 however, where the strain measures at the inductive vertical transducers 1(4) and 2(3) are described, it is easy to verify that over the $V=25\text{ kN}$ the tensile strain is not recorded in that the wall is subjected to a rigid rotation.

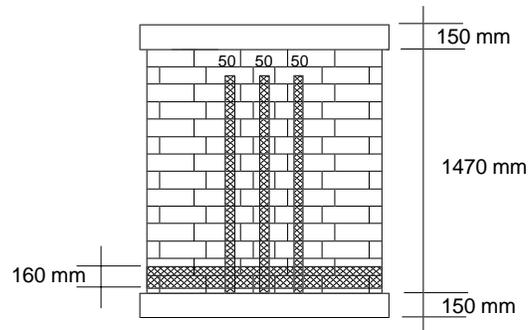
Figure 9 - Brickwork model reinforced by CFRP-sheets on the flange

The reinforced model is shown in Figure 9. Three CFRP-sheets each with a depth of 50mm, were located on the flange after the preparation of the brickwork surface. The clay wall was first thoroughly cleaned and then primed to seal the pores on the surface of the bricks and mortar using an epoxy primer.

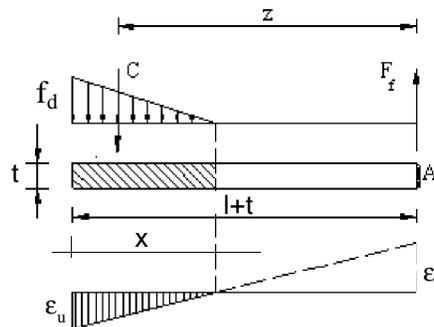
Figure 10 - Resistant section area of the strengthened model by CFRP.

Figure 10 shows an appraisal method to calculate the ultimate internal moment M_u of the masonry wall reinforced by CFRP. The resistant section is given by the carbon fibre area $A_f=1.65 \cdot 15=24.75\text{mm}^2$ and compressive area of masonry. We assume the following values of the ultimate state of masonry: $\epsilon_u=0.15\%$ and $f_d=7\text{N/mm}^2$, to determine the internal resistant moment. The following equations of equilibrium and compatibility may be written:

$$M_R = A_f \cdot \sigma_f \cdot z \cong 110\text{kNm} \quad (14)$$

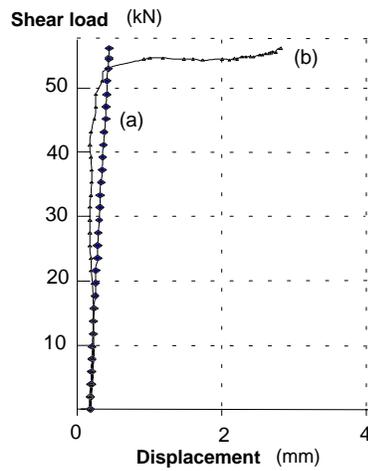
Figure 11 - Shear load vs displacements in the case of the first strengthened model

Figure 11 shows the experimental diagrams measured during the shear-bending test. The displacements were measured both by the diagonal transducers and horizontal E, G transducers. It is evident that the response is quite similar. In fact the behaviour is quasi elastic without cracking. This aspect confirms the convenience of strengthening by

CFRP-sheets. A decrease of displacements under loading and a relevant increase of the stiffness of model are obtained.

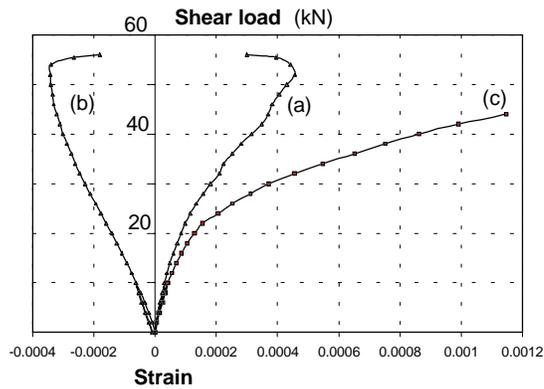
Figure 12 - Shear load vs strain on the tensile masonry (a) by 2 and 3 transducers, compressive masonry (b) by 1 and 4 transducers and on CFRP (c) by strain-gauges.

Figure 12 shows the diagrams shear load - strain both on the brickwork masonry and on the CFRP-sheets. The experimental test also evidences that the ultimate value of shear force is minor than theoretical V_u since the disposition of the sheets only on the external surface of flange is not totally adequate.

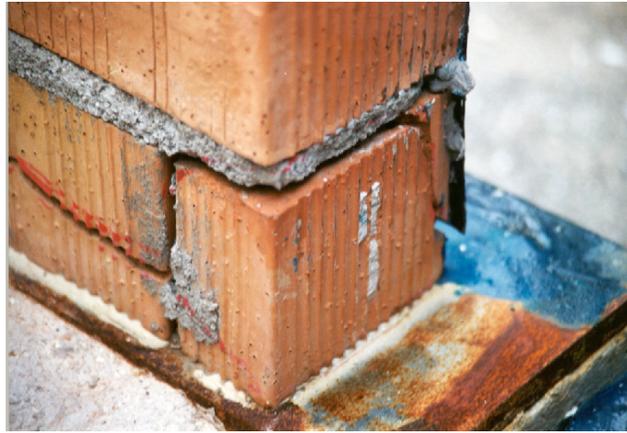
Figure 13 – View of local failure of the strengthened model

During the loading phase, a sudden local failure on the units appeared (Figure 13) due to the sliding of the external masonry sheet of the hollow units glued to the CFRP. The collapse of the model was consequently due to propagation of cracking through the units and the model collapsed at a value of shear force V minor than the theoretical value V_u .

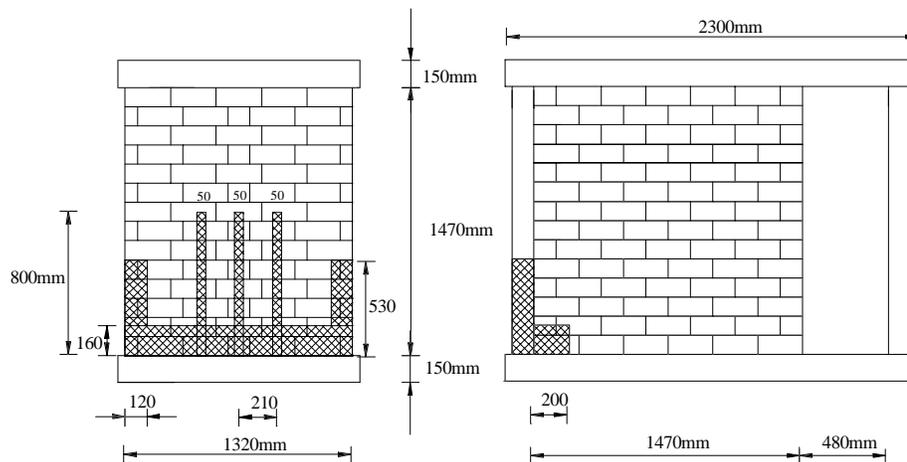
Figure 14 - Brickwork reinforced model

In the second reinforced model the CFRP-sheets are arranged as shown in Figure 14. In this case the CFRP-sheets are also arranged on the short sides of flange and partially on the web to avoid the weakness to slide of the external sheet of the hollow units. The shear force was increased and the failure load was equal to about 65.2kN(Figure 15). The ultimate mechanism of the second reinforced model was completely different with respect to the unreinforced and the first reinforced model since the two mechanisms of failure described above of cracking by bending and sliding of masonry sheets were avoided. The shear mechanism appeared in this case by ruining the flange and web in the part of model that had not been strengthened by CFRP-sheets. Figure 15 gives a comparison between the shear load vs displacements diagrams obtained on the three brickwork models. Diagram (a) refers the case of the unreinforced model, and (b) (c), to the cases of the reinforced models. The second mode of strengthening seems to be the most convenient method of arranging the CFRP-sheets since this avoids a dangerous brittle mechanism of failure due to the detachment of external masonry sheet of the hollow units.

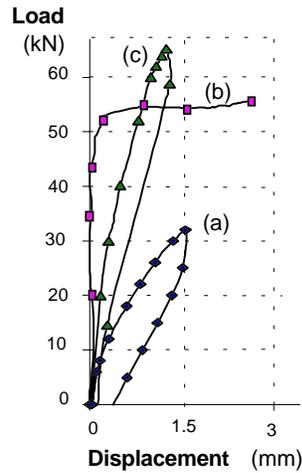
Figure 15 - Load vs displacements diagrams by shear-bending tests.
