PERFORMANCE OF ADHESIVE WALL-TO-DIAPHRAGM CONNECTIONS IN THE CANTERBURY EARTHQUAKES AND THE SUBSEQUENT EXPERIMENTAL PULL-OUT TEST PROGRAM

Dmytro Dizhur[1], Arturo Schultz[2] and Jason Ingham [3]

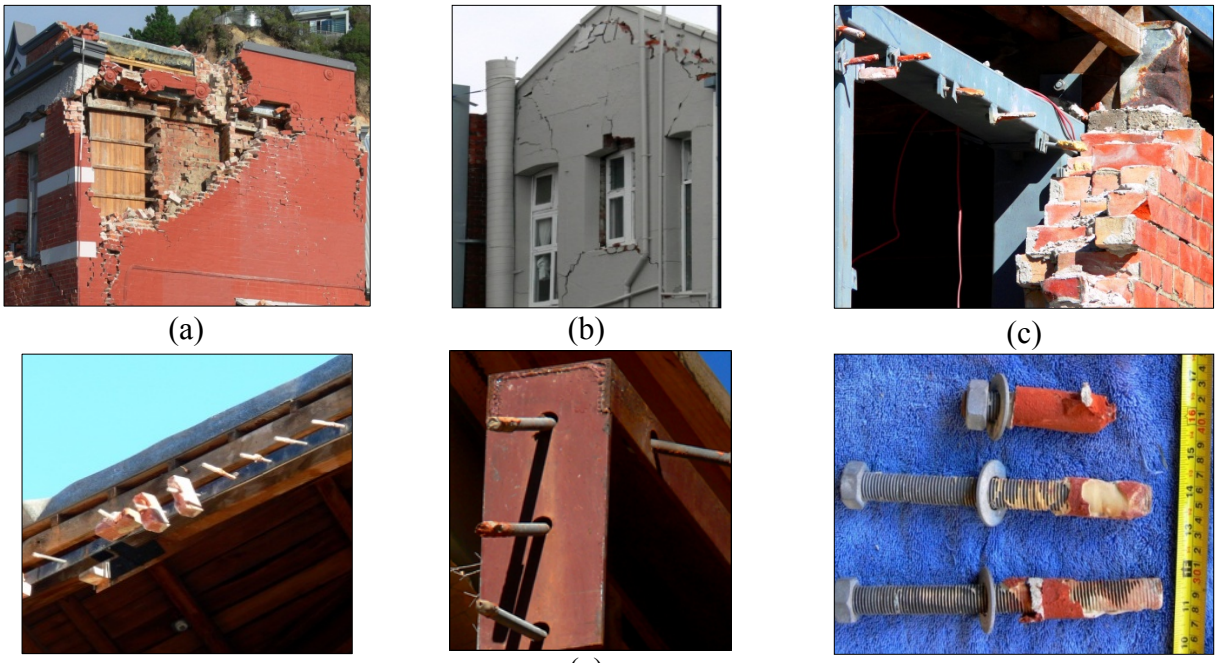
Field observations made during the initial reconnaissance and the subsequent damage surveys of clay brick URM buildings following the 2010/2011 Canterbury earthquakes revealed numerous cases where anchor connections joining masonry walls or parapets with roof or floor diaphragms appeared to have failed prematurely. These observations were more frequent for the case of adhesive anchors than for the case of through-bolt connections (i.e. anchorages having plates on the exterior façade of the masonry walls) [4, 5]. Punching shear failure of the through-bolt connections was a common failure type observed, and was mainly attributable to failure along weak mortar joints. In Figure 1(a) it is shown that the successful performance of anchors does not necessarily prevent out-of-plane wall failure, as the potential for one or two way spanning out-of-plane wall bending failure is not necessarily precluded. The out-of-plane failure of URM

walls was in many cases also attributed to the low shear strength of masonry (see Figure 1(b)), wide anchorage spacing and/or insufficient embedment depth of anchors (see Figure 1(c)). In some cases, the reasons for the adhesive anchor failures were apparent. As shown in Figure 1(f), the top anchor shown is an example of anchor pull-out due to insufficient embedment length, while the remaining anchors shown in Figure 1(e and f) indicate a lack of bonding between the anchor and the substrate material. In other cases, the reasons for such failures were not evident from visual observation. The construction quality of adhesive type anchorages was commonly observed to be poor, due to insufficient anchorage depths and poor workmanship, as shown in Figure 1(c-f).

Figure 1: Wall-to-diaphragm anchors: a) Row of successful wall-to-diaphragm anchors, with wall failure beneath; b) Failure of the gable due to low shear strength of masonry, despite sufficient anchorage; c) Insufficient embedment depth of adhesive anchors; d) Large number of adhesive anchors unsuccessful at preventing out-of-plane collapse of URM wall; e) Insufficient adhesive used only at the tip of anchors; f) Recovered adhesive anchors that performed inadequately.

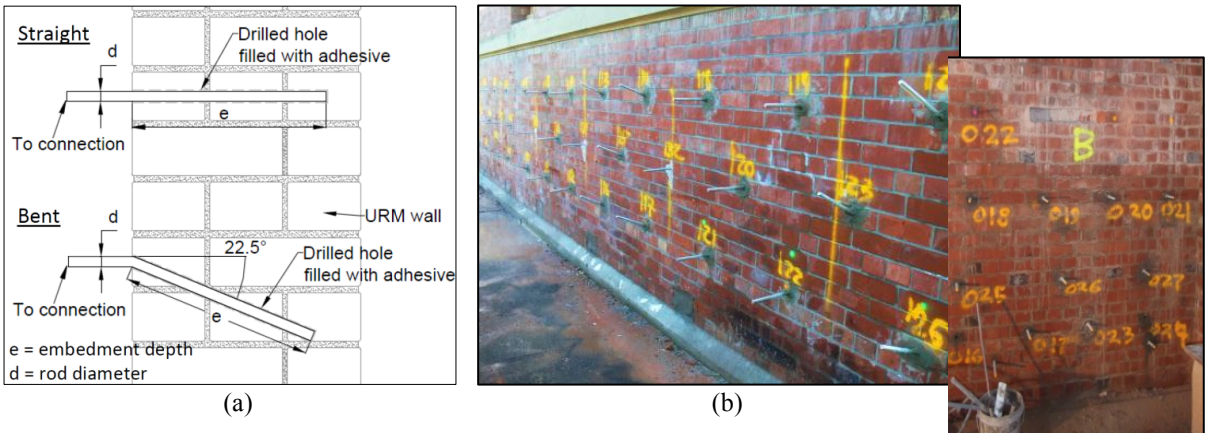
Installation of anchors with grout as adhesive proved to be difficult, mainly due to the rapid absorption rates of clay bricks. The non-saturated surrounding clay brick rapidly absorbed the moisture from the grout causing it to harden prematurely, making it difficult to fully insert an anchor rod. Three installation techniques of anchors with grout as adhesive were attempted. The first attempted installation method involved mixing grout with a high water content ratio and applying the grout onto the anchor rod as it was being slowly inserted with rotational motion into a water saturated hole. The second method involved a network consisting of perforated hoses that were inserted into the drilled holes for approximately one hour of continuous water spraying prior to injecting grout and inserting anchor rods. The third method involved insertion of an anchor rod and a small tube simultaneously. The tube was then slowly withdrawn from the hole as the grout was injected. Due to time frame restrictions on-site, grout anchors were tested 72 hours following installation. All anchors installed using epoxy products were allowed to cure prior to testing for at least 24 hours as specified. A typical testing arrangement is illustrated in Figure 3(b and c).

Figure 3: Testing arrangement of adhesive anchors: a) Test parameters; b) Wards Brewery Building 2, Christchurch; c) Phoenix Wine and Spirits Building, Whaganui.

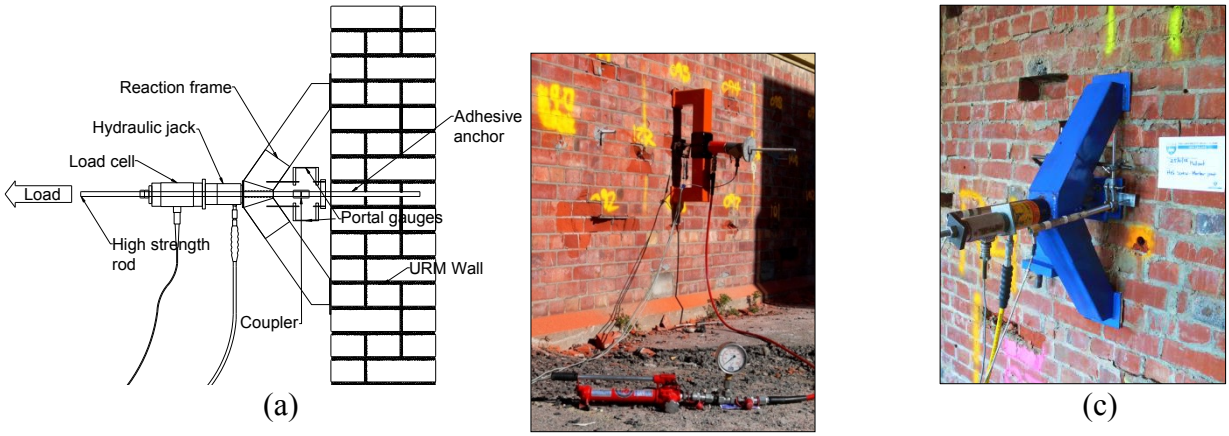
Figure 4: Test setup for adhesive anchor pull-out tests: a) Schematic view of the typical pull-out test apparatus; b) Typical test set-up used for pull-out anchor testing used in Christchurch; c) Typical test set-up used for pull-out anchor testing used in Whanganui.

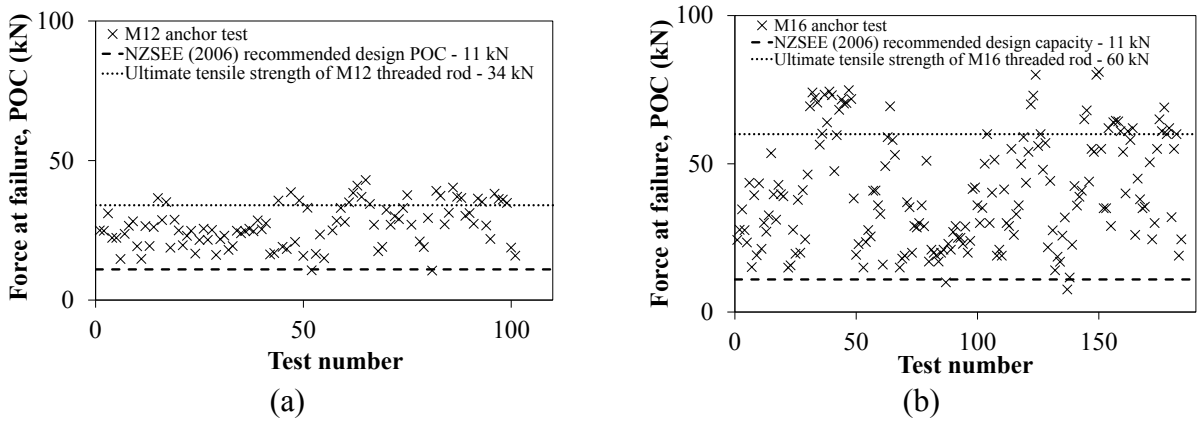
The POC for the overall results are shown in Figure 5(a) and (b) and the plots are separated into M12 and M16 threaded rods respectively. The majority (96%) of the adhesive anchors exceeded the NZSEE [3] recommended design capacity and all tested anchors exceeded FEMA [1] recommended design capacity (excluding grout anchors in Building 3, Christchurch). The performance of adhesive anchors below the NZSEE [3] recommended design capacity was attributed to the epoxy anchors being installed in excessively damp masonry, an excessively high water content of cementitious grout and insufficient volume of adhesive. In approximately 1% of the cases excessively low POC could not be attributed to any known parameter and was considered as an outlier and removed from the dataset.

Figure 5: Overall threaded rod adhesive anchor test results: a) Force at failure for M12 adhesive anchors in overall data set; b) Force at failure for M16 adhesive anchors in overall data set.

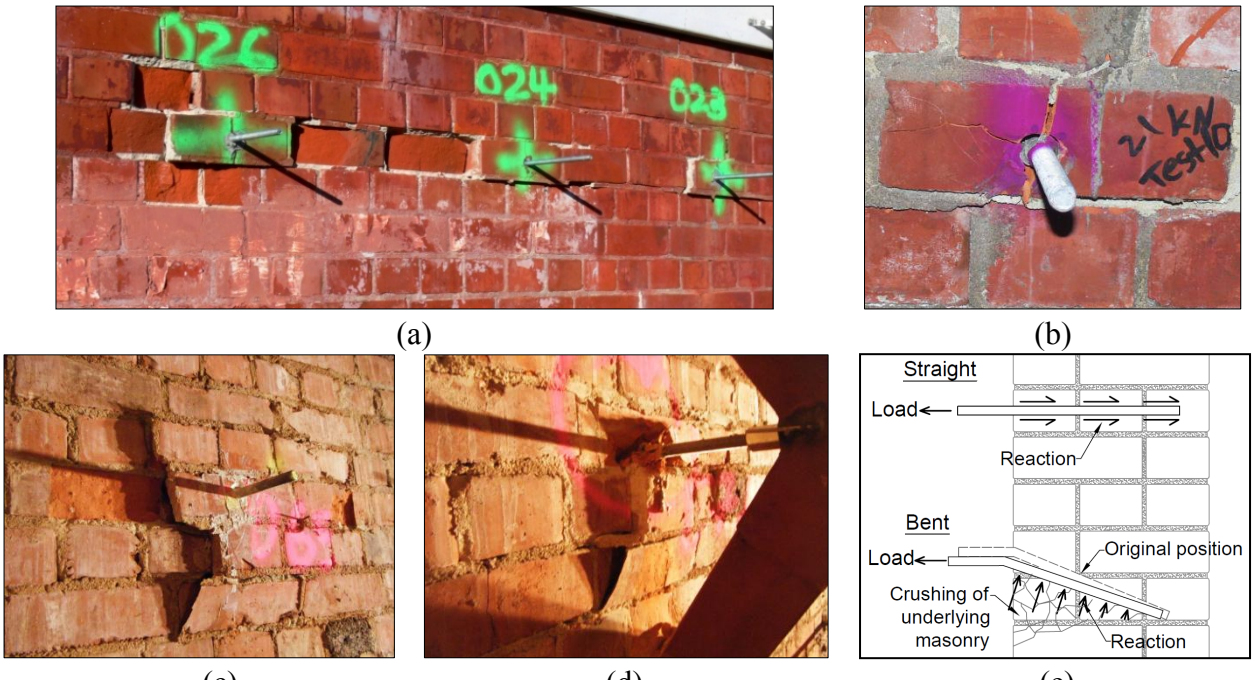
Failure of the masonry occurred in 91% of the tests. Failure modes included pull-out of the adhesive plug (particularly in weaker brick and mortar and shorter embedment depths), masonry breakout/anchor pull-out (where the leading brick, or part of it, is pulled out with the anchor as shown in Figure 6(a)), failure of the bond between the adhesive and the rod with localised splitting of bricks (Figure 6(b)), and yielding of anchor rods.

Figure 6: Typical failure modes: a) Typical masonry pull-out type failure observed; b) Localised splitting of brick; c) Straight anchors; d) Bent anchors; e) Schematic view of observed failure modes.

Figure 6(c-e) show the typical failure modes observed for straight and bent anchors. Crushing of the masonry below the bent anchors was typically observed. Tension loading of the bent anchor rod causes the rod to straighten, resulting in bearing of the rod against the underlying masonry and causing crushing. Furthermore, it was observed that the bent anchor lose the bond between

the top side of the rod and the surrounding masonry as it moves out of position (see schematic representation in Figure 6(e)).

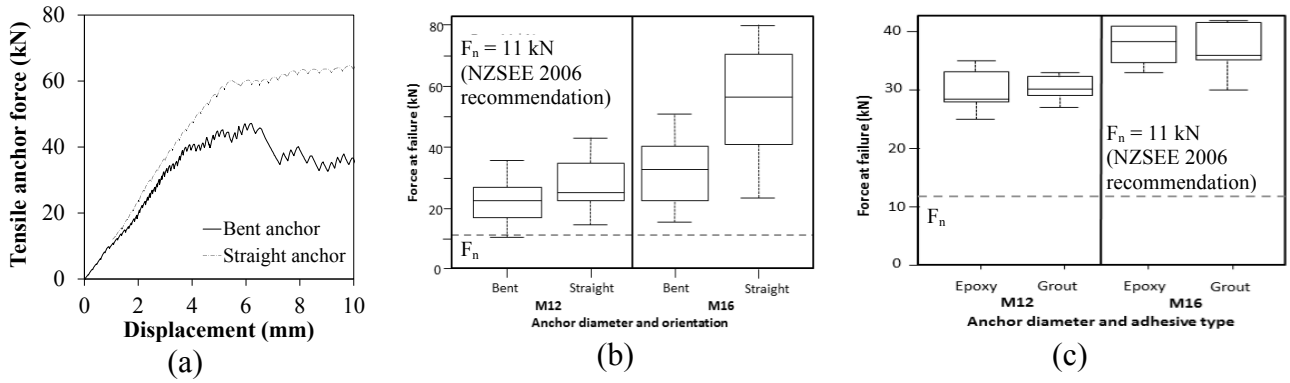
Adhesive anchors installed having an angle of minimum 22.5^{o} to the perpendicular projection from the wall surface had a lower POC compared to anchors that were installed horizontally. Straight anchors had a larger force at failure and typically had a larger residual strength, as opposed to bent anchors where following the peak force resistance, the residual strength diminished at a greater rate. Furthermore, straight anchors typically had a higher stiffness than bent anchors as shown by the gradients of the linear portions of the force-displacement response (see Figure 7(a)). A typical force-displacement response curve for M16 epoxy anchors installed with 300 mm embedment in the Phoenix Wine and Spirits Building, Whanganui is shown in Figure 7(a). From Figure 7(b) it is evident that for the 300 mm embedment depth, the average force at failure for straight M16 anchors was higher than for the bent M16 anchors. The large sample spread was attributed to the varying nature of URM material properties.

Figure 7: a) Typical force-displacement response for epoxy anchors with 300 mm embedment depth; b) Force at failure for bent and straight epoxy anchors embedded to 300 mm; c) Force to failure for epoxy and grout straight anchors embedded to 200 mm.

When installed using the second and third methods (see Installation procedure section) the anchors with grout as the adhesive had a similar average POC compared to the POC of the anchors with epoxy as the adhesive, for all combinations of parameters tested (see Figure 7(c)). The comparable POC between grout and epoxy adhesive material is applicable to threaded metric anchor rods as well as to threaded reinforcing steel bars. However, it was found that installing anchors using grout as the adhesive was more difficult due to the extra effort involved in drilling a larger hole. Moreover, grout requires mixing onsite and correct water content is essential in order to achieve full strength capacity of the grout. With acquired experience in the installation technique, the grout anchors provide a comparable POC results to the more expensive epoxy based systems.

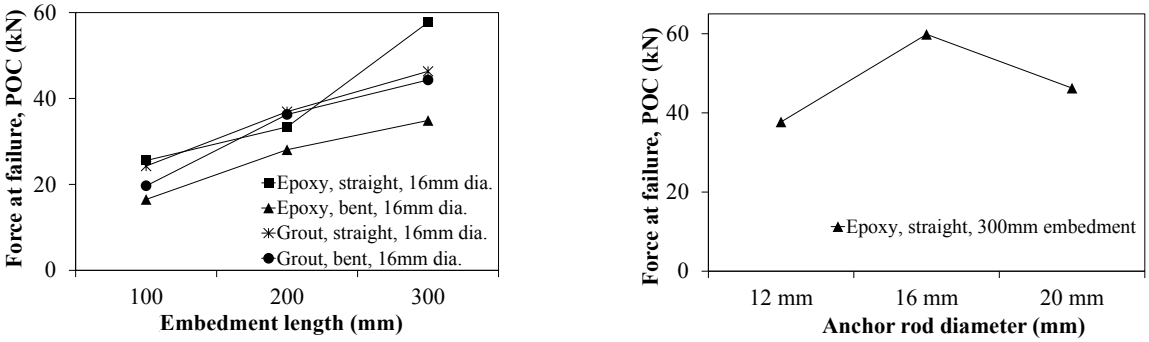
The POC of an adhesive anchor increased with increasing embedment depth. Nevertheless, the results show that when anchor embedment was 100 mm (fixed to a single brick) the POC was in excess of current capacity recommendations [1, 3]. Adhesive anchors embedded to 100 mm have larger average bond stress compared to anchors embedded at a greater depth (see Figure 8(a)). Figure 8(b) shows the POC of adhesive anchors with increasing rod diameter, with the maximum attained POC being for 16 mm anchor rod diameter. The reduction in POC for anchor rods having a 20 mm diameter was attributed to the clay brick propensity to split (see Figure 6(e)) at a lower POC as a result of a larger diameter hole and subsequent reduction of the brick cross-section. It is therefore evident that the use of anchor rods having large rod diameter is detrimental to the POC and hence is counterproductive.

Figure 8: a) Effect of embedment length on the average POC; b) Effect of anchor rod diameter on the average POC (M16, epoxy anchors).

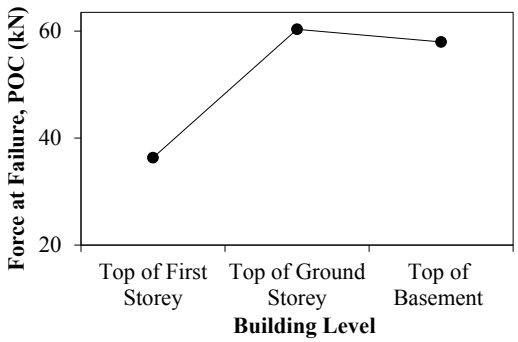
(a)

Overburden weight is of significance for adhesive anchors used in applications such as for parapet restraints, where low levels of overburden are present. The adhesive anchor test results acquired as part of the research presented herein show a clear reduction in the POC for anchors installed at upper building levels compared to the ground and basement levels of a building (see Figure 9(a)). Where high earthquake induced vertical ground accelerations are experienced (i.e. as observed during the 2010/2011 Canterbury Earthquakes) the axial overburden level is greatly reduced. In some instances, where the vertical ground acceleration is greater than gravity, the wall can be put into tension and the effect of friction on the bed joint shear strength is reduced to

Figure 9: a) Effect of overburden on the average POC, Building 7 Auckland, M16 epoxy anchors with 200 mm embedment; b) Effect of bond quality on the average POC, M16 epoxy anchors with 300 mm embedment.

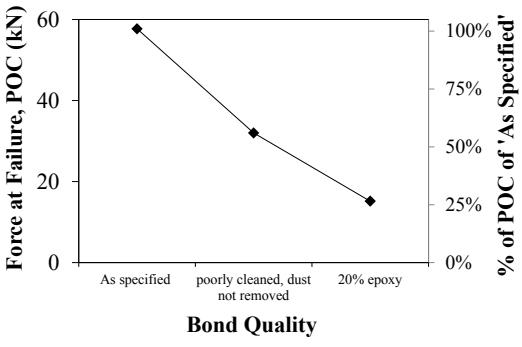
(b)

To address the poor quality of installation of adhesive anchors observed during the reconnaissance following the 2010/2011 Canterbury Earthquake, three sets of anchors where installed and tested with varying quality of installation. From Figure 9(b) it can be observed that the average POC dramatically decreased with decreasing quality level of installation. It was concluded that with poorly cleaned holes, such as dust lightly brushed (no air blowing), the average POC was reduced by 55% when compared to the capacity of epoxy anchors that were installed per manufacture's specifications. A reduction down to 26% of the average POC of the epoxy anchors that were installed per manufacture's specifications was observed for anchors that had approximately 20% of the hole filled with epoxy.
