## A FINITE ELEMENT APPROACH TO CALCULATE TWO ANCIENT MASONRY VAULTS

**Gero A. Marzahn<sup>1</sup>, Rüdiger Jahnel<sup>2</sup>, Michael Köhler<sup>3</sup>, and Nguyen V. Tue<sup>4</sup>**

### ABSTRACT

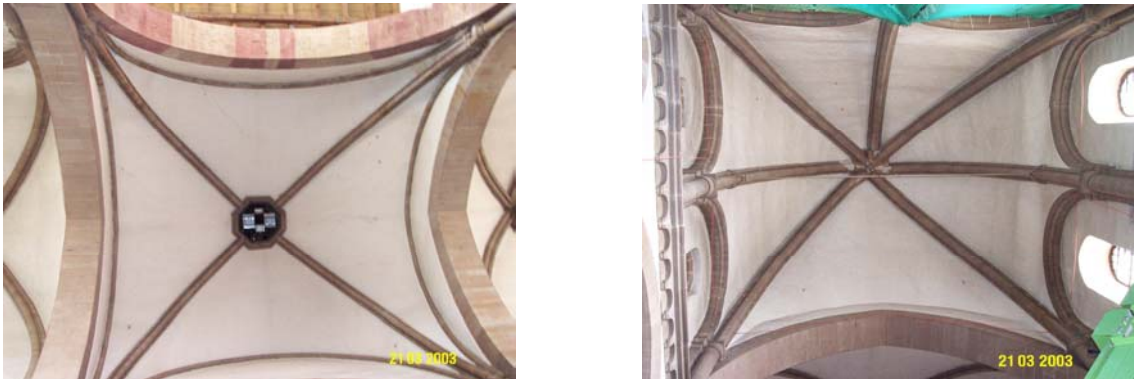
principally positioned in a diagonal direction above the quad (cross ribs); in some cases, however, ribs parallel to the exterior walls were added in the southern hall (Figure 3).

**Figure 3 – Views of the soffits of the vaults**  
**a) main quadrangle, b) southern side hall**
