## RESTORATION & STABILIZATION OF A DAMAGED & DETERIORATED CHURCH TOWER

P.A. Jeffs<sup>1</sup>

### ABSTRACT

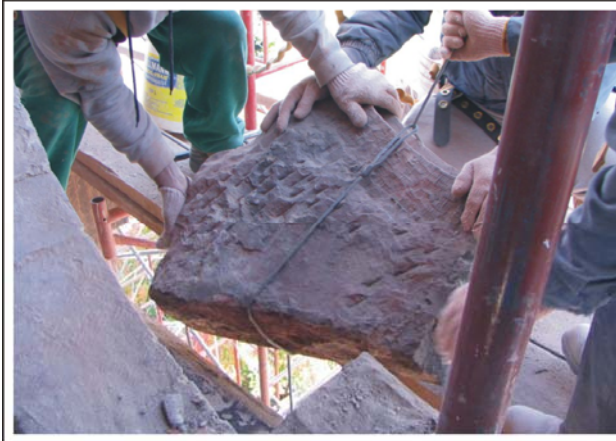
**Figure 17 - Removing a voussoir stone.**

The sandstone voussoir units around the round windows and the masonry units within the sections of wall between the buttresses were removed and rebuilt (Figures 17 and 18).

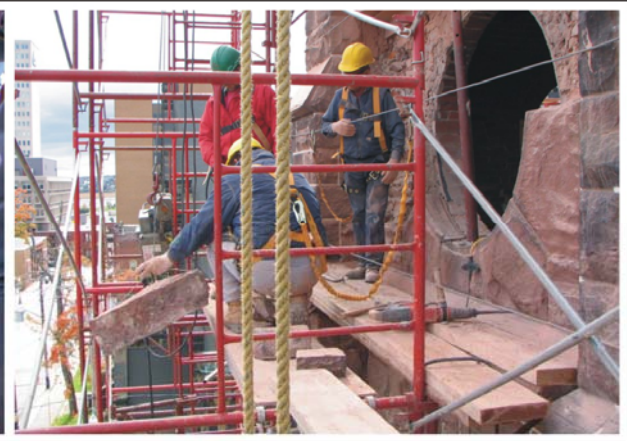
**Figure 18 - Lowering one of the voussoir stones to ground level.**

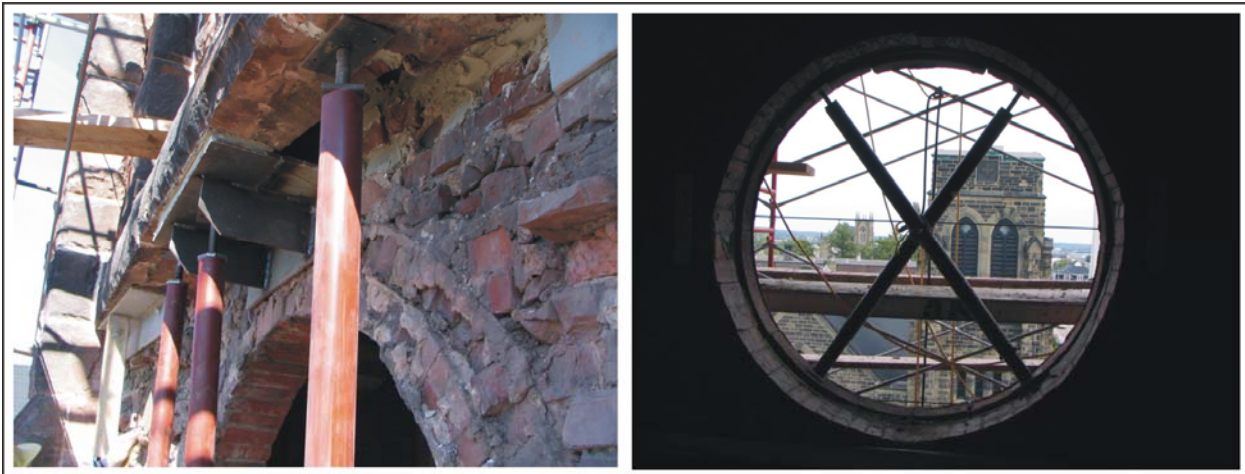
**Figure 19 - Examples of temporary and permanent shoring used to support the overhead masonry during masonry rebuilding work.**

Rebuilding the sandstone units from around the windows presented challenges in providing support to the remaining overhead masonry and a combination of temporary and permanent shoring and bracing techniques were used for this purpose. (Figure 19).

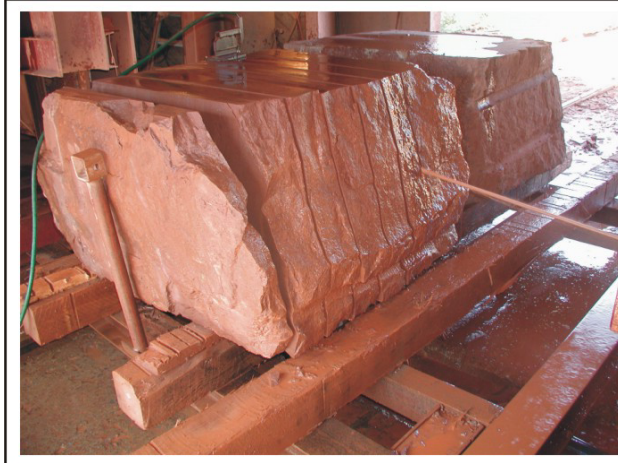
**Figure 20 - Cutting quarried stone into slabs prior to shaping and rock face dressing.**

The replacement stone was sourced from a recently opened quarry near Sackville, NB and fabricated a few miles from Moncton (Figures 20 and 21). Laboratory testing proved the suitability and quality of the replacement stone which blended well with the original masonry – the latter having been classified as consisting of a “Sackville Red Sandstone”.

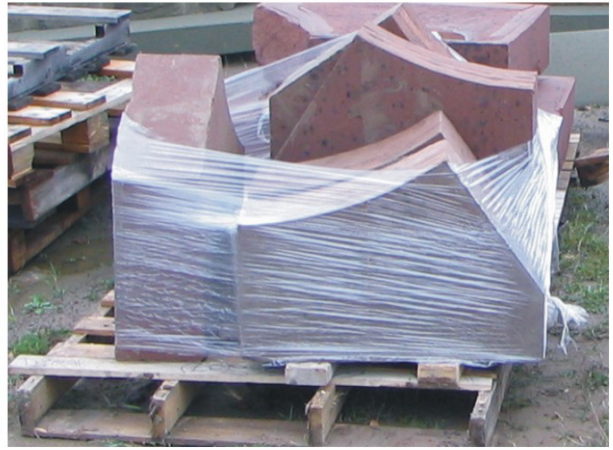
**Figure 21 - Fabricated voussoir stone units ready for shipment to the church.**

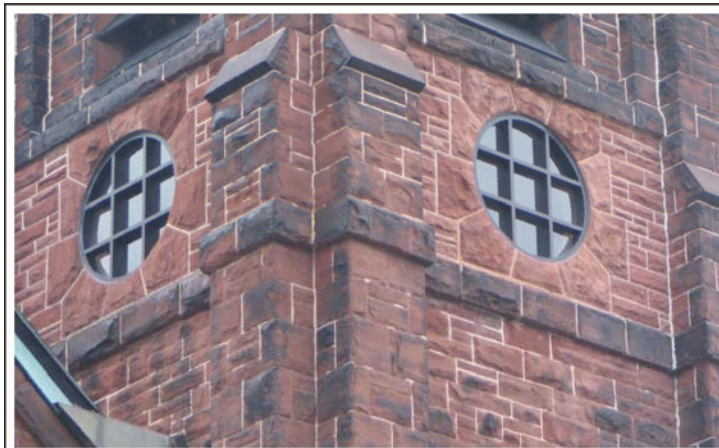
**Figure 22 - New round windows installed within the reconstructed masonry.**

After the masonry rebuilding work was completed, new custom-fabricated round windows were installed (Figure 22). In view of the likelihood that future timely re-painting and maintenance would be difficult to assure, it was decided that the windows should be constructed from anodized aluminium. To eliminate previous problems with snow build-up and moisture penetration through window frames, the window units were positioned almost flush with the exterior masonry. The remains of the old roof and its temporary replacement were removed and a new deck constructed, waterproofed and flashed (Figure 23). A watertight hatch was installed and a new improved drainage system installed.

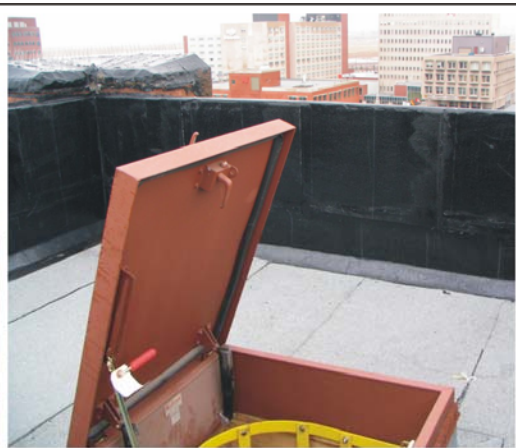
**Figure 23 - Waterproofed new deck with watertight hatch.**

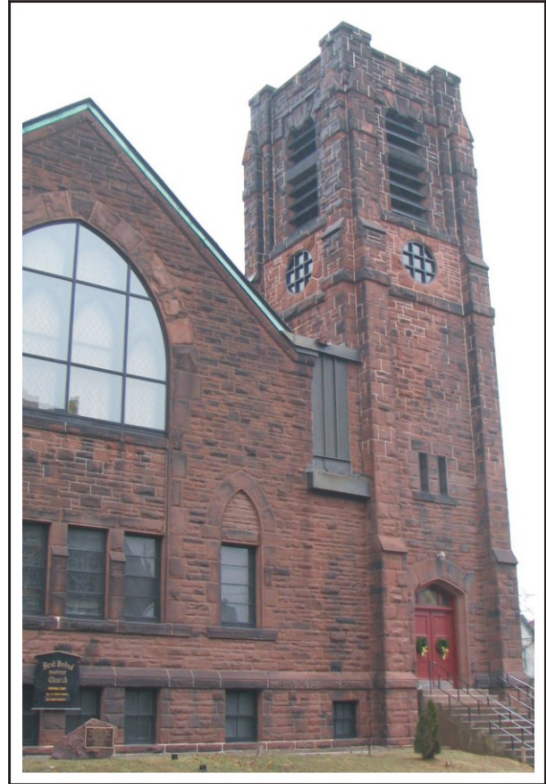
**Figure 26 - The restored and stabilized bell tower**

Prior to the detailed stabilization and restoration project, the First Moncton Baptist Church bell tower was in an advanced stage of deterioration. Lateral movement of buttress stone masonry units and serious cracking had seriously compromised the tower's structural stability. However, due to the dedication and commitment of the church's congregation and their Board of Trustees, the masonry structure has been restored and stabilized to a durable condition. Moreover, it is now better equipped to withstand the extremes of Canada's climate and accommodate the movement that previously had caused considerable damage to its components.
