## DIAGNOSTIC INVESTIGATION OF THE STONE PILLARS OF S. NICOLO' L'ARENA, CATANIA

A. Saisi <sup>1</sup>, L. Binda <sup>1</sup>, L. Zanzi <sup>2</sup>

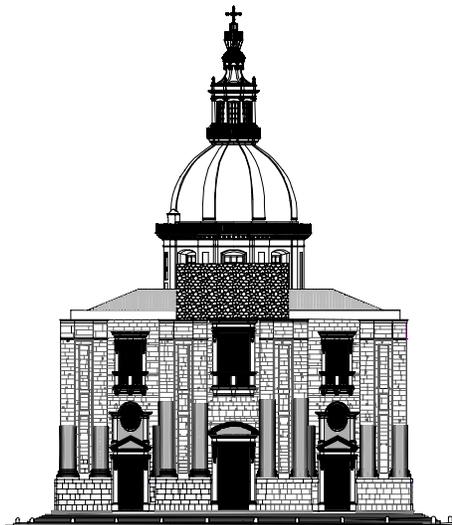
Figure 1. S. Nicolò Church. View of the facade.

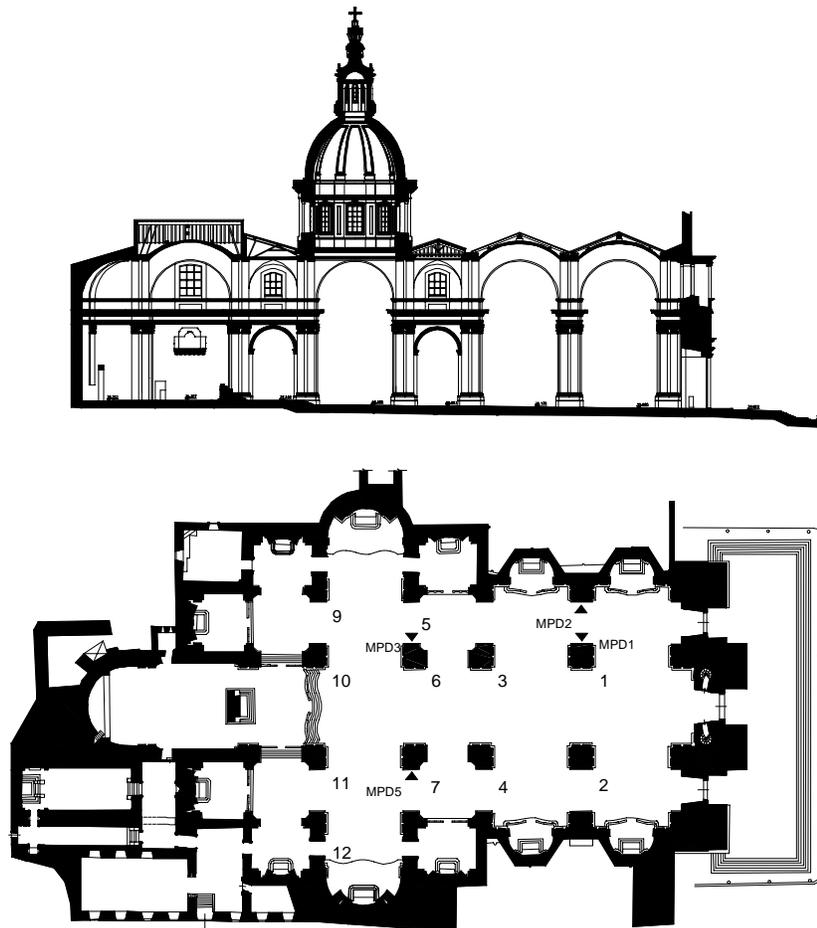
Figure 2. Localisation of the tested piers.

The data were processed by using a dedicated software developed by the authors. The two most damaged pillars at the entrance of the church (pillars 1 and 2 of Fig. 2) have been investigated with much care: five horizontal sections at different heights plus vertical sections have been executed on each pillar.

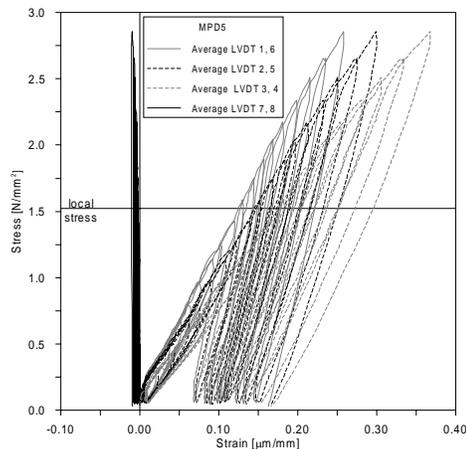
Fig. 10 and 11 show the masonry texture, the flat jacks position, the measurements tools and the stress-strain plots from double flat-jack test. The stress strain diagrams (Fig. 12 and 13) demonstrate the good characteristics of the pillars in terms of compressive strength and elastic properties.

Figure 12. Stress strain curve of test MPD5.

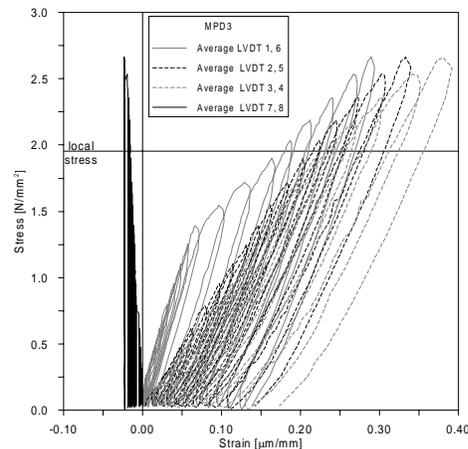
Figure 13. Stress strain curve of test MPD3.
