INTERNAL STRENGTHENING OF HISTORIC CLAY BRICK MASONRY PUMP HOUSES IN NEW ORLEANS

ABSTRACT

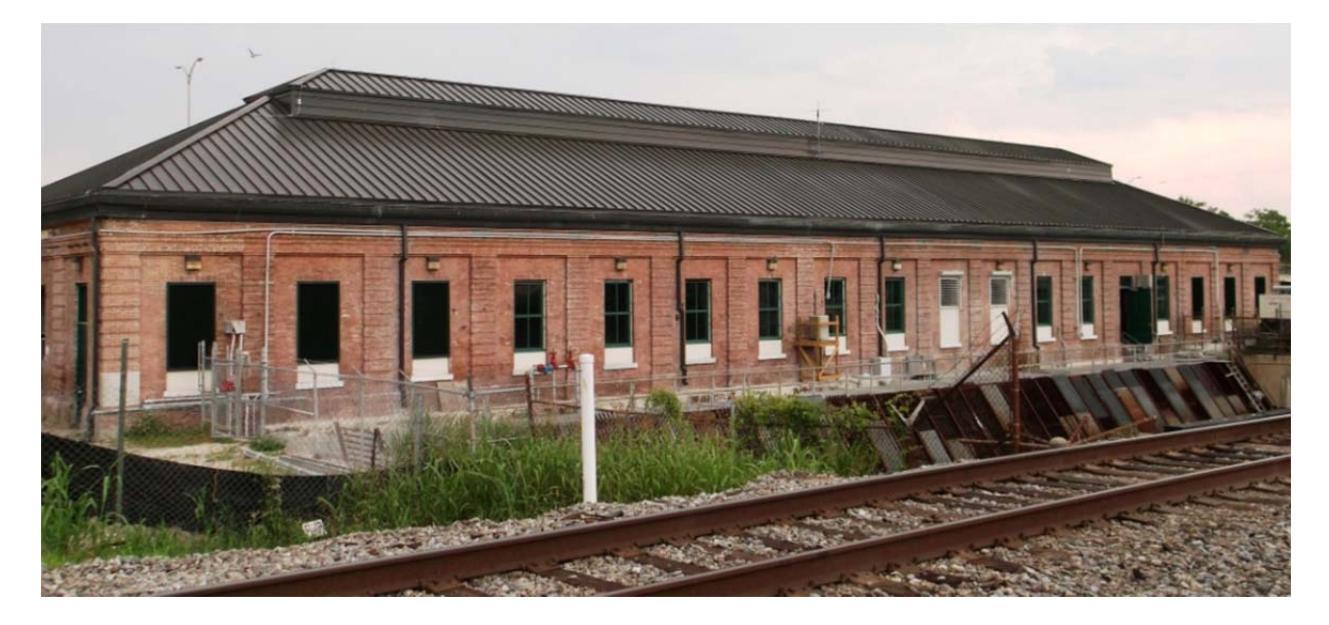
Figure 2: Overall view of typical Drainage Pump Station. Pump Station 7 is shown here.

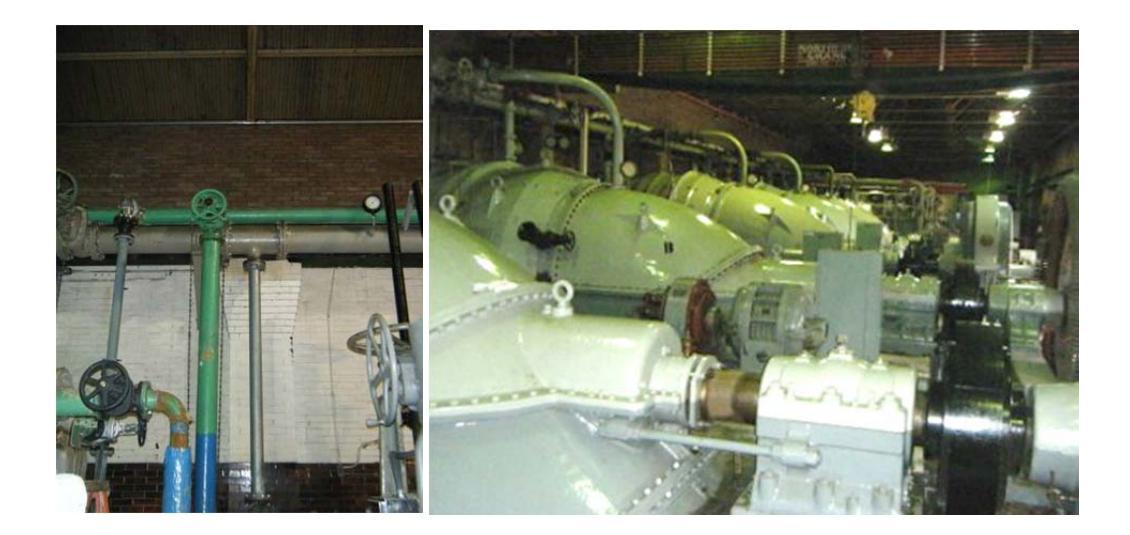
In addition to the structural challenges associ ated with this project, there were significant logistical obstacles associated with working on the pu mp stations. The pump stations contain extremely large water pumps, generators, and other mechanical equipment that is tightly spaced and requires access on all sides for maintenance. This equipment and the associated plumbing and overhead cranes provide m inimal opportunities for supplem ental interior fra ming and strengthening members (Figure 3). The building ex teriors are considered to be histor ically significant and were not to be altere d by the strengthening measures. Additionally, these pump stations are used on a regular basis to remove rain water and runoff from the storm sewer system of New Orleans. Therefore, the pump stations were required to remain fully and completely operational during the entire structur al enhancement process. This placed severe restrictions on the amount and type of work that could be performed at the building interior.

Figure 3: View of pipes adjacent to exterior walls at left and large pumps housed by the pump stations at right.

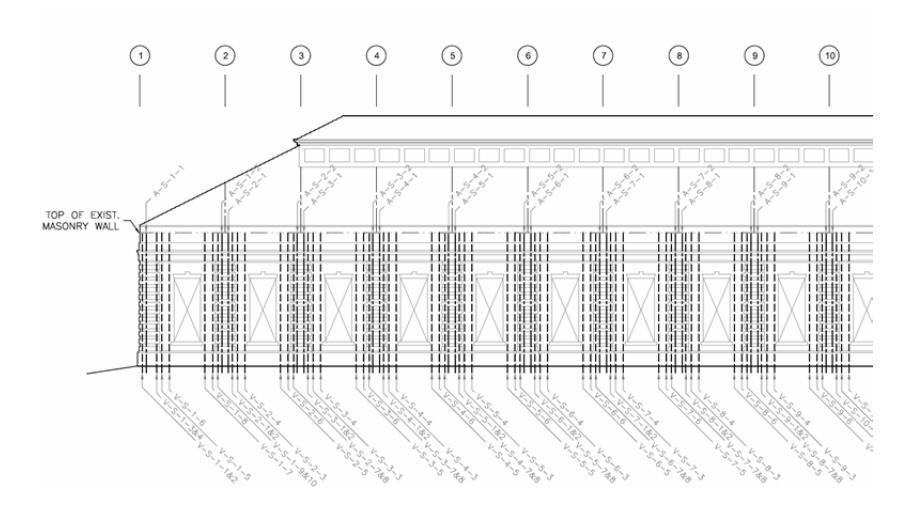
Figure 5: Portion of reinforcing bar shop drawings showing typical vertical reinforcing location and spacing.

The final retrofit stre ngthening design included several components. As mentioned previously, the existing masonry wythes were tied together using stainless st eel helical rods and injected solid with CIF. The masonry walls were also strengthened internally using vertical and horizontal stainless steel reinforcing bars (Figure 5). Vertical bars were installed into holes that were cored from the top of the wall into the foundation using specialty coring equipment. Since development of the vertical reinforcing at the base of the wall was som etimes critical to the strengthening design, a special end detail was used to engage the reinforcing into the foundations. The bottoms of core holes were reverse tapered, and the bars were installed with a washer and sock at the base (Figure 6). This connection norvided a positive, mechanical attachment to the found ations that can be significantly more effective than adhesive bonding of the reinforcing alone. The stain less steel reinforcing was comprised of bars with a hollow core that permitted relatively simple filling of the taper with CIF material.
