REPAIR AND SEISMIC RETROFIT OF A XV CENTURY BUILDING COMPLEX HEAVILY DAMAGED IN THE L'AQUILA EARTHQUAKE

A.Benedetti¹ and S.Verlinghieri²

ABSTRACT

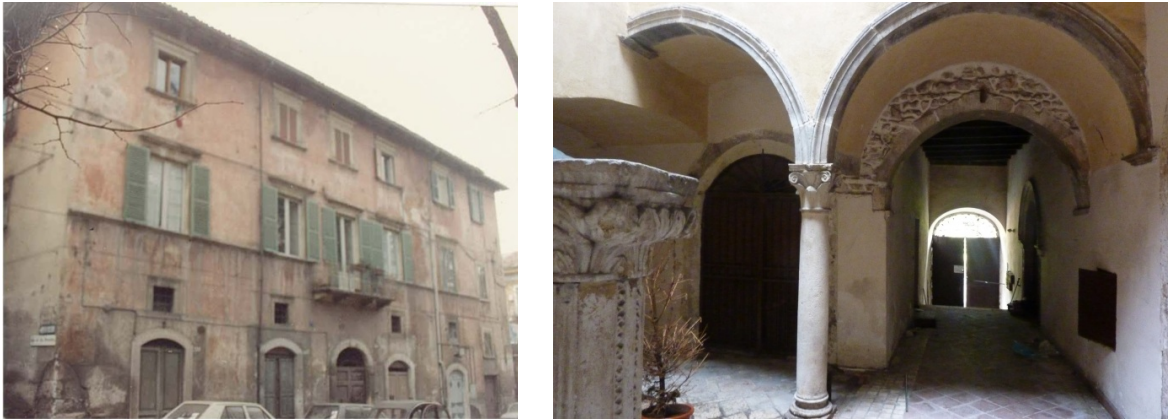
Micheletti Palace (figure 1) has arisen from a long path of modifications and additions to the original medieval building. It suffered diffused strong damage in the April 9th 2009 L'Aquila earthquake. In the reconstruction phase begun after the shock, a careful survey of the building has been completed concerning the historical, geometrical and mechanical data of the building.

Figure 1: View of Micheletti Palace and open internal court

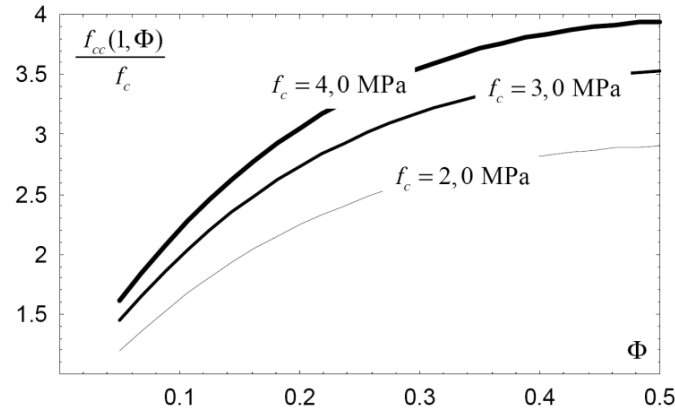
In this situation the interaction of stone and mortar does not lead to cracking of the stones due to the horizontal self-stress, but the mortar collapses in confined compression instead [3]. As a

rough approximation, the confinement stress in mortar is up to 30% of the vertical one; in this situation the use of a Bresler-Pister type constitutive criterion [4] leads to the evaluation of the multi-axial compressive strength of mortar, which can be considered the limit strength of the stone masonry too. In figure 9 the vertical stress amplification due to confinement in horizontal direction is calculated by means of the cited criterion.

Figure 9: Tri-axial amplification factor for compressive strength of mortar

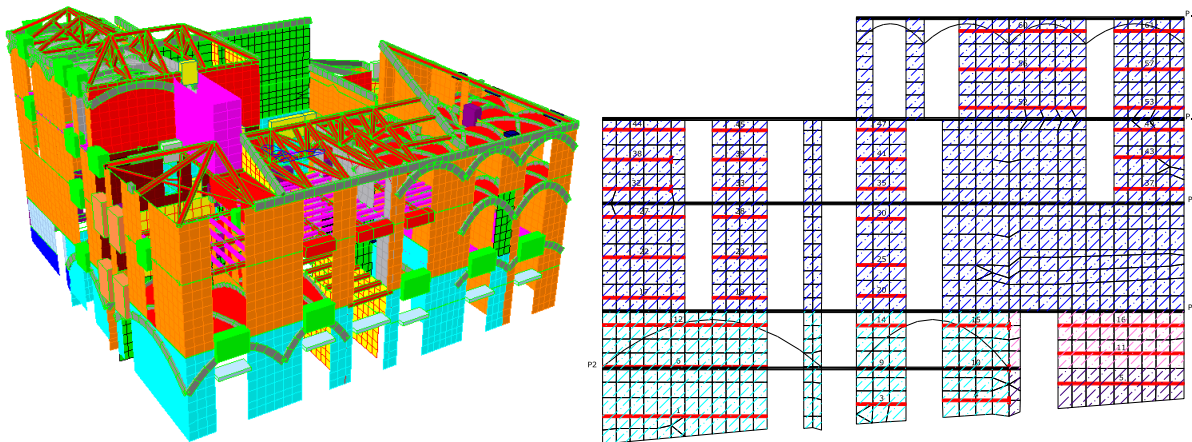
The verification of the seismic vulnerability of the Micheletti Palace has been carried out by means of a comprehensive model including shell, beam and truss elements (figure 10). The model is used in a response spectrum linear dynamic analysis in order to evaluate the seismic actions. The design acceleration is defined as $a_g = 0.31$ g on the basis of a structural behaviour factor of 2.25. The stress distributions were extracted from a subset of relevant sections for each wall, as depicted in figure 10.

Figure 10: 3D FEM Model and schematic view of the verification sections for a wall (in red)

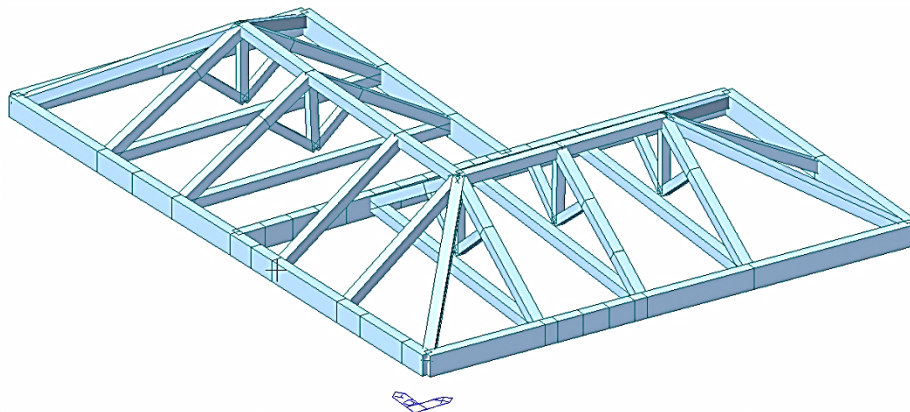
Figure 12: Model for the analysis of the timber roof in design situation

Finally, it should be mentioned that the timber roof (figure 12) was reconstructed in recent times but the lumber deck has a relatively small stiffness in its plane due to the soldier organization. In spite of this, the ceiling of the second storey, originally realized with in-folio vaults, was substituted with a timber deck composed with a lightweight concrete slab.

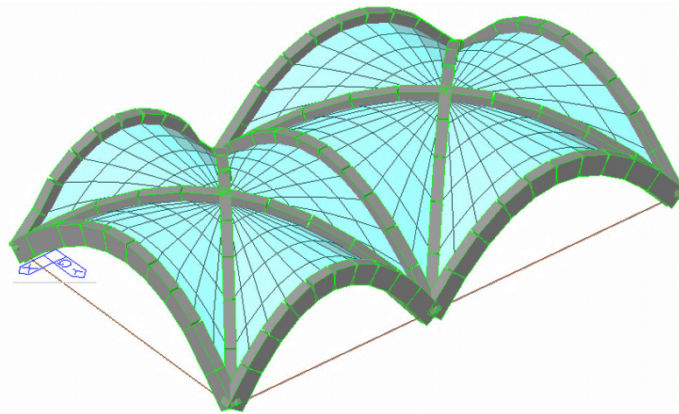
Figure 14: Model for the restoration design of the rib-stiffened cross vaults

A specialized retrofit technique was used for vaults (figure 14); first of all, all the cracks were filled with fluid mortar and sewed with fibre strips. Afterwards, the masonry shells were strengthened with a grid of fibre strips and by formation of masonry reinforced ribs (figure 15). Finally, the vault volume was filled with expanded clay aggregates, a nonwoven film, and a thin finishing concrete slab. Where necessary, inside the vault volumes were placed the tie bars connecting the facing walls supporting the vault.

As said before, in order to maintain the transpiration of the masonry shells, steel wire bundles were bonded with high strength lime mortar. This made easier the fastening of the strips into the neighbouring walls simply by inserting the twisted ends in drilled holes and filling with mortar.
