## SEISMIC ANALYSIS OF THE WEST BLOCK PARLIAMENT BUILDING IN OTTAWA – CHALLENGES AND APPROACH

### ABSTRACT

The West Block Parliament Building in Ottawa is currently undergoing major rehabilitation and expansion. The building was built in three construction phases from 1860 to 1909, and has subsequently undergone a series of changes and partial rebuilding. The last significant renovation was completed in the 1960s.

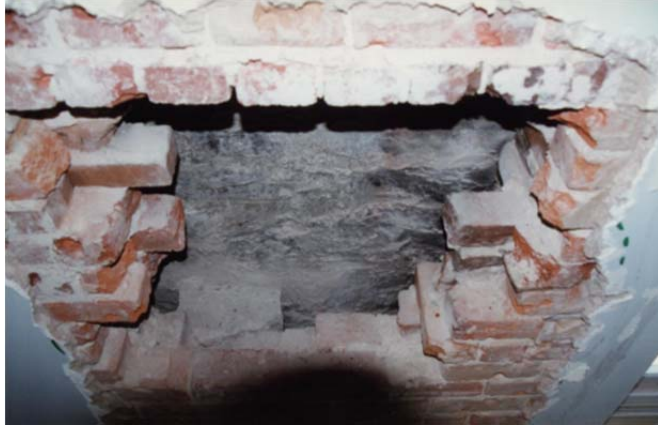
**Figure 2: Typical Cavity Wall**

The exterior walls are made of rubble core unreinforced stone masonry. The wall thickness is largest at the base (1200 mm). From the water table at the second floor level and up, the construction changes to a stone and brick masonry cavity wall. Exterior wall wythes are made of 530 mm thick rubble core stone masonry, and interior wall wythes consist of approximately 230 mm thick clay brick wall. Exterior and interior wall wythes are separated by a 100 mm air cavity, as shown in Figure 2. Different stone types and dressing practices were used for wall construction. The façade was usually built using random coursed Nepean sandstone. The interior wythes of stone masonry walls were built using irregular limestone backing, and the void between the two stone wall wythes was filled with stone rubble and lime mortar. Decorative stone arches were built using reddish Potsdam sandstone, and the quoins and window surrounds were made of cut Berea sandstone, as shown in Figure 3. While the original specifications called for massive “bond stones the whole thickness of the walls”, none of the many exploratory openings, and subsequent two pilot restoration projects revealed a single through-stone (bond stone) connecting the wall wythes.

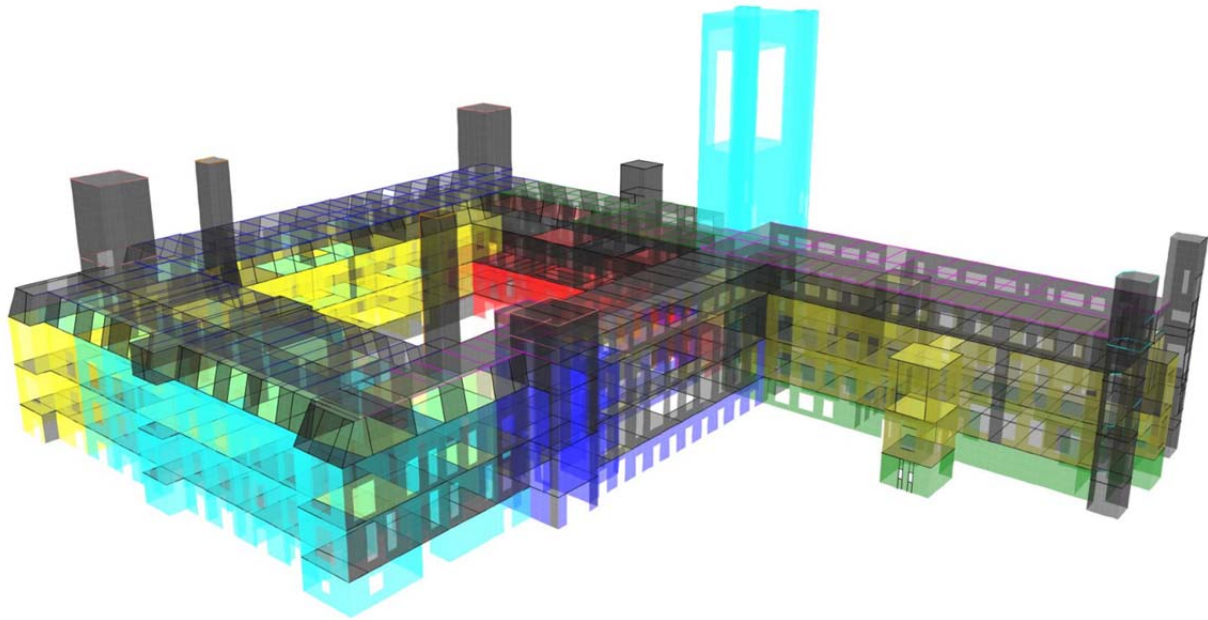
**Figure 13: SAP2000 Analysis Model of the West Block Building**

The modelling was a complex process, and it was challenging to determine an appropriate degree of accuracy for modelling the geometry and other building characteristics. The model consisted mainly of shell elements representing both walls and floors. An attempt was made to capture all openings in walls and floors, and account for variations in wall and floor thicknesses. The size of the model as shown in Figure 13 was significant - it consisted of 52,600 shell elements and 54,000 nodes.

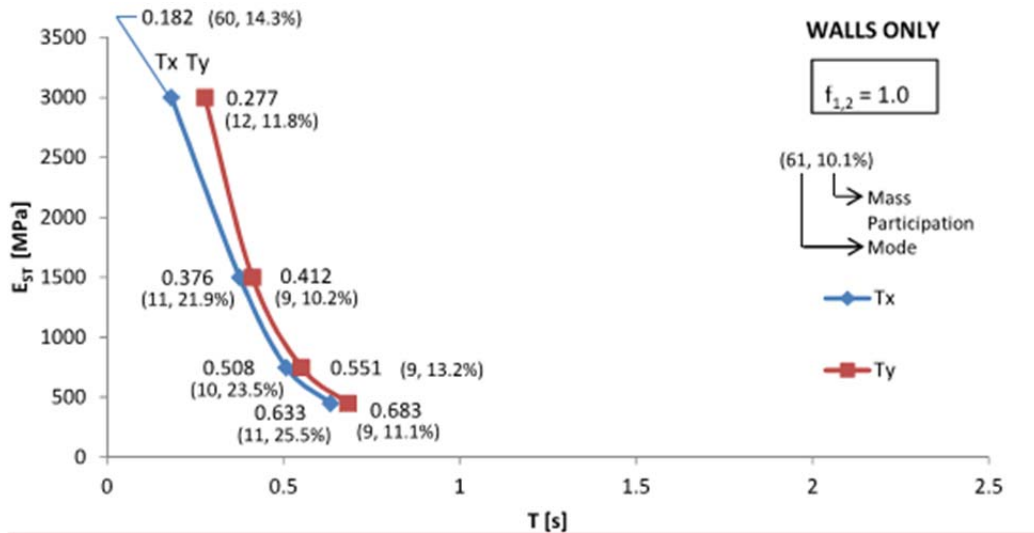
**Figure 14: Fundamental Period as a Function of the Modulus of Elasticity**

A sensitivity study was performed to evaluate the effect of variation in modulus of elasticity ( $E_{st}$ ) on fundamental period of the building. Figure 14 illustrates variation in fundamental period depending on the modulus of elasticity value for dominant vibration modes (and the corresponding mass participation factors). Note that the fundamental period of 0.44 sec was obtained from the NBCC 2010 empirical formula. The authors felt comfortable with the period of around 0.4 s.
