## SEISMIC VULNERABILITY OF MONASTERY TEMPLES OF STONE MASONRY

**Durgesh C Rai<sup>1</sup>, Vaibhav Singhal<sup>2</sup>, Tripti Pradhan<sup>3</sup> and Neha Parool<sup>4</sup>**

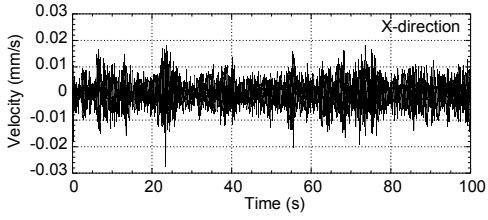
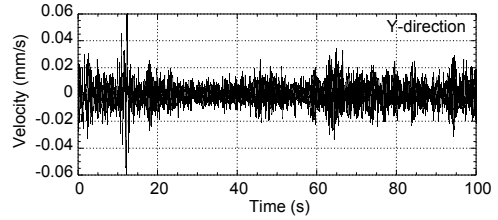
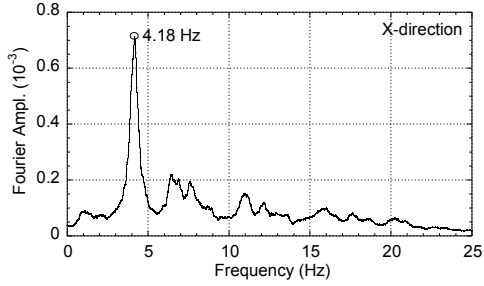
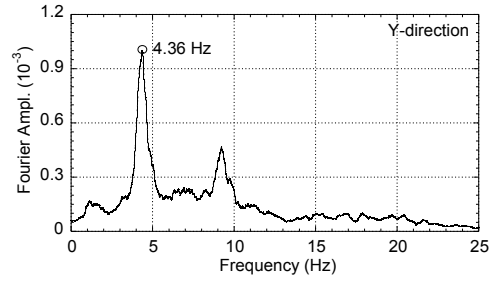
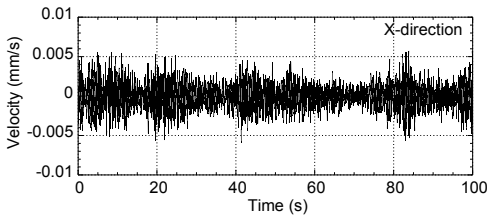
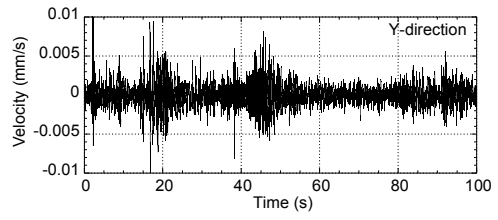
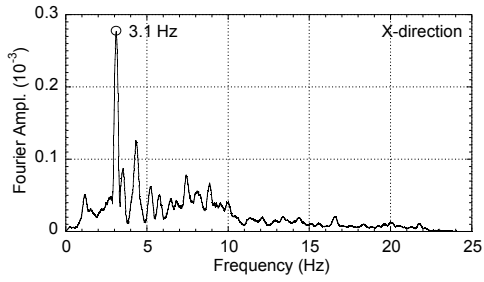
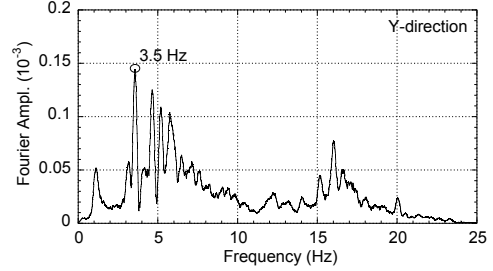
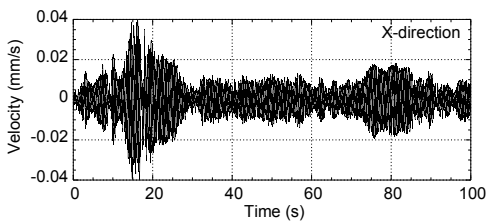
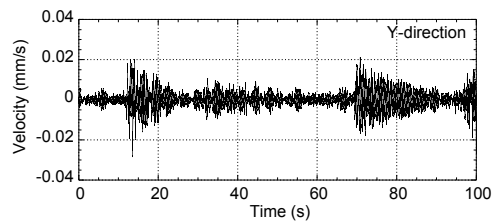
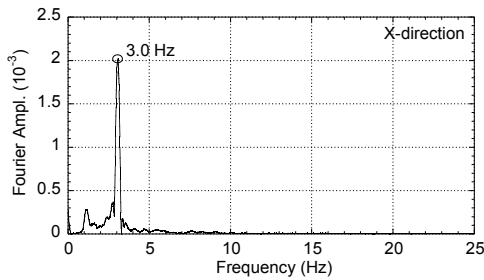
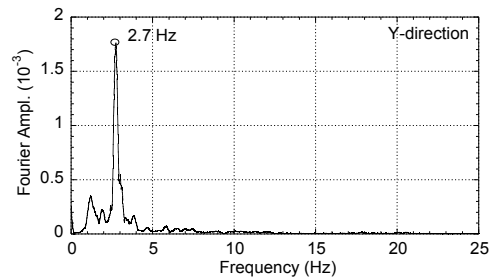
**Figure 9: Recorded time-history and Fourier spectrums at three monasteries in  $x$ -direction parallel and  $y$ -direction perpendicular to the main entrance**

The measurement was taken at every floor and at different locations, chosen depending on the ease of placing the sensor. The sampling frequency was 2000 Hz which was recorded for about 100 s each time. The recorded time-history in both the direction and its corresponding Fourier spectrum at three temple sites is shown in Figure9. The data are filtered and re-sampled to remove the high frequency content. It was observed that all the three temples were short period structures and fall in the acceleration sensitive region of the seismic design response spectrum. In addition the floor vibrations were also measured by placing the seismometer in upright position and creating vibration by tapping the floor.

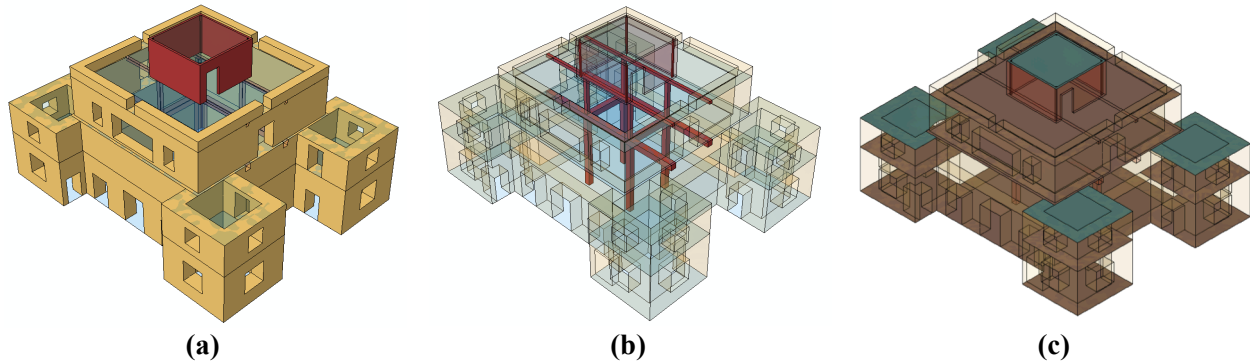
**Figure 10: View of FE models (a) Exterior masonry walls and small wooden cabin (b) Frame system of the structure comprising of wooden beams and columns (c) Roof and floor diaphragms modeled using solid shell elements.**

A three dimensional FE model was developed for Enchey monastery using the general purpose program Abaqus [8]. At this stage, no material characterization could be possible due to insufficient data on the strength of the masonry walls. The properties of the stone masonry, corrugated GI sheets and timber used for analysis are mentioned in Table 3. The typical value of Young's modulus for stone masonry ranging from 200 to 1000 MPa has been reported by Tomažević [9]. A modulus of 300 MPa near lower values of the range was chosen considering the age, quality and type of masonry construction. The masonry walls and timber frame were modelled as 3D solid elements while the floor and roof components were modelled as 3D shell elements. The second and third storey floors were modelled as isotropic shell of thickness 145 and 210 mm to match the frequencies of two floors (9.4 Hz and 13.5 Hz) as obtained by the ambient vibration test in the vertical direction. The discretization of masonry walls and timber frame was achieved by 4-noded linear tetrahedron elements (C3D4) whereas 3-noded triangular shell elements (S3) of the Abaqus element library were used for roof and timber floors. Monolithic connection was assumed between the column and beam joints and between frame and diaphragm. A view of the FE model is shown in Figure 10.

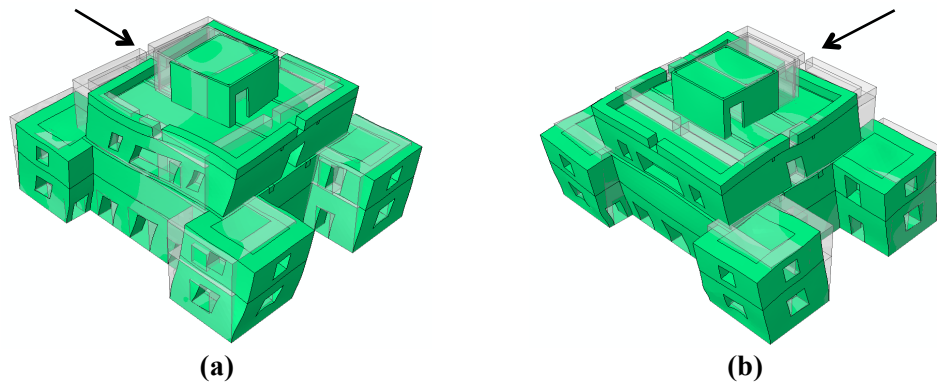
**Figure 11: Mode shapes for natural frequency in (a)  $x$ -direction and (b)  $y$ -direction**

The modal analysis of the structure was performed by assuming fixed translational and rotational boundary conditions at the base of the structure. The frequency in the orthogonal direction: parallel ( $x$ -direction) and perpendicular ( $y$ -direction) to the entrance was found to be 4.5 Hz and 4.8 Hz, respectively as shown in Figure 11. These obtained frequencies are in a good agreement with the observed values of 4.2 and 4.4 Hz measured by ambient vibration tests.

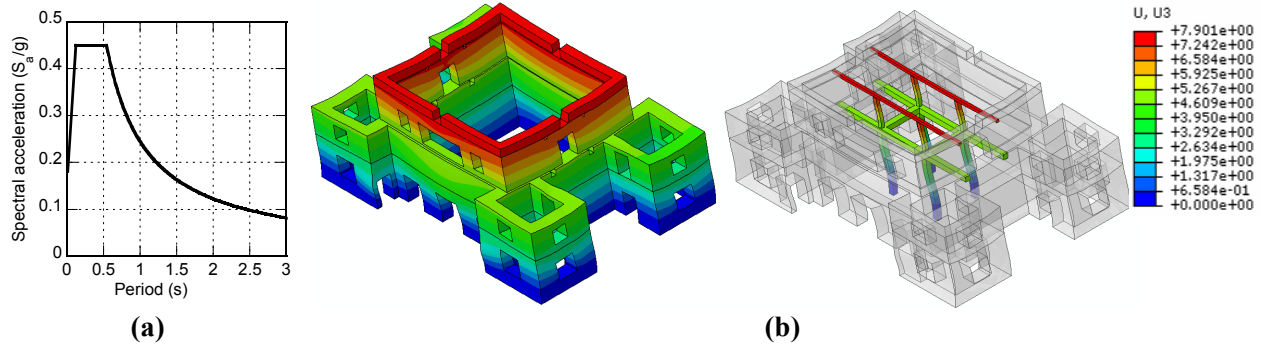
**Figure 12: (a) Response spectrum for zone IV soil type II with 5% damping,(b) displacement contour for loading in y-direction as obtained by RSA for masonry walls and timber frame**

Response spectrum analysis (RSA) considering all significant modes in both the direction was performed to predict the seismic demand for Zone IV (zone factor of 0.24g). For the design basis earthquake (DBE), 5% damped elastic design response spectrum for soil type II was scaled so that the zero period acceleration (ZPA) is 0.18g which includes a load factor of 1.5 (Figure 12a). The total base shear was calculated which was found to be 29% and 31% of the self weight in  $x$ - and  $y$ - direction, respectively. The obtained base shear was divided by the net wall area in both directions at the window level to estimate the average wall shear stress. Figure 12b shows the displacement contour for loading in  $y$ -direction as obtained from the response spectrum analysis.

In order to identify the stress critical zone in the structure, a uniform static horizontal load taken as 20% of the weight as per the Indian seismic code was applied in both the directions. Table 4 summarizes the stresses obtained by response spectrum analysis and lateral load analysis. The maximum tensile stresses observed at the corner of openings exceeded the lower bound cracking value of 0.08 MPa [9] (Figure13). The location of maximum stresses was same as the location of damage observed during the 2011 earthquake (Figure 5).
