CLAYBANK BRICK PLANT – A FUNCTIONAL AND BUILDING ENVELOPE/ WATER DIVERSION RECOMMENDATION FOR A HISTORIC BUILDING

P. Glanville¹

ABSTRACT

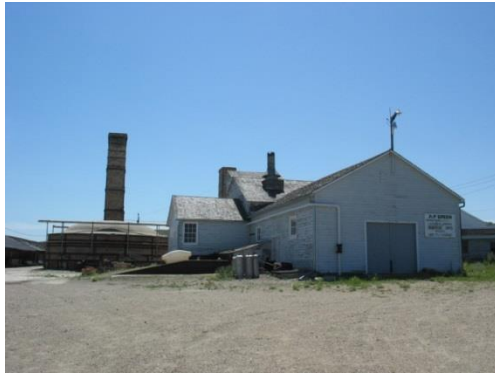
Figure 1: a) Clay Bank Brick Plant site office, kiln and smoke stack, b) Section of down draft kiln.

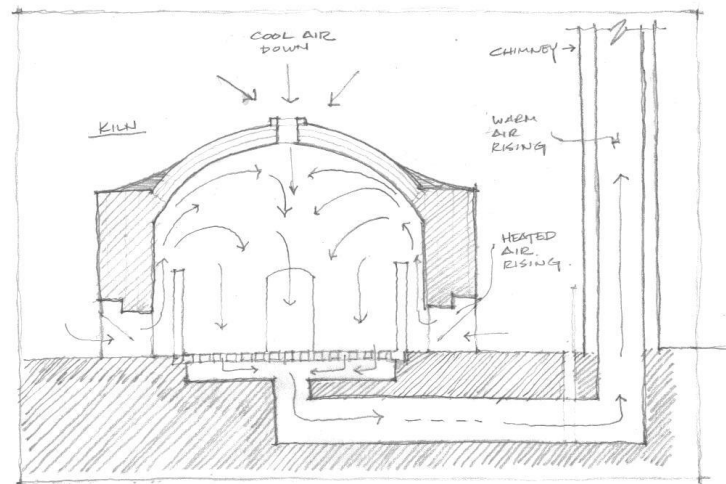
b)

Note that the cool air forces the warm air down through to the kiln floor and releases the air through the connected smoke stack.

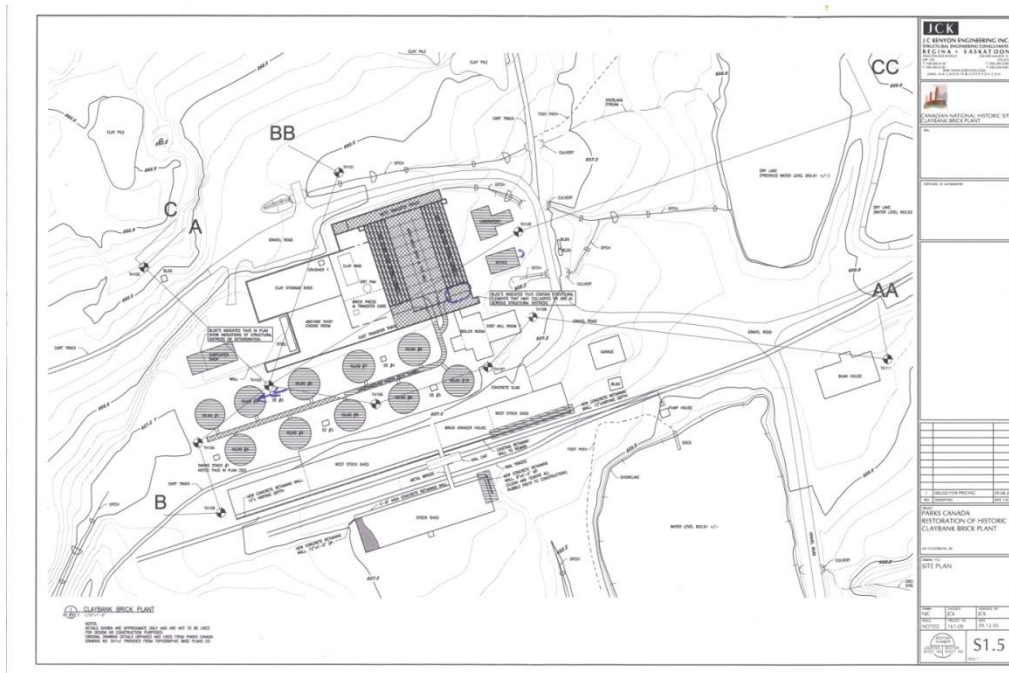
At the Clay Bank Plant site, the surface elevations range from 660.0m at the north end to 662.5m at the south end. Run-off from a hill approximately 6m in height at the south end of the site causes a point of concentrated ground moisture, running towards the kilns. The most southerly kilns are affected more by this flow.

Figure 3: Clay Bank Brick Plant site plan including site grading pattern.
