STRUCTURAL INVESTIGATION OF MASONRY KILNS AT CLAYBANK BRICK PLANT NATIONAL HISTORIC SITE

ABSTRACT

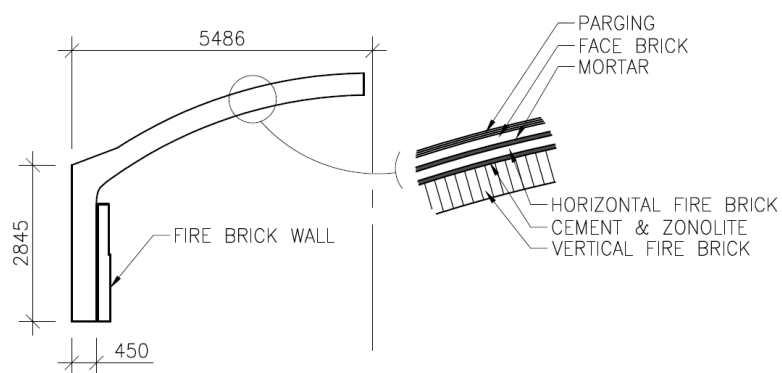
Figure 1: Half Cross Section of Kiln

Documentation indicates that the dome roof of the kilns was constructed with brick in the following order, inside to out (see Figure 1):

- Layer of vertical firebrick, dipped in very liquid cement
- Layer of cement and zanolite mixture, 25 mm thick
- Layer of horizontal firebrick
- Layer of mortar
- Layer of face brick
- Three layers of parging
