Jasper, Alberta
May 31 - June 3, 1998

DETECTION AND DELINEATION OF VOIDS IN
REINFORCED AND NON-REINFORCED MASONRY

Dr. A. Rhett Whitlock, P.E., and J. Eric Peterson, P.E.
Whitlock Dalrymple Poston & Associates, Inc.
Manassas, Virginia USA

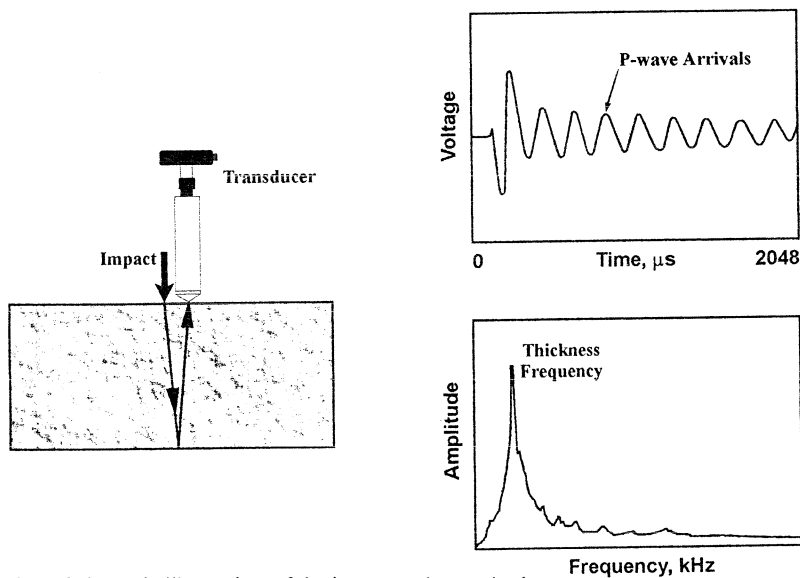
the surface where the impact was generated produce displacements which are monitored by a transducer. A schematic illustration of the impact-echo method is presented in Fig. 2.

Fig. 2 — Schematic illustration of the impact-echo method.
