**INVESTIGATION PROCEDURES BASED ON THE
COMPLEMENTARITY OF NON-DESTRUCTIVE AND SLIGHTLY
DESTRUCTIVE ON SITE TESTS: APPLICATION TO THE TWO
CASTLES OF AVIO (ITALY) AND PISECE (SLOVENIA)**

L. Binda¹, L. Cantini², M. Lualdi², C. Tedeschi³, A. Saisi³ and L. Zanzi⁴

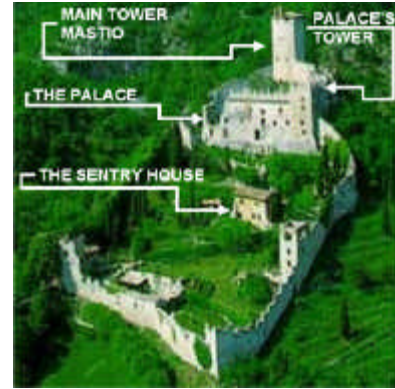
Figure 4 - The Castle of Avio

The building complex of the Castle of Avio nestles around the Main Tower and is surrounded by the circles of walls (Fig. 4).

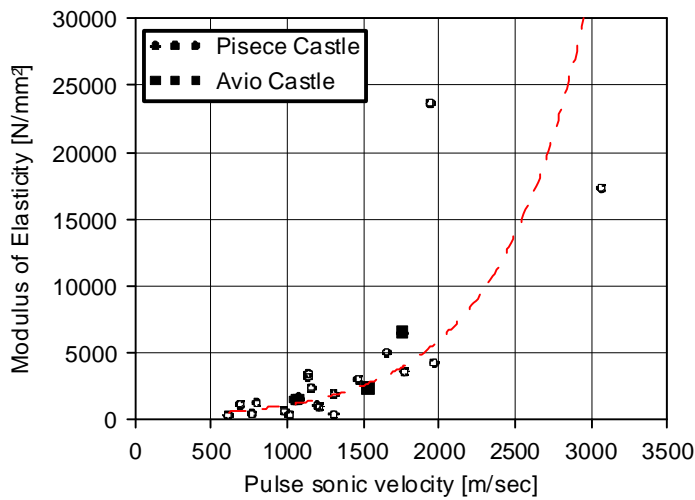
Figure 14 – Correlation between the pulse sonic velocity (average of the measured values) and the modulus of elasticity obtained by double flat jack on a group of 25 cases

Fig. 14 shows a tentative correlation between pulse sonic tests and the modulus of elasticity by the double flat jack on a group of 25 cases. The test results of Pisece and Avio Castles seem to be aligned with the other data.

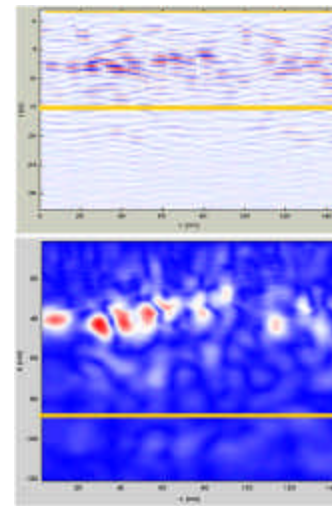
Figure 15 – Radar profiles which indicate the presence of a two leaves section. Red spots indicate high radar energy reflected by the transition between the leaves

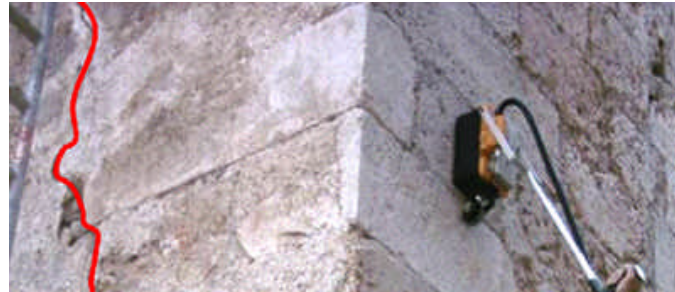
Finally, at the Pisece Castle an important crack pattern was inspected in order to evaluate its depth. A radar vertical profile was executed on the external side of the tower starting at a height of 190 cm from the base and moving upward (Fig. 18). The profile is parallel to the corner at a

distance from the corner of 70 cm. The inspection was carried out in order to verify if radar was able to detect the presence and the depth of the wide cracks visible on the corner (Fig. 19).

Figure 18 - Position of the vertical radar profile collected with a 1GHz antenna to map some important cracks
