A CASE STUDY IN STRUCTURAL RENOVATION AND MASONRY RESTORATION

William D. Bast, P.E., S.E.¹ and Terry R. McDonnell, P.E., S.E.²

A four-story unreinforced brick masonry building in Cleveland, Ohio was studied for the purpose of performing structural renovation and restoration of the brick, terra cotta and limestone masonry façade. New Code provisions from International Building Code 2000 (IBC) and International Existing Building Code 2003 (IEBC) were applied. A reinforced concrete addition to the building was designed to carry the bulk of the seismic load. An opinion of cost was developed for the masonry façade restoration.

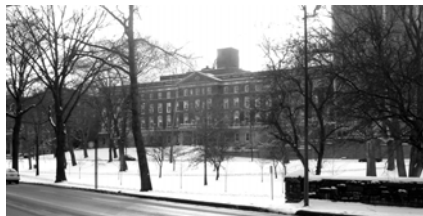
Figure 1 – Existing east elevation of the 1914 South Building

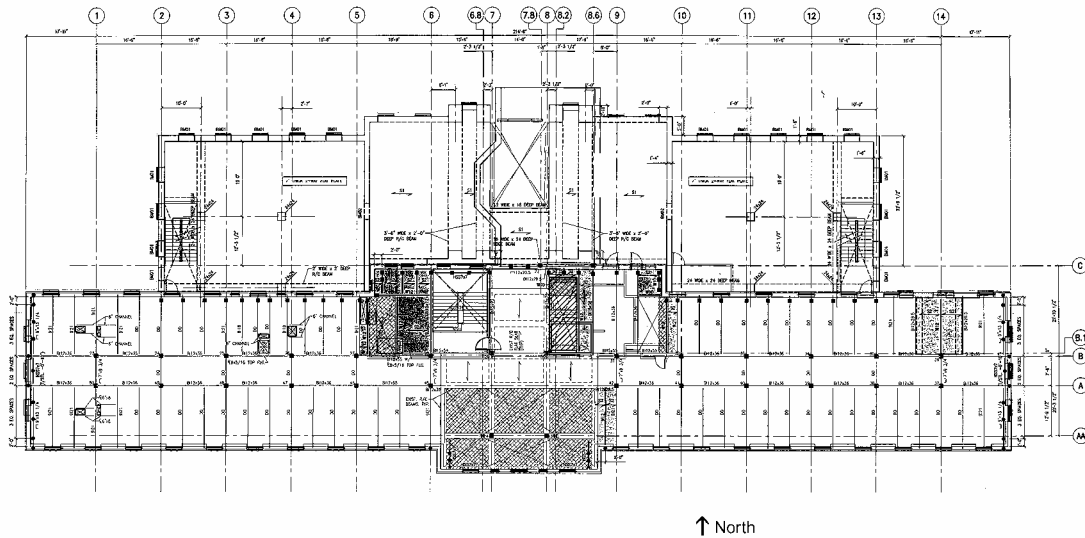
Figure 2 – Typical South Building floor plan. (In general the original building is south of Column line C, and the new portion is north of line C)
