## CATHEDRAL OF PORTO, PORTUGAL: CONSERVATION WORKS 2003-2008

This paper presents selected works carried out at the Cathedral of Porto, Portugal, as a case study that challenges current recommendations for the conservation and restoration of architectural heritage. The historical information is briefly reviewed and the general conservation approach for the different works is addressed. Afterwards, the aspects regarding the strengthening of the towers, diagnosis of a chapel, strengthening of the transept and diagnosis of the main façade are addressed.

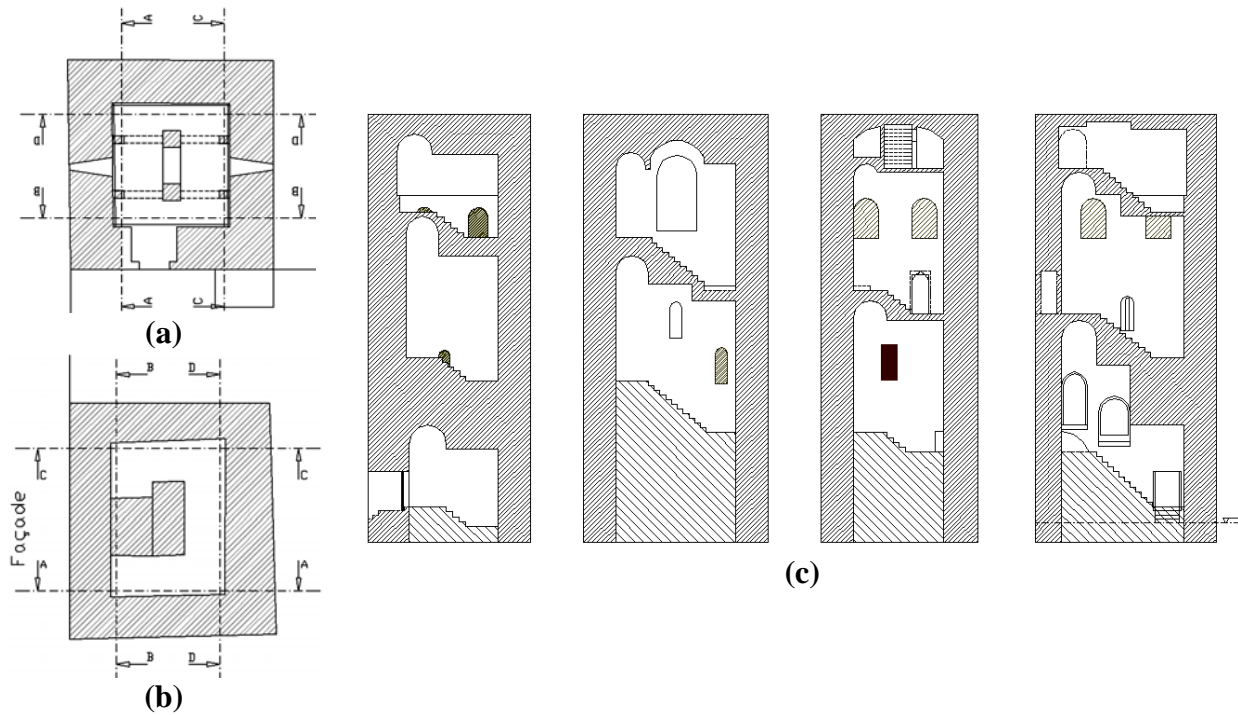
The cross section of the towers is approximately square with a side of 10.0 m and exhibits a variable thickness, with a minimum of 1.7 m at the base. The height of the towers is approximately 35 m, which means that the average stress at the base is around  $1.0 \text{ N/mm}^2$ . This value is rather low for regular granite masonry but it is rather high for rubble masonry (with or without mortar joints). In the main façade, two buttresses are apparent in each tower, see Figure 1b. As addressed above, the structure suffered several major modifications through time, which resulted in a very complex internal structure with different load bearing internal elements at each level. The structure of the towers cannot be understood from structural reasons and several openings are closed, facing staircases or vaults. The entrance for both towers is located at mid-height, with a connection between both towers from the top of the main vault. But the two towers have a rather different structure. The North tower (presently with the bells and clock) features a horizontal mid-level with stone slabs and architraves apparently supported in columns and stone struts, see Figure 6a. The South tower possesses an internal core with a staircase shaped helicoidally, see Figure 6b,c.

**Figure 6: Partial Sections of the Towers: (a) Horizontal Section of the South Tower, (b) Horizontal Section of the North Tower; (c) Sections A-D for the South Tower.**

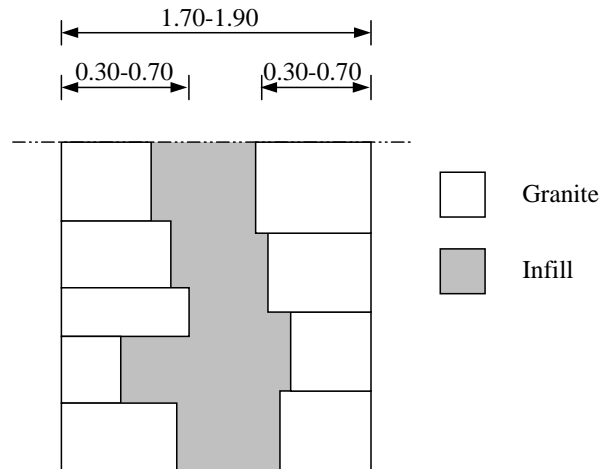
The constitution of the masonry walls from the towers was characterized using visual inspection, both by removing stones of the outer leave in the interior of the tower and by using a boroscopic camera inserted in cracks or in holes drilled in joints, see Figure 7a. From the inspection, it was possible to conclude that the three-leaf walls have external leaves of granite ashlar with a thickness ranging from 0.30 to 0.70 m, while the middle leave is made from loose smaller stones and / or silty soil, see Figure 7b and Figure 8. The combination of heavy rain in Porto, strong winds in the top of the hill where the Cathedral is located, and the open joints in the external masonry face, results in a wet infill even in the summer and the continuous washing out of the infill.

**Figure 8: Typical Cross Section of the Masonry Walls.**

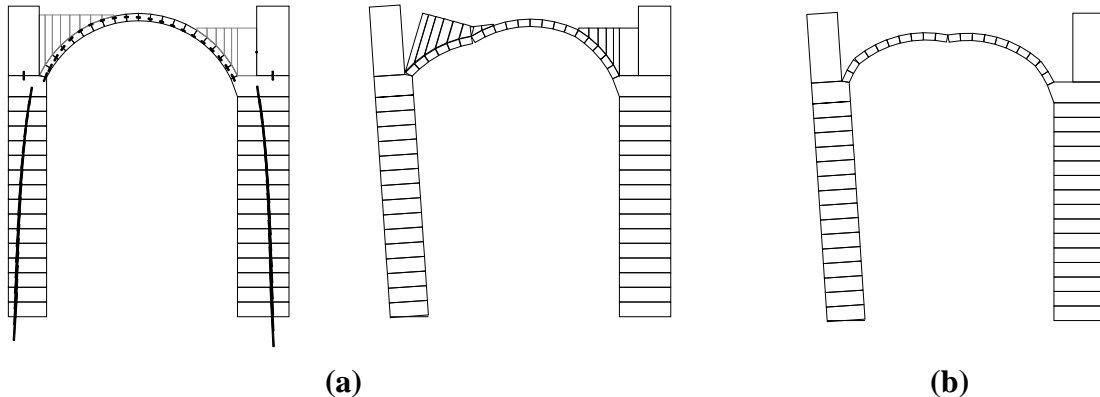
The numerical results are given in Figure 15, in terms of thrust-lines and collapse mechanisms, for the model with and without infill. The ultimate load factor increases 45% if the infill is removed, which seems also natural because it was not originally planned for this construction.

**Figure 15: Results of the Numerical Analysis, in Terms of Thrust-lines and Failure Mechanisms: (a) With Infill, for an Ultimate Load Factor Equal to 6.5; (b) Without Infill, for an Ultimate Load Factor Equal to 9.4.**

The infill was removed but, for safety reasons, it was recommended to accompany this task with topographic measurements, see Figure 16a. The targets were read always at early morning to reduce temperature effects, daily during the process of infill removal (one week) and weekly during one month after load removal. Approximately 35 m<sup>3</sup> (7000 kg) of rubble were removed from the vault and no movements were recorded in the targets. Figure 16b demonstrates that the vault was never conceived to accommodate infill, and a timber roof existed at the level of the vault, before the construction of the vault and the new roof at a higher level.

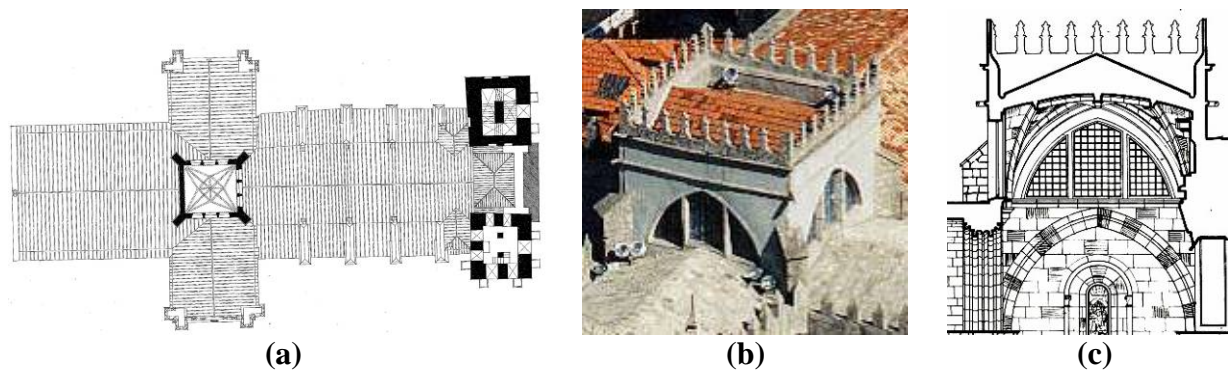
The skylight is located above the transept and presents different cracks, which occurred after the works carried out in the first half of the 20<sup>th</sup> century. In addition, infill material from the vault had recently fallen in the transept. The skylight is made of four walls supported in large arched windows opened in the 18<sup>th</sup> century, with the exception of the East façade with exhibits no opening, see Figure 17.

**Figure 17: Views of the Transept: (a) Plan; (b) Aerial View; (c) Cross Section.**

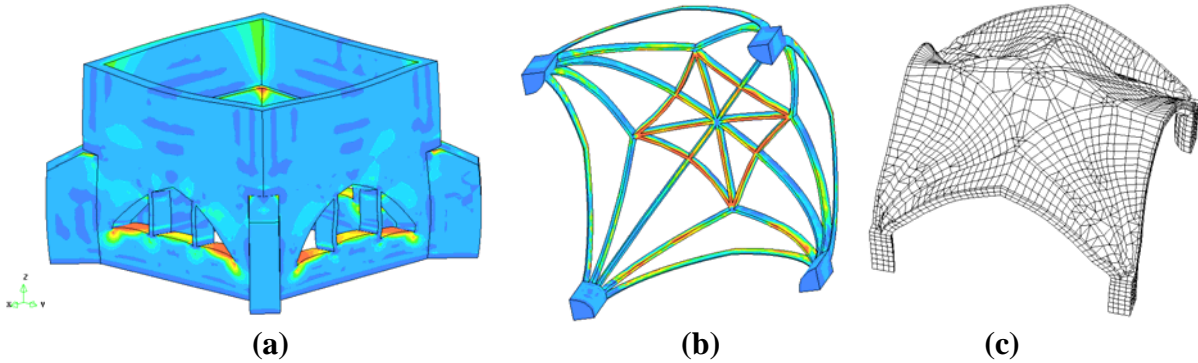
Figure 20 presents the results in terms of deformed meshes and maximum (tensile) principal stresses for the combination of self-weight plus rubble infill. The maximum tensile stress found is lower than  $0.1 \text{ N/mm}^2$  and is located in the window-sills and ribs. These values are low and no cracking is thus expected in the structure. The vault is fully under compression for the self-weight and reaches a maximum tensile stress of  $0.15 \text{ N/mm}^2$  for the infill. The maximum compressive stress is lower than  $0.6 \text{ N/mm}^2$ , and is located in the columns, window corner, base of the buttresses and keys of the vault. In conclusion, the skylight should have minor or no damage under self-weight and infill, and the presence of the infill is unfavorable.

**Figure 20: Results for Self-Weight Plus Rubble Infill: (a) Maximum Principal Stresses in Walls; (b) Maximum Principal Stresses in Ribs; (c) Deformed Mesh for the Vault. The Red Color Indicates the Maximum Values, Which Are Below  $0.1 \text{ N/mm}^2$ .**

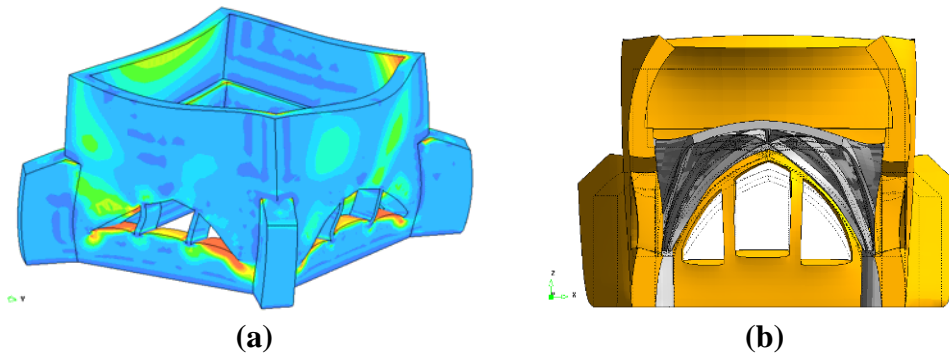
Seismic loading and temperature were then added to the structure, aiming at explaining the damage, see Figure 21. Even if the deformation for seismic loading has some resemblance with the observed movements in the structure for the West wall, the stresses found are too low to provoke any damage. The deformed mesh associated with the differential temperature indicates

that the walls move to the exterior and suffer significant bending, with significant curvatures in the columns. Still moderate stresses are found and the deformation is not in agreement with the observed movements, meaning that the temperature effect is relevant but should not be the main cause of the damage.

**Figure 21: Results with Live Loads: (a) Earthquake Combined with Other Loads; (b) Deformed Mesh Only for Differential Temperature.**

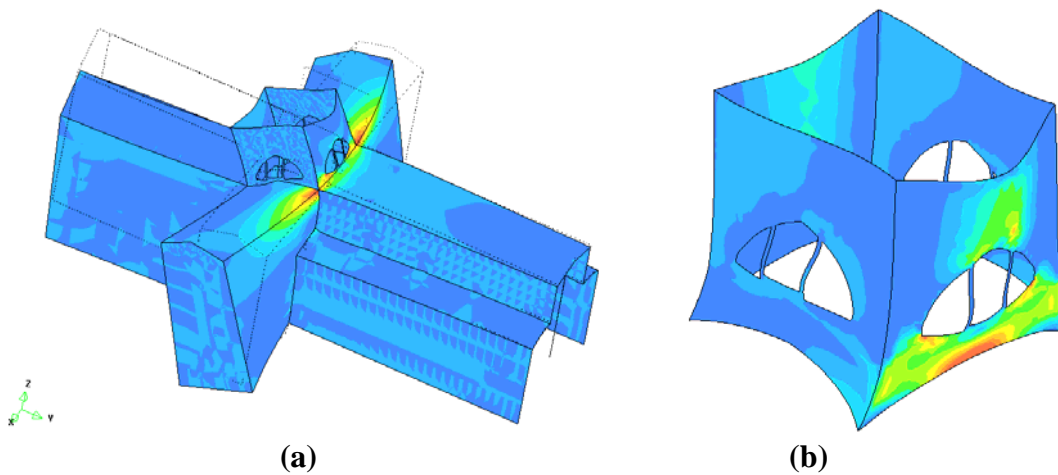
A full model of the church was then prepared to analyze the influence between the skylight, the adjacent structure and the soil, see Figure 22. The finite element model, even if over simplified, has about 50000 degrees of freedom and is made with plane shell elements, curved shell elements and beam elements. Interface elements were added to the supports in order to replicate the soil-structure interaction. The deformed mesh with the new analysis is shown in Figure 22 for the church and skylight. Very high tensile stresses are found in the skylight and the deformation is similar to the one observed in the structure, indicating that this is the major cause of damage.

**Figure 22: Results for the Analysis of the Complete Church in Terms of Maximum Principal Stresses: (a) Full Model; (b) Detail of the Skylight. The Red Color Indicates the Maximum Values, Which Reach  $4.5 \text{ N/mm}^2$ .**

The details of the new steel structure are shown in Figure 23. It consists of a steel ring made of channel profiles that connects the internal and external part of the wall at the thirds of the span, and includes tensioning bars at 45° angle also at the thirds of the span. Details of the execution works are shown in Figure 24, namely with respect to the operation of cleaning the joints before injection, selecting an appropriate lime mortar composition with matching color and a view of the new steel and timber elements.

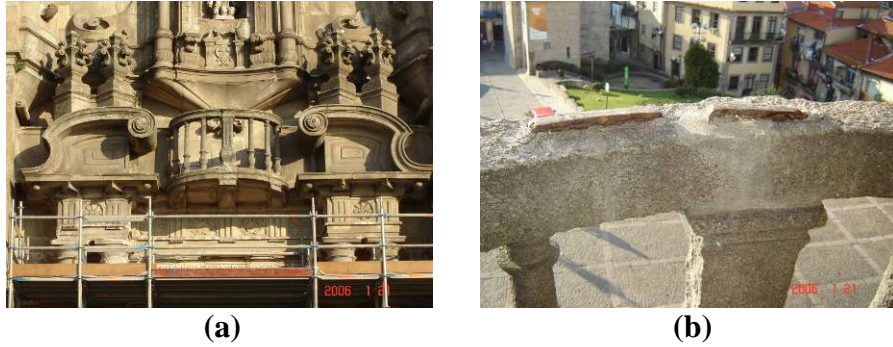
The central façade is composed of several salient elements, namely a central balcony and two lateral pinnacles, see Figure 25. The advanced degradation state of the granite and the fall of stone pieces led to an auxiliary protection structure to avoid injuring people. Due to the movements, cracks and a large number of cramps existing in the façade, an assessment of the stability conditions of the main salient structural elements of the façade was carried out. The elements considered are the balcony and the pinnacles.

**Figure 25: Salient Elements in the Façade: (a) General View; (b) Detail of the Balustrade.**

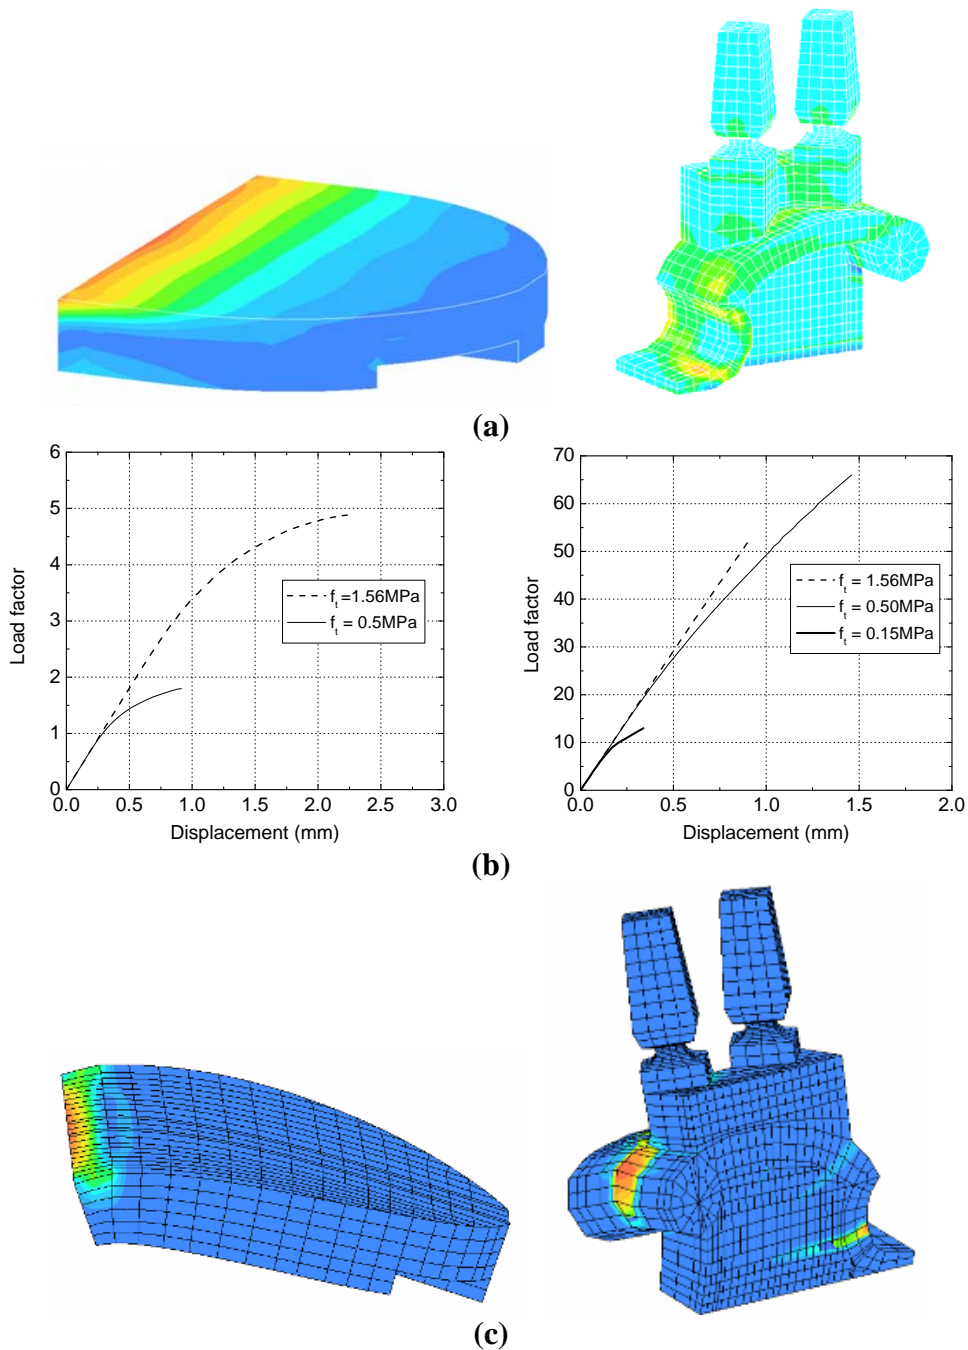
Finally, a structural analysis of the salient elements was carried out using non-linear finite element analysis, see Figure 28. From the distribution of the maximum and minimum principal stresses it was found that low values of both tensile and compressive stresses are present. Still, a non-linear analysis was carried out, allowing to obtain a safety factor, with respect to the applied loads, between five and over sixty for the balcony and the pinnacles structure, respectively. Even if the tensile strength is significantly reduced, a safety factor over two and over ten is obtained for the same structures, with a clear failure mechanism. It is noted that the models assume a monolithic behavior of the elements, which is certainly not the case for the pinnacles structure. Therefore, some remedial measures have been proposed and are currently under execution.

**Figure 28: Structural Analysis of Balcony and Pinnacles Structure: (a) Maximum Principal Stresses, with Highest Values in Red; (b) Force-Displacement Diagrams, Where the Load Factor Indicates the Magnification of the Self-weight and the Displacement is the Maximum Vertical Displacement; (c) Collapse Modes, with Highest Strains in Red.**
