11th Canadian Masonry Symposium, Toronto, Ontario, May 31- June 3, 2009

REBUILDING A MASONRY/CONCRETE SINGLE-FAMILY HOUSE FOR ECONOMICAL HEATING AND COMFORTABLE LIFE

B.G. Hellers

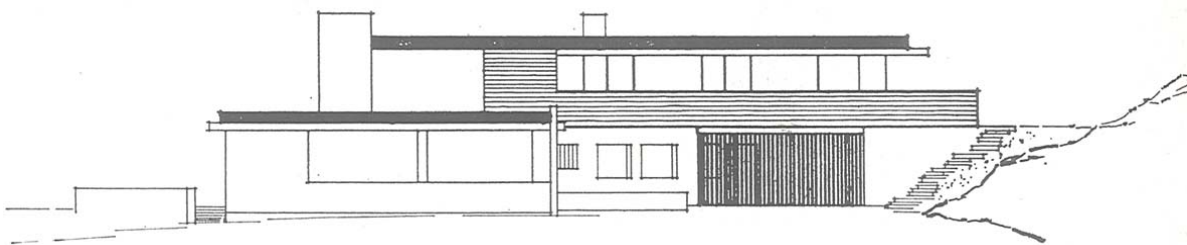
Fig 1. Outline of a one-family house from the late 1950s. Architect: Folke Hedérus

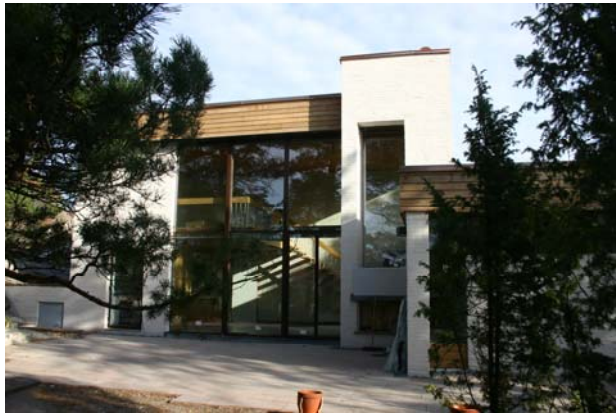
Fig 7. The masonry house after rebuilding, view from the garden

According to consultants, the new heating system, demonstrated in Fig 6 is designed to deliver a pleasant climate, thermal comfort improved, at a total of 28,000 kWh electricity per annum (no solar panels yet), down from 110,000 kWh from combined electricity and oil before rebuilding. It means close to 75% reduction of energy but an increase of electricity use. After rebuilding the energy requirement accounts for 90 kWh/m²/year, less than the required 110 kWh /m²/year. The coming winter season will test the accuracy of this prediction. So far, let us enjoy the results, Fig 7.
