ON-SITE INVESTIGATION AND MONITORING FOR THE ASSESSMENT OF A HISTORIC BRICK MASONRY TOWER

An experimental investigation aimed to the evaluation of the state of damage of historic brick masonry structure, referred to as The Bellevue Tower, is presented. The tower was built at the beginning of the 16th century as part of the Ferrero Palace-Masserano-La Marmorata, on the highest part of Biella, in the Italian region of Piedmont, and became the city landmark. The tower has a square plan for the first three lower floors from the ground level and an octagonal plan for the remaining four floors, ending with a stone-decorated cantilevered crowning.

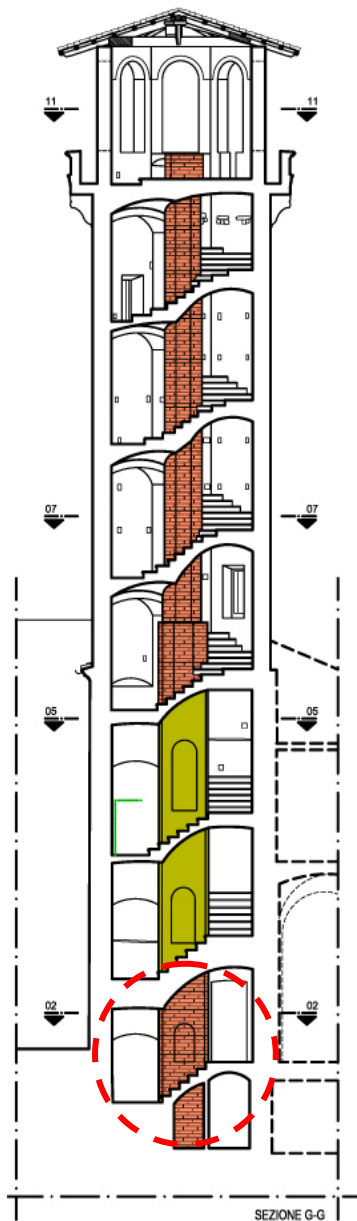
The Masserano Tower, built in solid brickwork masonry, has a square plan for the first three lower floors, inserted in the Ferrero Palace, and an octagonal plan for the remaining four floors, ending with a crowning supported by stone cantilevers and is characterized by a central pillar having a squared base 1.56 m wide and an octagonal upper part of about 1.21 m radius (Figure 9).

Many of the cracks cut the whole wall thickness, in other cases they only run on the surface. Sometimes the cracks can be interpreted as the results of compression, like for instance those on the central pillar at the ground level (Figures 9 and 10) and those on the South side at ground level (Figures 11 and 12) where very low sonic velocity was also recorded.

The state of damage of the central pillar at the underground level appeared immediately particularly serious due to the presence of diffused vertical cracks, taking also into account the presence of two recesses on opposite sides of the basement that abundantly reduces the solid cross section. On the contrary, the upper part of the central pillar till the crowning presents no cracks.

Figure 9: Vertical section showing the central pillar.
