13TH CANADIAN MASONRY SYMPOSIUM
HALIFAX, CANADA
JUNE 4TH – JUNE 7TH 2017

**PERFORMANCE OF REINFORCED CONCRETE FRAMES WITH UNREINFORCED
MASONRY INFILL DURING THE 2016 ECUADOR EARTHQUAKE**

Schultz, Arturo E.¹

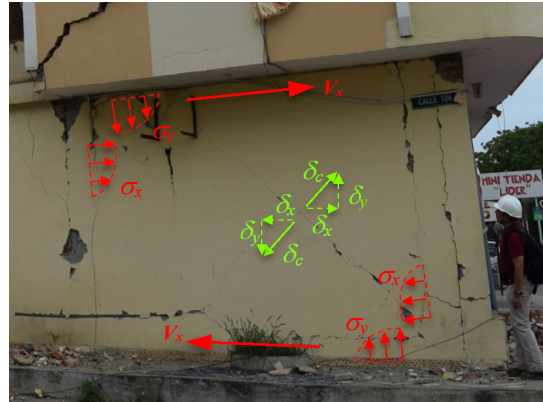
Figure 11: Idealized infill panel response

If the URM infill panel works as intended, it will develop cracks that increase progressively in width (δ_c , δ_x and δ_y in Figure 11) and number as the panel undergoes increasing cyclic drift demands. Depending upon aspect ratio, sliding along the perimeter may initially crack the panel and separate it from RC frame (Figure 12a). If not restrained from out-of-plane motion, transverse loading may initiate out-of-plane displacement relative to the frame (Figure 12a) that can eventually lead to collapse. A well-restrained URM infill will develop inclined cracks if the diagonal tension strength of the URM masonry is exceeded (Figure 12b). Under repeated cycles of load, cracked surfaces will slide generating strength degradation from abrasion and increased crack widths.
