**Moisture Conditions Across Stone Masonry Walls
- A Case Study -**

ABSTRACT

The paper deals with the results of a 12-month monitoring program of massive sandstone masonry walls in a heritage structure in Ottawa. Measurements included temperature, moisture, relative humidity and pressure across the exterior wall system and windows. The purpose of this monitoring program was to determine the source of moisture in the stone masonry walls. The results clearly established that moisture in the walls is primarily from exterior sources (i.e. rain and snow) but that air exfiltration in localized areas is also a contributory factor. The information obtained from this monitoring program has been considered in the design of the restoration program which will be underway shortly.

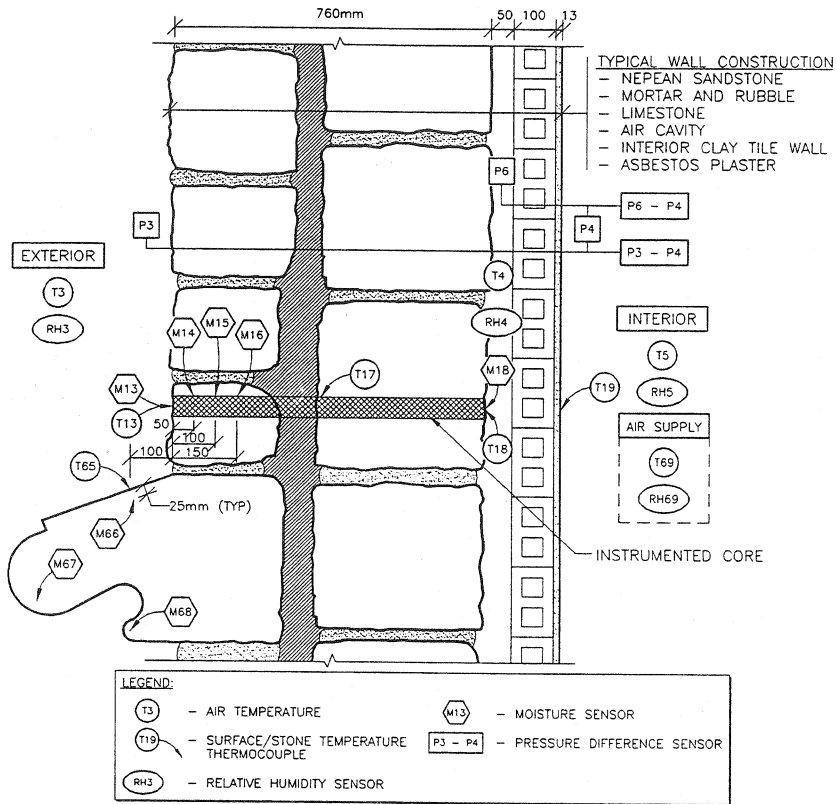
Fig. 4 Instrumentation at Fourth Floor Monitoring Station, North Side

Instrumentation consisted of thermocouples, electrical resistance moisture sensors, relative humidity transmitters and pressure difference transducers. To install the thermocouples and moisture sensors through the thickness of the stone masonry wall, 75 mm (3 in.) diameter cores were removed from the walls in two locations. Sensors were installed along the length of the cores and the cores were then replaced and sealed at their original locations. The locations of the monitoring stations on the fourth floor of the museum are shown in Fig. 3. In each of these locations, sensors were also installed on the interior and exterior of the museum as well as in the air space between the stone masonry wall and the interior clay tile wall. The type and location of the sensors through the wall are shown in Fig. 4. To assess the pressure differences across the exterior walls over the height of the building, pressure difference transducers were installed both at the fourth floor and at the ground floor level. The data was collected using automatic data loggers.
