**Jasper, Alberta
May 31 - June 3, 1998**

**MONITORING THE HYGROTHERMAL PERFORMANCE OF A MASONRY WALL
WITH AND WITHOUT THERMAL INSULATION**

A H P Maurenbrecher, M Z Rousseau & M N A. Saïd
Institute for Research in Construction, National Research Council, Ottawa K1A 0R6

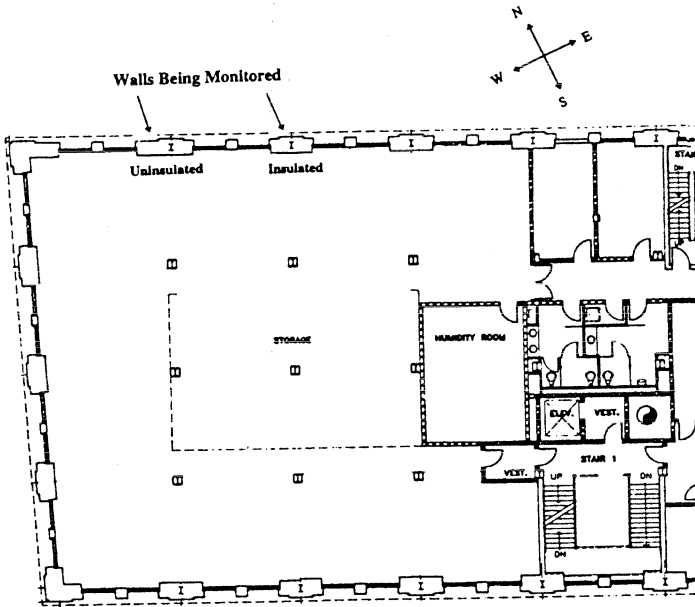
Figure 2 Plan of west end of building (3rd floor)

The Winnipeg Customs Examining Warehouse (also known as the Inland Revenue Building) is a historic four-storey masonry building built in 1908-1911 (Fig 1). The structural components consist of a steel frame encased in concrete or masonry, reinforced concrete floors and roof deck, and masonry exterior walls. Large windows comprise about 38% of the facade. The solid masonry walls consist of one wythe of clay facing brick backed by multiple wythes of sand-lime brick (from two to seven wythes). The thickness of the walls varies from about 900 mm on the ground floor to 300 mm on the top floor. Steel columns are embedded in the masonry on three facades (Fig 2).

The monitored wall sections are located on the third floor on the north side of the building near the north-west corner (Fig 2). This location was chosen because it is exposed to prevailing wind-driven rain, receives little solar radiation, and is easily accessible from the exterior for the placement of the sensors. The indoor air pressure on the third floor was expected to be higher than the outdoor air pressure in the winter due to stack effect (any air leakage would then be towards the exterior). The location was also in an open storage area so that both wall sections were exposed to the same indoor temperature and humidity conditions. The area contained desks around the perimeter for personnel.

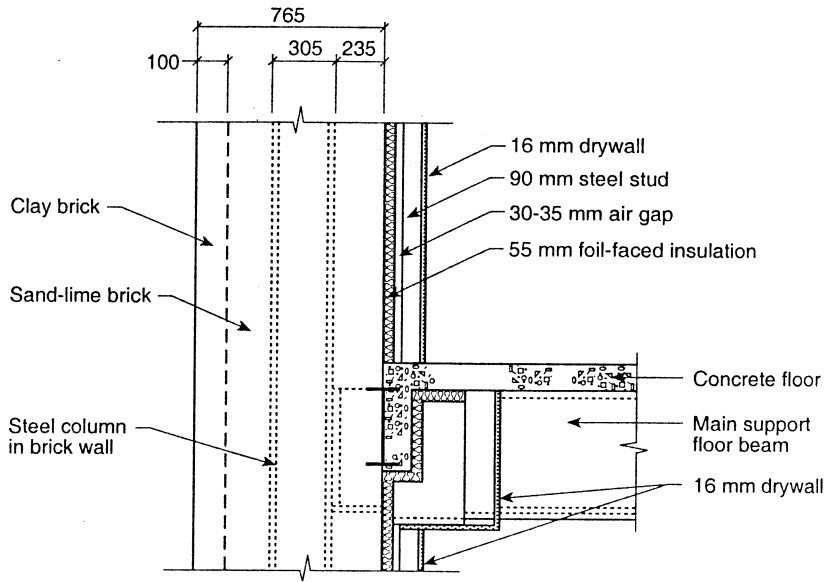
Figure 3 Renovated wall composition

A very extensive renovation was completed in 1993. The ground floor now houses Customs offices while the upper three floors house the Artifact Restoration workshops and laboratories of the Canadian Parks Service. This new use of the building space required stable indoor temperatures, and, in some areas, stable humidity levels. The renovation of the building envelope consisted of insulating the inside of the masonry walls, adding a vapour barrier, replacing all windows, installing a new waterproof roofing membrane on the flat roof, and installing a forced air HVAC system and hot water radiators under the windows. Figure 3 shows the composition of the retrofitted masonry wall. Aluminum foil on the inside surface of the semi-rigid glass fibre insulation acts as the vapour barrier. All the joints between the insulation boards were taped and the top and bottom were caulked to the concrete slabs at the ceiling and floor levels. However, the authors suspect that the thick masonry in the wall would probably act as a better air barrier system than the foil, provided that the junction with the windows was sealed. On the inside of the insulation and vapour barrier, a steel stud frame was installed about 35 mm away from the insulation; that stud space was used for the installation of services. The drywall interior finish was fixed to the stud frame, and painted (Fig. 3).

left uninsulated for research purposes. Indeed the wall on the second floor as well as a small section of its ceiling have been insulated (Fig. 3). Minimal heat flow from adjacent materials was available to raise the temperature of the masonry at the floor level of the monitored uninsulated wall section. If the wall underneath the uninsulated test section was not insulated (like in a fully uninsulated building), the interior face of the wall/floor junction would be at a higher temperature than what was measured. Based on the temperature measurements, condensation would occur at the wall/floor interface when humidity level indoors exceeds 35 % RH.

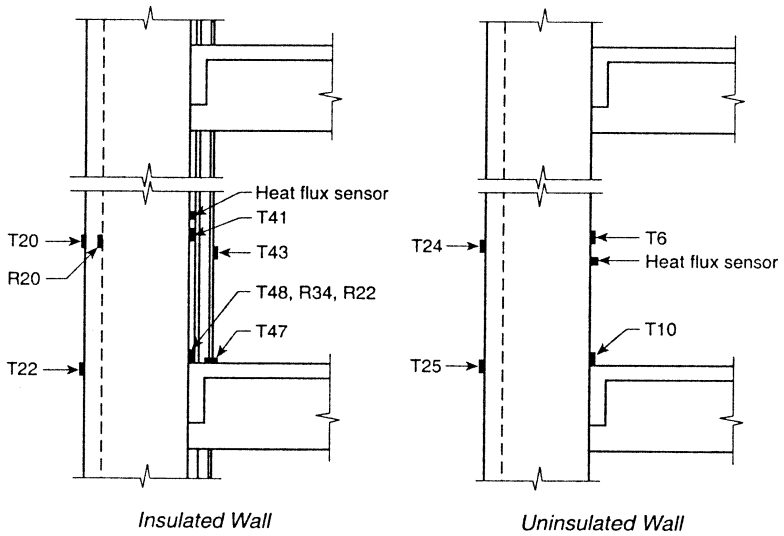
Figure 4 Location of thermocouples (T) and moisture sensors (R)

Preliminary investigations of the building indicated that steel beams and columns embedded in the masonry could act as thermal bridges where they connect with concrete encased steel beams in the heated space. The concrete floor slab is also in direct contact with the exterior masonry wall thus producing a low resistance path for heat to flow around the insulation. The potential thermal bridge at the floor slab-wall intersection was selected for further investigation. Modelling of the temperature profile was used at the design stage to support the selection of a retrofit technique while monitoring was used in the operational stage to follow-up on actual performance. For the monitoring, thermocouples were located in both the insulated and uninsulated wall sections on the surface of the floor (Fig 4, T10, T47, and T48).
