## **IMPACT RESISTANCE OF BRICK VENEER STRUCTURES TO HURRICANE DEBRIS**

**Richard M. Bennett<sup>1</sup>, J. Gregg Borchelt<sup>2</sup>, Jim Bryja<sup>3</sup>, and Bill Kjorlien<sup>4</sup>**

### **ABSTRACT**

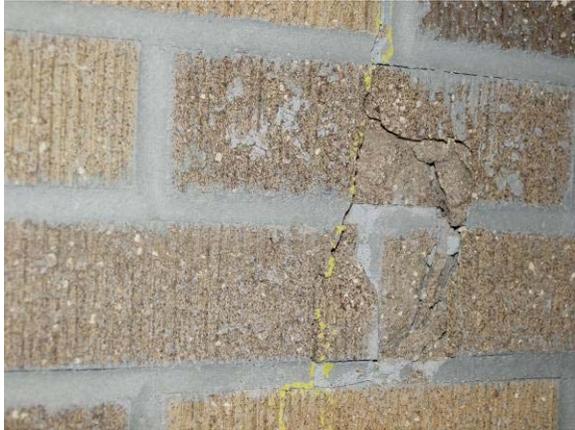
**Figure 1 - Missile Penetration, 2<sup>nd</sup> Shot of 40 N (9 lb) 56 km/hr (35 mph) Missile**

The first specimen was impacted at the center of the panel with a 40 N (9 lb) missile traveling at 55 km/hr (34 mph). This missile rebounded from the brick veneer and caused a vertical crack in the masonry that went from 0.8 mm (1/32 in.) wide at the top to hairline at the bottom of the wall. There was no other visible damage. A second shot at 56 km/hr (35 mph) at the same impact location caused the vertical crack to open to 10 mm (3/8 in.) at the top and 1.6 mm (1/16 in.) at the bottom. There were additional horizontal and diagonal hairline cracks. The missile penetrated about 19 mm (3/4 in.) into the brick veneer, causing an indentation about the same size as the end of the 50 mm x 100 mm (2 in. x 4 in.) stud (Figure 1). No further tests were performed on this panel. The brick veneer was removed, and it was determined that there was no

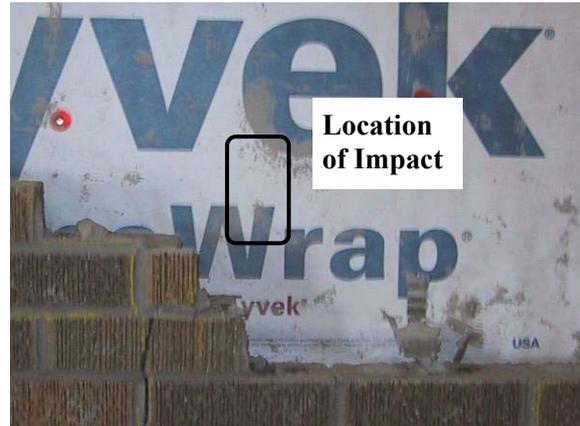
**Figure 2 - Weather-resistant Barrier After 2<sup>nd</sup> Shot of 40 N (9 lb) 56 km/hr (35 mph) Missile**

damage to either the weather-resistant barrier or the sheathing (Figure 2). Thus, it is clear that brick veneer is very capable of resisting a hurricane missile of 40 N (9 lb) at 55 km/hr (34 mph).

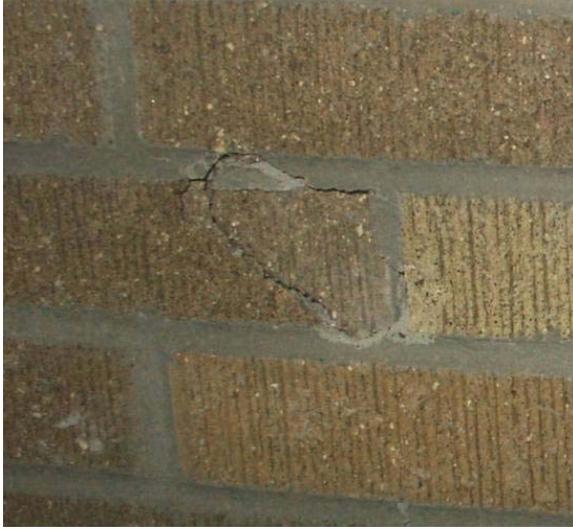
**Figure 3 - Penetration of 40 N (9 lb) 88 km/hr (55 mph) Missile**

The first shot on this panel was a 40 N (9 lb) missile at 88 km/hr (55 mph) in the center of the panel. There was 9.5 mm (3/8 in.) penetration into the veneer, with the penetration being almost exactly the size of the 50 mm x 100 mm (2 in. x 4 in.) missile (Figure 3). There was a vertical crack similar to that of the first specimen, being 0.8 mm (1/32 in.) wide at the bottom and hairline at the top. There was also a hairline horizontal crack. After all the testing on this panel was completed, the brick veneer was removed to examine the sheathing and weather-resistant barrier. Small holes and abrasions were visible in the weather-resistant barrier at the point of impact (Figure 4) apparently caused by flying debris or impact from mortar bridging. There was no damage to the sheathing.

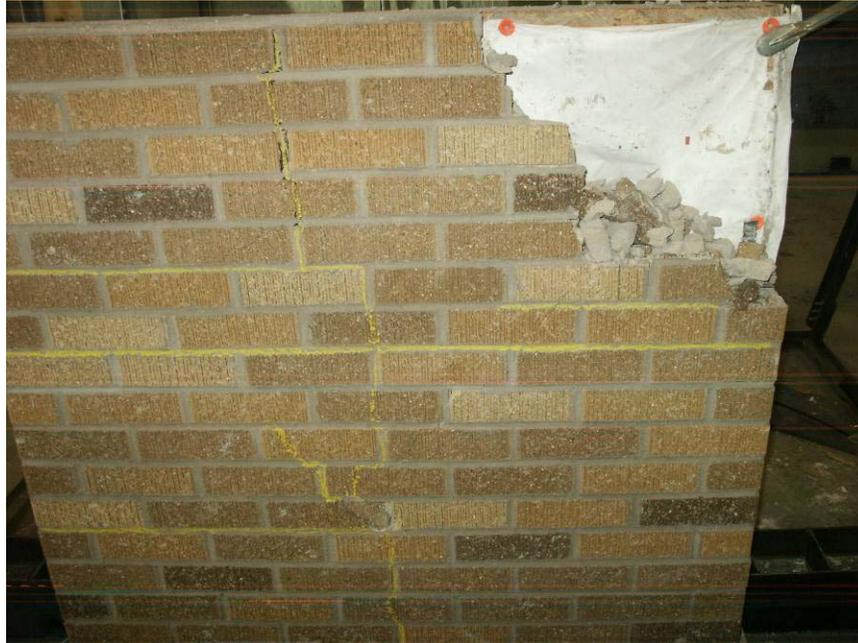
**Figure 5 - Brick Veneer Cracking and Failure from 40 N (9 Lb) 108 km/hr (67 Mph) Missile Shot at Corner of Previously Tested Panel**

The second shot on this panel was in the upper right, unrestrained corner, with the 40 N (9 lb) missile traveling at 108 km/hr (67 mph). This missile shot caused a triangular area to be knocked off the corner of the brick veneer, about 0.46 m (18 in.) wide x 0.43 m (17 in.) high (Figure 5). There was a 0.30 m (12 in.) wide x 0.25 m (10 in.) high damaged area of the sheathing, with the sheathing being knocked in about 50 mm (2 in.). The gypsum wallboard had a 2.4 mm (3/32 in.) wide crack that extended from the location of the first impact to the second impact.

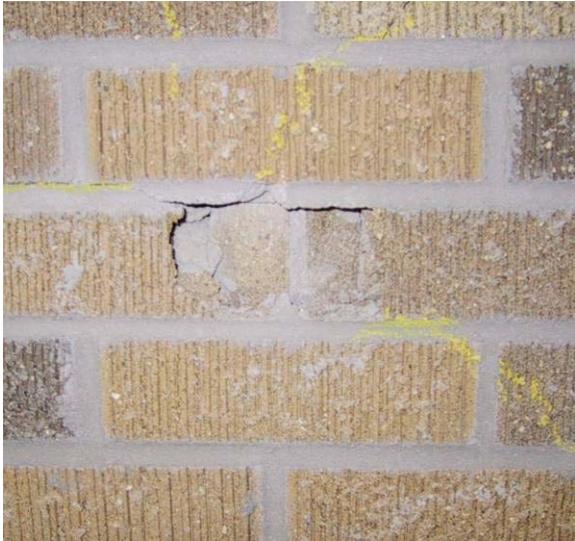
**Figure 6 - Missile Penetration and Panel Cracking, 40 N (9 lb) 109 km/hr (68 mph) Missile**

The third brick specimen was of identical construction to the first specimen. It did not have any mortar around the sides and top, as the second specimen did. The first shot on this panel was a 40 N (9 lb) missile at 109 km/hr (68 mph) in the center of the panel. There was significant cracking of the brick veneer and a 38 mm (1-1/2 in.) penetration of the missile into the brick veneer (Figure 6). There was a vertical crack that went from 3.2 mm (1/8 in.) wide at the top to 0.8 mm (1/32 in.) wide just above the point of impact. The brick face texture, including the head joint, was visible in the end of the missile (Figure 7). After this test, the top portion of the panel was torn down so the impact area could be examined. There was minor scuffing of the weather-

resistant barrier and no damage to the sheathing. A shear crack was visible through the thickness of the brick below the point of impact. The crack appeared to be at about 45° to the face of the veneer.

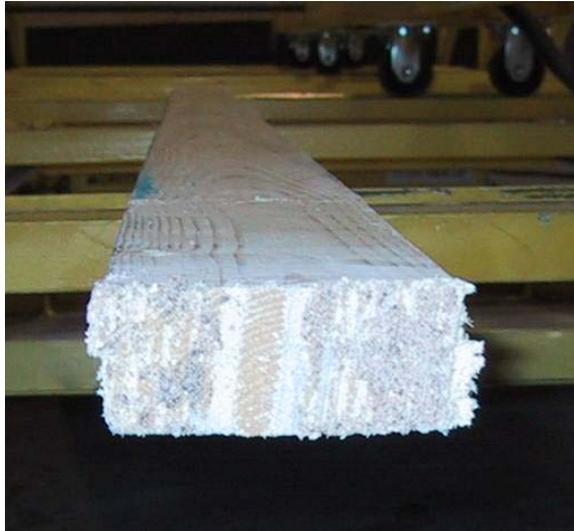
**Figure 7 - Impact End of Missile After 109 km/hr (68 mph) Shot**

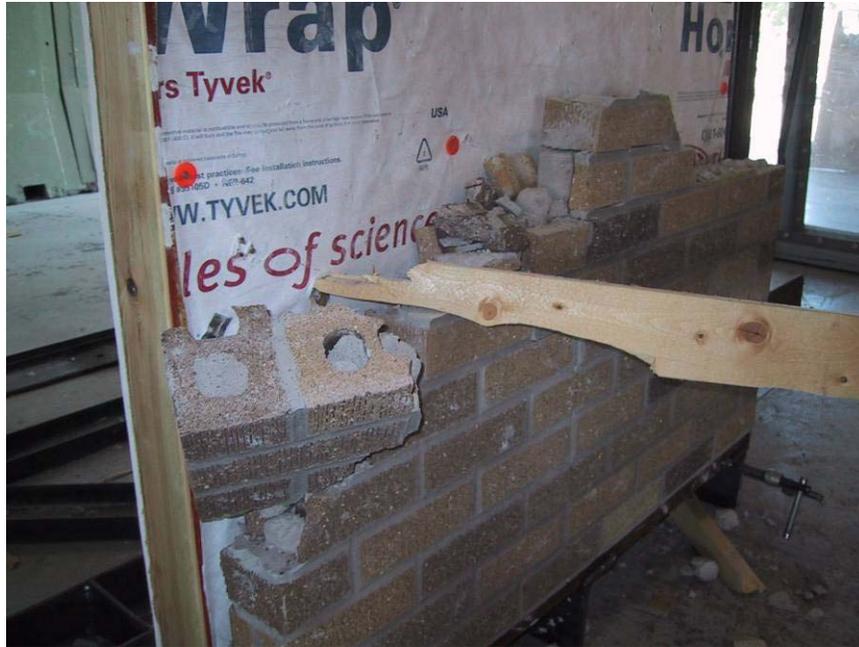
**Figure 8 - Damage from 40 N (9 lb) 122 km/hr Missile**

The remaining lower portion of the panel was impacted with a second missile traveling at 122 km/hr (76 mph) in the lower left hand corner. The point of impact was one course above the lower row of ties. The brick corner was shattered, and there was a large vertical crack in the veneer. The missile split upon impact, with one piece penetrating about 25 mm (1 in.) into the sheathing, Figure 8. No cracks were present in the gypsum wallboard.

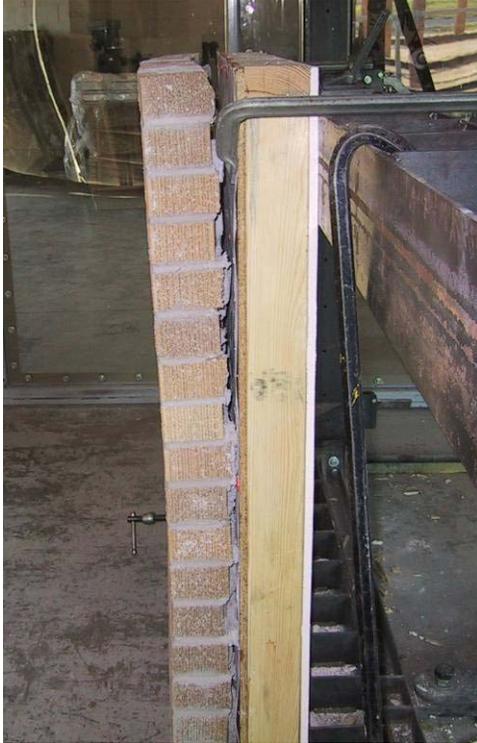
**Figure 10 - Side View of Veneer after Impact with a 40 N (9 lb) 127 km/hr (79 mph) Missile**

The fourth specimen had only one row of ties 660 mm (24 in.) from the bottom, conforming to normal brick construction. The specimen was impacted with a 40 N (9 lb) 127 km/hr (79 mph) missile between the center studs, two courses below the row of ties. A vertical crack formed in the veneer, with the crack being 14 mm (9/16 in.) wide at the top and 8 mm (5/16 in.) wide at the bottom (Figure 9). There was also extensive diagonal cracking, and an approximate 50 mm x 100 mm x 6 mm (2 in. x 4 in. x 1/4 in.) deep penetration of the brick. The missile broke at a knot. The brick above the ties rocked upon the impact. The top portion maintained position approximately 38 mm (1.5 in.) out at the top, leaving a 64 mm (2.5 in.) air space (Figure 10). There was no permanent movement at the tie level. Upon removal of the brick and examination of the specimen, it was determined there was no substantial damage to the weather-resistant barrier; there was a little scuffing, but no holes or tears (Figure 11).

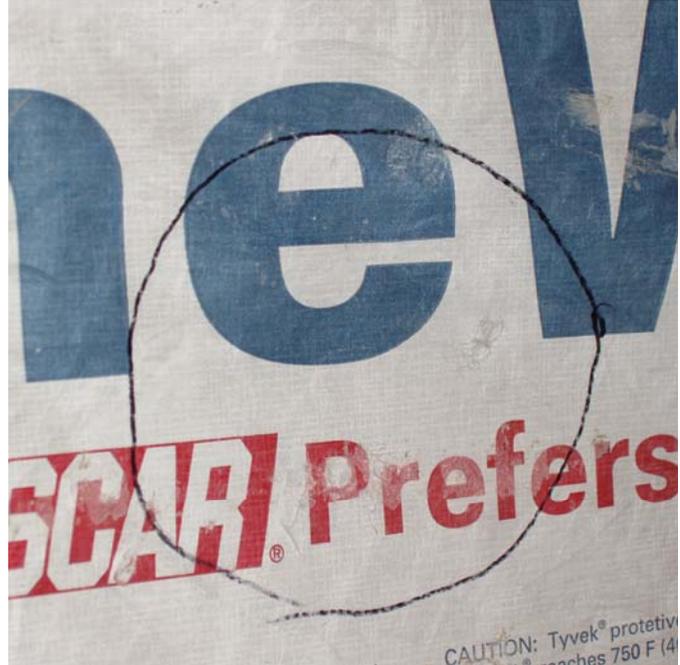
**Figure 11 - Weather-resistant Barrier after 40 N (9 lb) 127 km/hr (79 mph) Missile Impact**
