**13<sup>TH</sup> CANADIAN MASONRY SYMPOSIUM**  
**HALIFAX, CANADA**  
**JUNE 4<sup>TH</sup> – JUNE 7<sup>TH</sup> 2017**

**EMPIRICAL VULNERABILITY ASSESSMENT OF REINFORCED CONCRETE FRAME  
WITH MASONRY INFILL BUILDINGS IN THE CANTERBURY EARTHQUAKE  
SEQUENCE**

**Fikri, Rijalul<sup>1</sup>; Dizhur, Dmytro<sup>2</sup> and Ingham, Jason<sup>3</sup>**

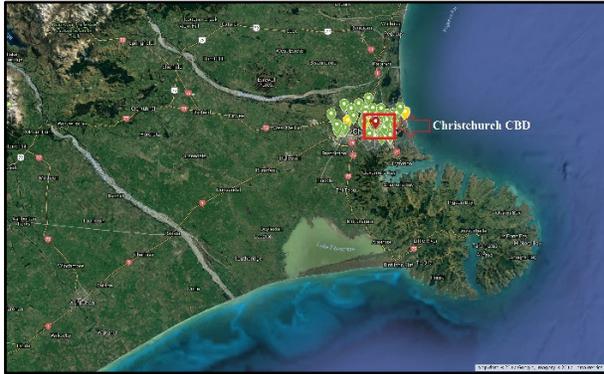
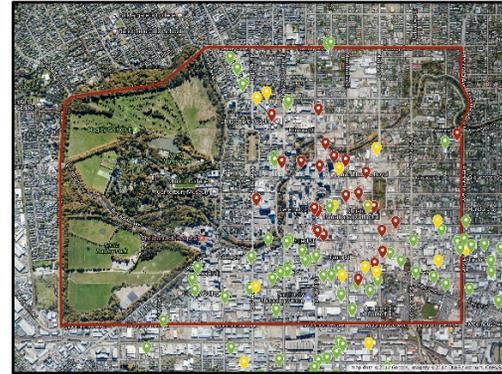
Figure 1: Location of 191 damaged RCFMI buildings in the Christchurch region

Figure 1 shows the location of damaged RCFMI buildings in the Christchurch region in conjunction with building placard status assigned from Level 1 assessments conducted by CCC following the 2011 Lyttelton earthquake [13]. Green placards indicate that the buildings have been inspected and were determined to be safe for reoccupation with no further structural intervention required, yellow placards represent the buildings having been inspected and assigned restricted entry, and red placards indicate the buildings that were considered unsafe and likely to have moderate to major level of damage.

(a) Location of buildings shown at region scale

(b) Surveyed buildings in the Christchurch CBD

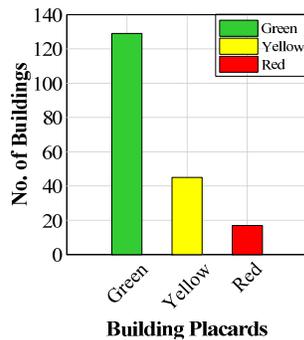
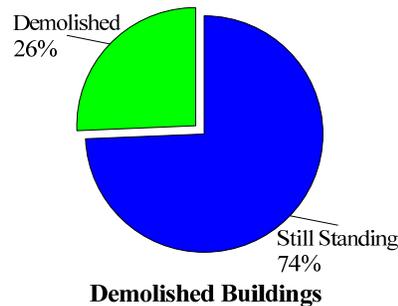
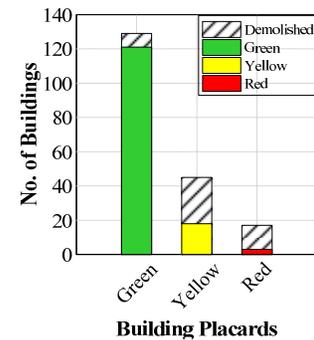
Figure 2: Damage and demolition statistics for RCFMI buildings

RCFMI buildings generally exhibited good performance during the Canterbury earthquakes, as it was established that the majority (129 out of 191 buildings; 68%) of the observed buildings were assigned green placards, (see Figure 2(a)). Recall also that it is suspected that additional RCFMI buildings were not surveyed because they exhibited no damage, such that the proportion of buildings meriting a green placard may well be significantly higher than 68%. In comparison, a

The current state of the 191 RCFMI buildings as documented on 31 October 2016 reveals that there were 49 demolished buildings (26%), while the majority (74%) of these buildings remained standing, as shown in Figure 2(b). A high proportion of the RCFMI buildings assigned a red placard, (14 out of 17 buildings; 82%), and yellow placard, (27 out of 45 buildings; 60%), following the 2011 Lyttelton earthquake were demolished (Figure 2(c)) whereas only a small number of buildings having been assigned a green placard, (8 out of 129 buildings; 6%), were demolished, despite these 8 buildings having initially been assessed to have insignificant damage. The cost of repairing and strengthening these buildings to the minimum national standard of earthquake capacity is likely to have been the dominant factor dictating building demolition, with insurance companies perhaps deeming that replacement with a new building was more cost effective.

(a) Building placard assignments following the 2011 Lyttelton earthquakes

(b) The current state of buildings documented on 31 October 2016

(c) Proportion of demolished building for each building placard type

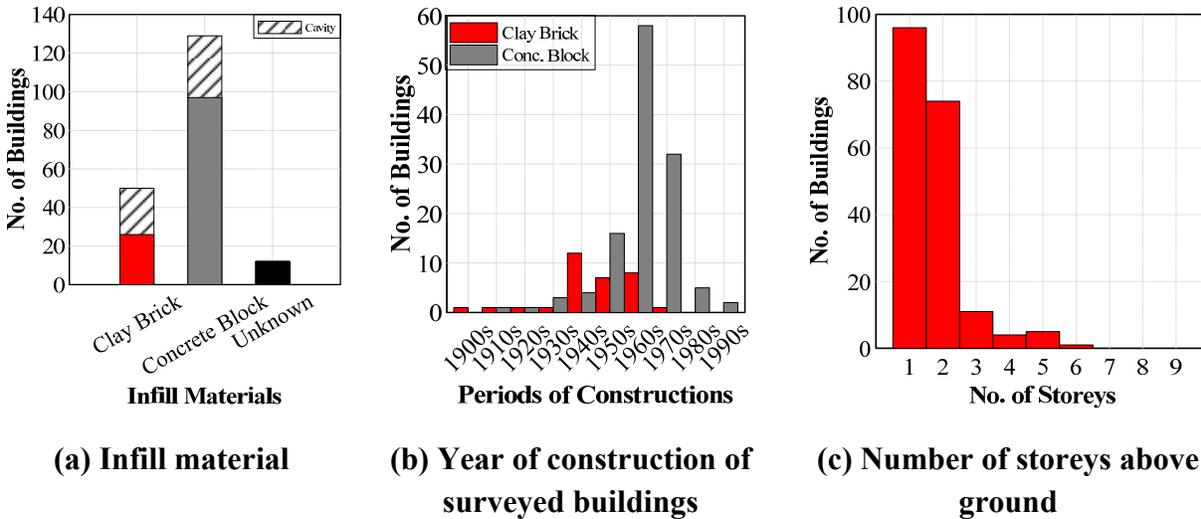
**Figure 3: RCFMI building attributes**

It was observed that the use of concrete block as infill was more prominent (68%) compared to clay brick infill (26%), as shown in Figure 3(a). Of the total surveyed buildings, there were 56 buildings (29%) having been determined as cavity-wall construction based upon the visible presence of air ventilation, weep holes and running bond patterns on the infill wall. The proportion of clay brick cavity-wall was observed to be 48% of the total surveyed clay brick infill construction, while concrete block cavity-wall construction was 25% of the total observed concrete block infill buildings.

The selection of infill material was strongly associated with the period of construction of the RCFMI building. As can be seen in Figure 3(b), clay brick infill buildings were initially constructed in the early 1900s, and these buildings were widespread from the 1940s to the early 1960s. However, the use of concrete block as infill substantially increased in the 1950s, and, commencing in the late 1950s, concrete block replaced the use of clay brick as infill material in the region.

Figure 3(c) shows the number of stories for the surveyed RCFMI buildings in Christchurch. The majority (95%) of surveyed buildings were 1 to 3 storeys, where 1-storey buildings constituted the greatest proportion (50%) of the total 191 observed buildings. 2-storey buildings had a proportion of 39% and 3-storey buildings accounted for 6% of the total surveyed buildings. It should be considered that RCFMI construction was generally not used in New Zealand for mid to high-rise buildings, explaining the small number of buildings (5%) having 4+ storeys.

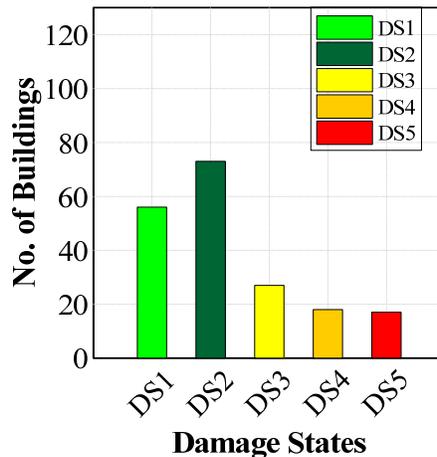
**Figure 4: Damage state assessment for observed damaged buildings**

Level 1 rapid assessments assigning the level of damage into three building placards of green, yellow, and red on the basis of estimated building damage that was observed from the exterior of buildings. Level 2 detail assessments categorise the level of damage into five categories in line with general rapid assessment methods used worldwide, such as ATC-20 and EMS-98[14]. The damaged buildings were assigned to damage states of Slight (DS1), Light (DS2), Moderate (DS3), Heavy (DS4), and Major (DS5), as defined in Table 1. The number of observed damaged buildings associated with each damage state are presented in Figure 4.

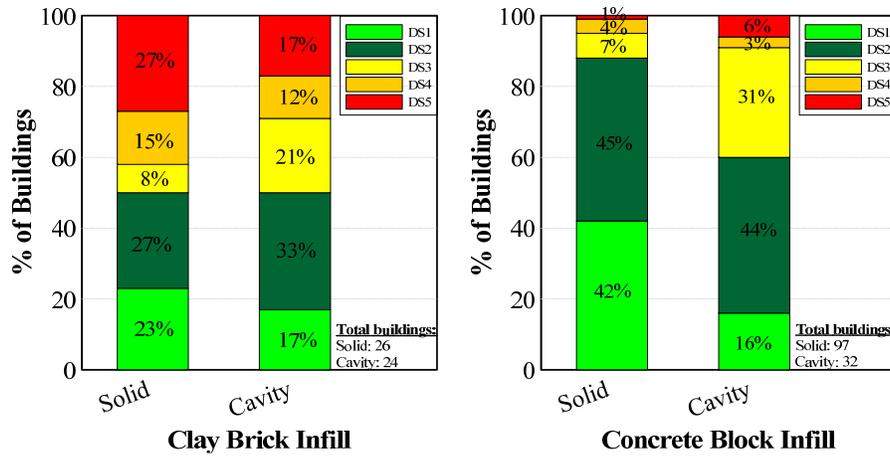
Figure 5 illustrates the damage sustained by infill material for different wall morphology (solid and cavity-wall construction) in accordance with the level of damage following the 2011 Lyttelton earthquake. In general, it was observed that clay brick infill experienced considerable damage

compared to concrete block infill. Clay brick RCFMI buildings sustained a similar performance in the 2011 Lyttelton earthquake for both solid and cavity-wall construction as 50% of the total surveyed clay brick buildings experienced moderate to major damage (DS3-DS5) for both wall morphologies. Despite 40% of the concrete block RCFMI buildings that had cavity-wall construction sustaining moderate to major damage, the majority of RCFMI buildings (82%) constructed using solid concrete block infill showed an adequate performance during the 2011 Lyttelton earthquake.

(a) Clay brick (b) Concrete block  
**Figure 5: Extent of damage to infill material**

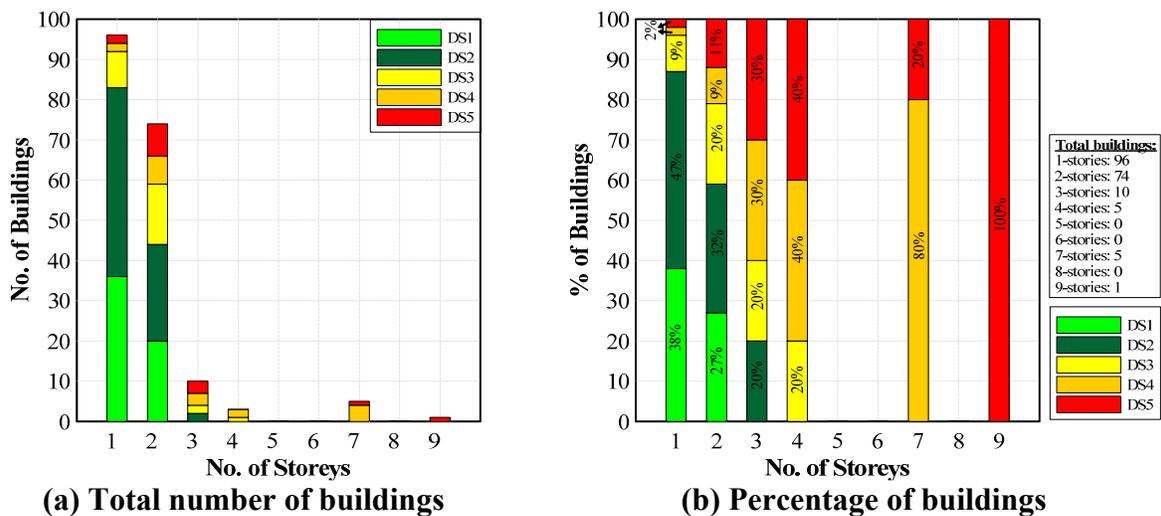
**Figure 6: The influence of RCFMI building height on damage**

It was observed that the level of damage to RCFMI buildings following the 2011 Lyttelton earthquake was higher with an increased building height (see Figure 6). The majority (more than 80%) of RCFMI buildings having 3+ stories sustained moderate to major damage, while most of the buildings having 1 to 2 stories experienced less damage.

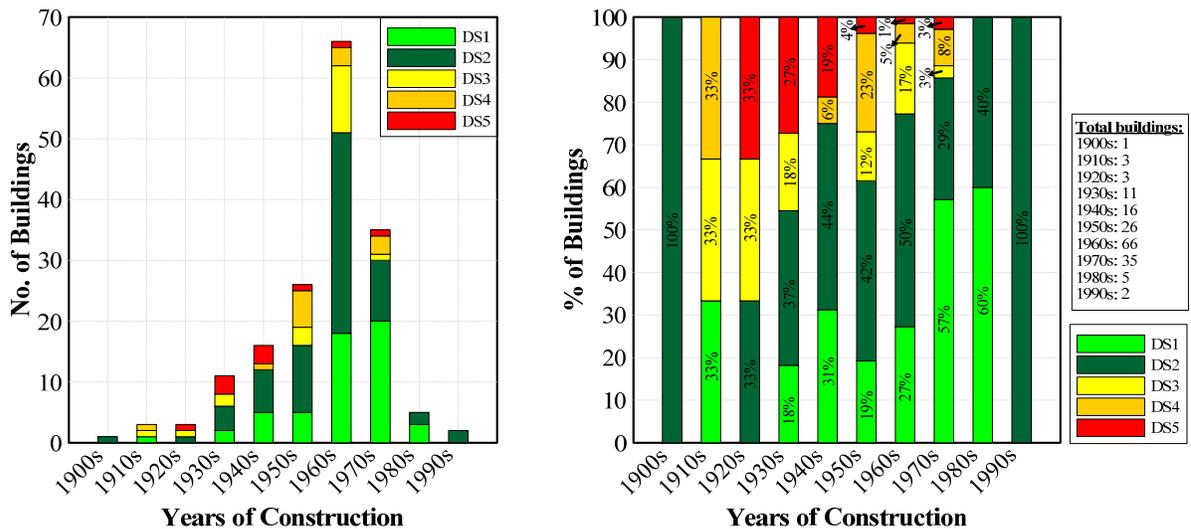
Figure 7: The influence of period of construction on damage

Figure 7 presents the recorded level of damage sustained by RCFMI buildings following the 2011 Lyttelton earthquake, correlated against period of construction. It was observed that RCFMI building constructed between the 1910s and the 1930s (more than 45% of the total number of surveyed buildings) had considerably more damage because these buildings were constructed before the introduction of the first New Zealand seismic code in 1935. It was documented that a large number of these buildings experienced moderate to major damage, and, as expected, the buildings constructed in that era were likely prone to earthquakes.

In contrast, RCFMI buildings constructed from the 1940s onwards exhibited better performance compared to the buildings constructed between the 1910s to the 1930s, as seismic requirements would have been incorporated into the design process (see Figure 7). It is considered that the New Zealand seismic code had a significant elevation in seismic criteria in 1976, which required seismic detailing and ductility [18]. As a result, it is unsurprising that RCFMI buildings constructed in the late 1970s onwards performed satisfactorily during the earthquakes.

(a) Number of damaged buildings

(b) Damage state as a percentage

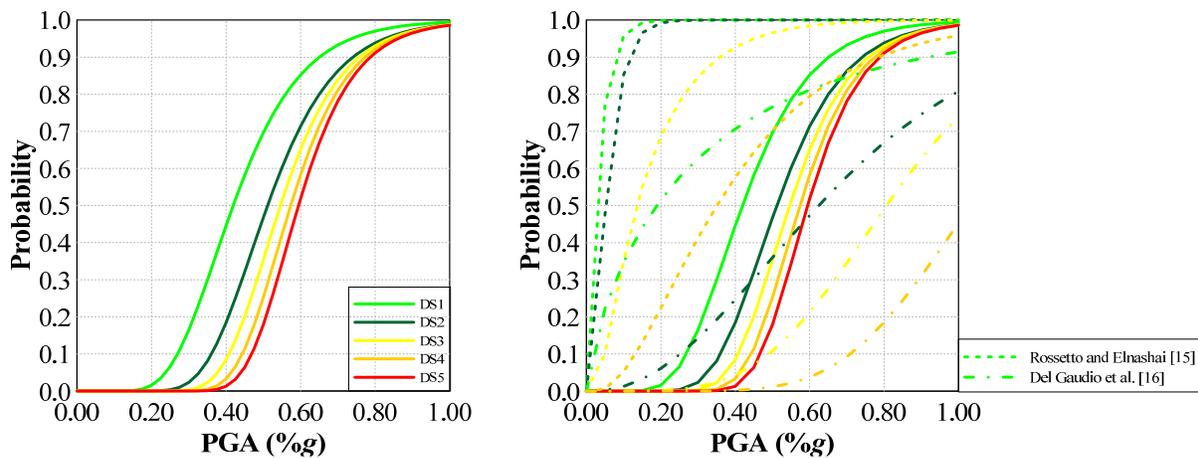
**Figure 8: Empirical fragility curves for RCFMI buildings**

The empirical fragility curve for each damage state was generated through the corresponding value of median ( $\theta_{DS_i}$ ) and standard deviation ( $\beta_{DS_i}$ ), which were calculated based on the Maximum Likelihood Estimation (MLE) method as this method has been widely utilised to generate fragility functions from post-earthquake data [22-24]. The estimated median and log standard deviation values are presented in Table 3, and the fragility curves for RCFMI buildings following the 2011 Lyttelton earthquake for each damage state are shown in Figure 8(a).

The empirical fragility curves were subsequently compared with previous empirical fragility curves for RCFMI buildings generated by Rossetto and Elnashai [15] and Del Gaudio et al. [16] (see Figure 8(b)). Rossetto and Elnashai [15] generated empirical fragility curves based on a large post-earthquake data set obtained from 19 events, including European and non-European earthquakes, while Del Gaudio et al. [16] derived empirical fragility curves based on damage data following the 2009 L'Aquila, Italy earthquake. The fragility curves were derived for each damage state, adopted from EMS-98 [14] as Slight (DS1), Light (DS2), Moderate (DS3), and Extensive (DS4). It is considered that Extensive (DS4) damage in the previous studies was consistent with the definition of Heavy (DS4) and Major (DS5) damage in this study. The comparison of empirical fragility curves between this study and previous studies can be seen in Figure 8(b).

(a) The 2011 Lyttelton earthquake

(b) Comparison with previous fragility curves in different countries

As shown in Figure 8(b), the fragility curves generated by Rossetto and Elnashai [15] (dashed line) for each damage state indicated significantly higher expected levels of damage for a prescribed PGA value when compared to the fragility curves proposed in this study (solid line). This discrepancy might be caused by the nature of the building characteristics, in which Rossetto and Elnashai [15] considered a considerable extent of building data, including European and non-European buildings, that might lead to large uncertainties associated with empirical relationships between the ground motion data and building damage state due to the scarcity of observational data. In addition, the structural details and quality of construction are likely to be distinctly different to the building characteristics for New Zealand RCFMI buildings, leading to greater earthquake vulnerability.

Despite indicating a higher probability at the DS1 (Slight) damage state, the fragility functions derived by Del Gaudio et al. [16] revealed a lower probability for DS2 (Light) to DS4 (Heavy) damage states compared to the fragility curves developed in this study. The difference between the

two fragility curves for the DS1 (Slight) damage state would be further amplified if efforts were made in the New Zealand study to account for the suspected number of undamaged buildings that were omitted from the CEBA data set because surveys were not conducted for some undamaged buildings. These uncounted buildings might induce large uncertainties regarding the total number of existing RCFMI buildings that were subjected to the Canterbury earthquakes. Furthermore, the difference between the DS2 (Light) to DS4 (Heavy) damage states might be affected by site effects, earthquake parameters (such as depth, soil type, and 'other'), and the natural characteristics of buildings. It was also considered that a lower probability for the DS4 (Extensive) damage state from the Del Gaudio et al. [16] study may be the result of different definitions of damage states for DS4 (Heavy) and DS5 (Major) when compared to the definitions adopted in this study.
