13TH CANADIAN MASONRY SYMPOSIUM
HALIFAX, CANADA
JUNE 4TH – JUNE 7TH 2017

**SHAKING TABLE TEST ON A FULL-SCALE UNREINFORCED CLAY MASONRY
BUILDING WITH FLEXIBLE DIAPHRAGMS**

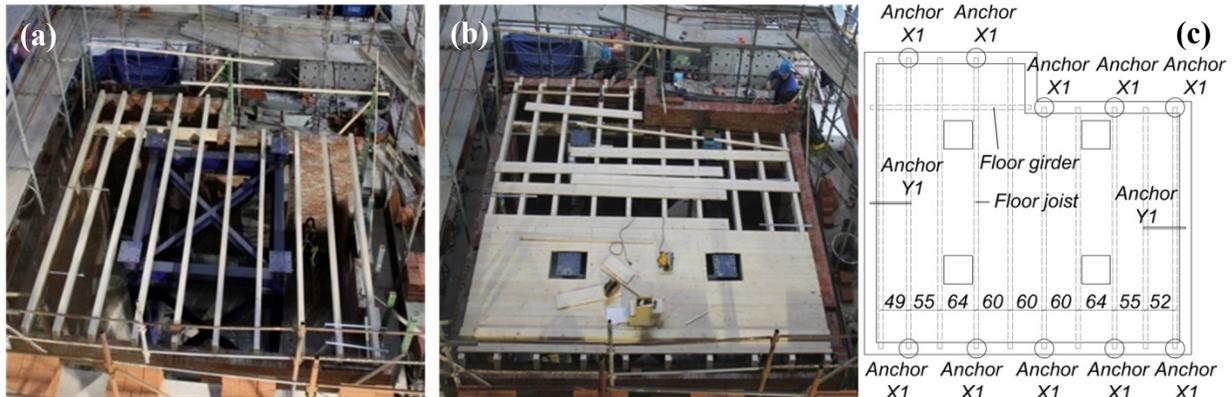
Figure 4: First floor framing: (a) floor joists during construction; (b) floorboards during construction; (c) floor framing plan (units of cm)

The floor system consisted of 200×24 mm timber (spruce) floorboards, nailed perpendicularly to ten 80×180 mm timber joists spanning continuously between the East and West URM walls (Figure 4). The joist ends were cut at an 80° angle (Figure 5) and were supported on the interior wythe of the longitudinal walls at a height of 2700 mm above ground.

Connection between the floor diaphragm and the East and West walls was provided by 14-mm-diameter L-shaped steel anchors (labeled X1 on Figure 4c and Figure 5), screwed to the timber joists and embedded into the masonry between the two wythes (Figure 5a, b, d, and e). Flat S-shaped steel connectors (labeled Y1 on Figure 4c and Figure 5) provided wall-to-diaphragm connection for the North and South façades, restraining these walls against out-of-plane overturning mechanisms. These anchors, located at mid-span of each façade (Figure 4c), ran below the timber floorboards and were screwed to the first two floor joists from the restrained walls (Figure 5c and f). One laid-across brick per side was modified in order to fit the anchor in the brickwork.

A rigid steel frame was installed inside the building specimen. This structure served as a safety system, providing support in case of partial or global collapse of the specimen, and constituted a rigid reference system for direct measurement of floor, walls and roof displacements. The frame was not in contact with the building, since its columns ran through four holes in the floor diaphragm, oversized to accommodate the specimen lateral displacements (visible in Figure 4 and Figure 7f). A video showing the construction phases of the specimen is available on line [6].
