## THE ROLE OF THE MASONRY QUALITY EVALUATION IN HISTORIC CONSTRUCTIONS IN SEISMIC AREA

A methodology to define essential parameters and consequently the stone masonry quality, especially in seismic areas, is presented in this paper.

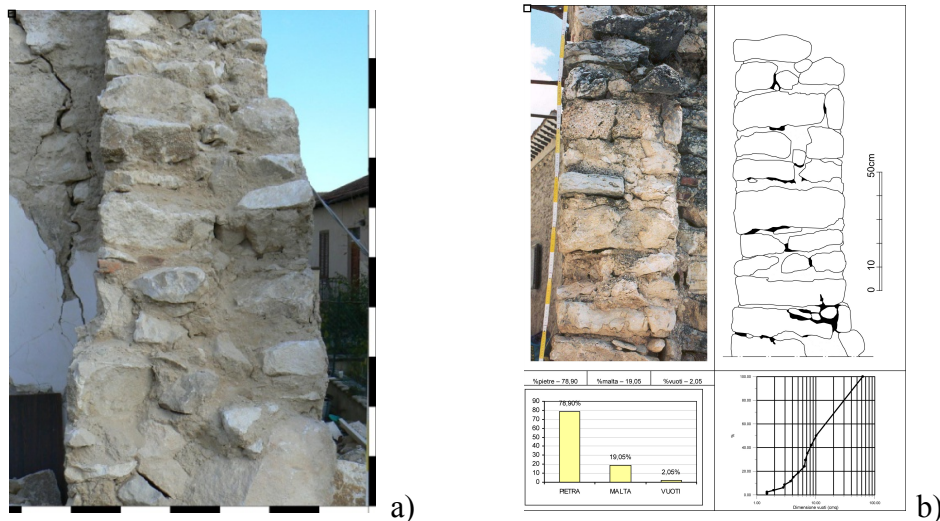
**Figure 1: Examples of cross masonry sections of poor residential buildings that present no or very few voids and so no injectable: a) residential building in a seismic town (Onna,L'Aquila, Abruzzo region; b) fully filled form for masonry cross sections (Campi, Perugia, Umbria region).**

There is a real difficulty in applying some intervention techniques for some type of stone masonry [4]. For example the results obtained from direct inspections showed that some masonry walls were not injectable or injectable with great difficulties if the voids inside the masonry did not exceed a minimum percentage (around 4%) and were not transversally connected (Fig.1) The injections are effective where cracks are present but it is practically impossible to inject the mortar even if it is highly porous and weak.

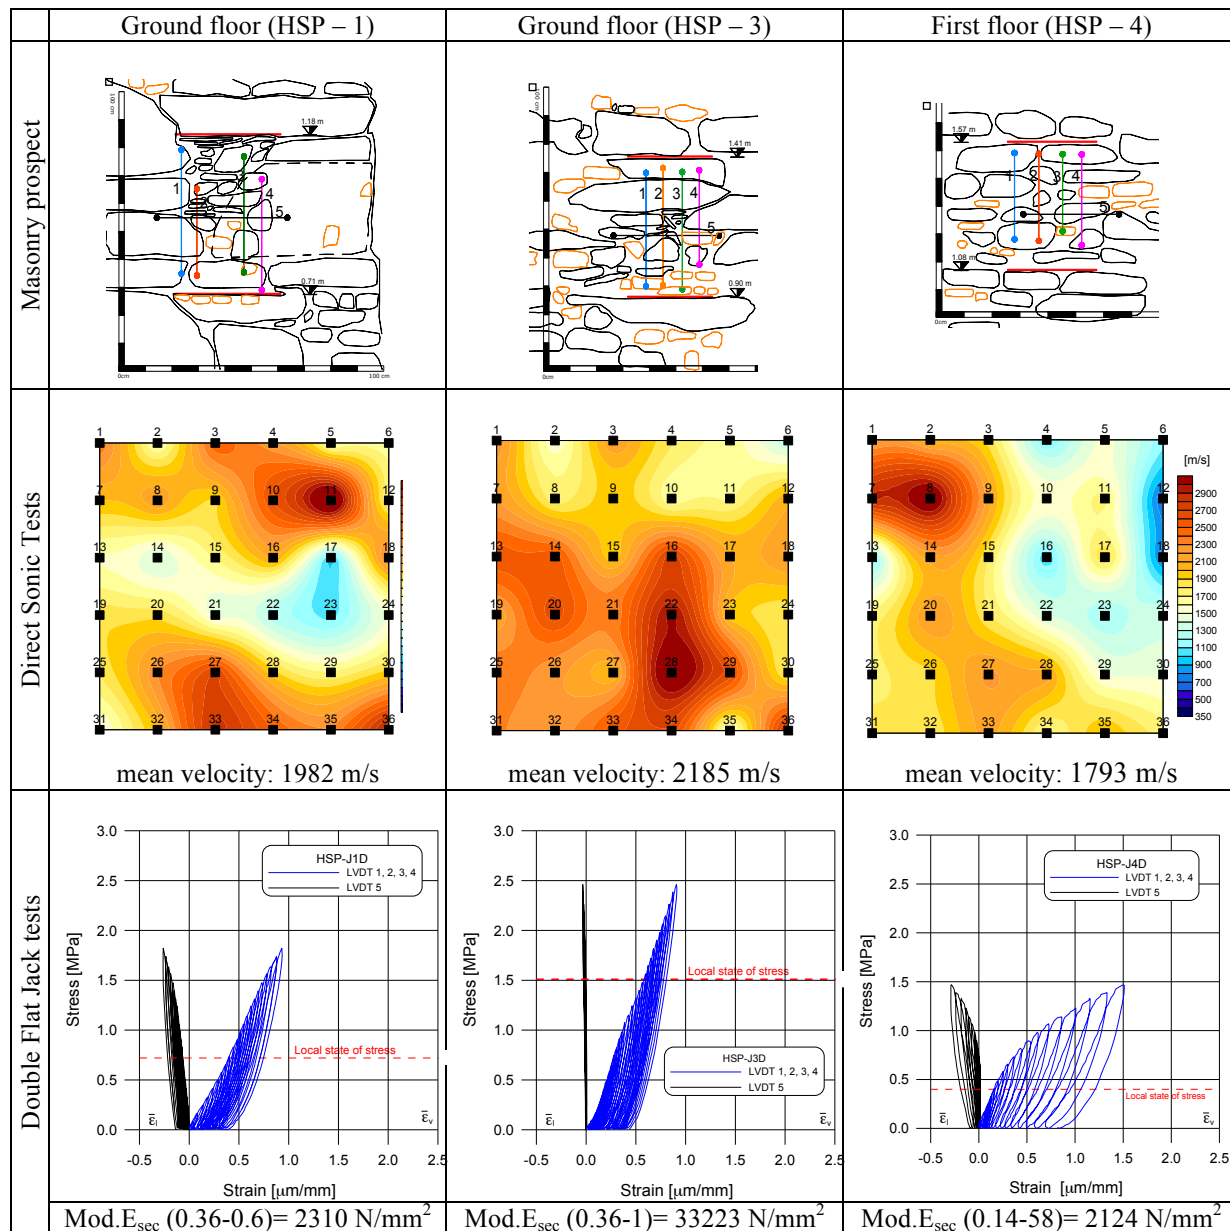
**Figure 7: Sonic and Flat jack tests results on the stone masonry of the Ground floor and at the First floor of the Savona ex-hospital.**

Similar results are here presented for the ex-hospital of St-Paul in Savona. The test points selected for sonic pulse velocity tests in the masonry showed a non-homogeneous distribution of the sonic velocity, as usual in an irregular stone masonry; nevertheless the values are on average high for a stone masonry 0,64 m thick, around 2000 m/s, presenting a good connection among the stone elements. Higher peak values could represent the presence of longer stones like “*diatoni*”. (Fig.7).

Single and double flat-jack tests were carried out in the same area where sonic tests were executed. The single flat jack tests were aimed to define the local state of compressive stress and presented a good behaviour and a low scattering of the results despite the irregular stone masonry. Found values are quite high (from 0,7 to 1,5 N/mm<sup>2</sup>) but no cracks were visible, showing a good performance of this masonry.

The execution of the double flat jack tests was difficult due to non-homogeneity of the masonry: large stones can show too high stiffness and small stones can reduce the reliability of the results. However the average values obtained in all tests showed a rather compact masonry, well organized and with resources higher than 2,5 times the measured local state of stress (Fig.7).

Figure 7 also allows to notice that the first floor masonry is weaker than the ground floor one.
