EXPERIMENTAL STUDIES ON DOUBLE LEAF MASONRY WALLS

S. Michos¹ and J. P. Forth²

ABSTRACT

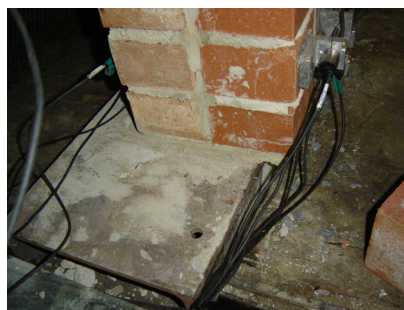
Figure 4: Sliding failure of CNT-I under the eccentric applied load

A number of preliminary tests have been carried out to allow the optimisation of the testing rig and the setup of the monitoring equipment. All the preliminary specimens were built by an experienced builder that came from industry. The first wall to be tested (CNT-I) was collar jointed without ties. The failure mechanism (Figure 4) showed that the initial testing rig had an important design flaw. Due to the eccentricity of the applied load to the restrained panel (Figure 2), the wall failed under a sliding action that clearly cannot take place in practice. So, the testing rig was modified and a 14mm steel angle was placed in the cavity and welded to the steel base (see Figure 5), prohibiting the walls from exhibiting sliding failure at the base in the future, by restraining any lateral movement of the panel resting against the portal.

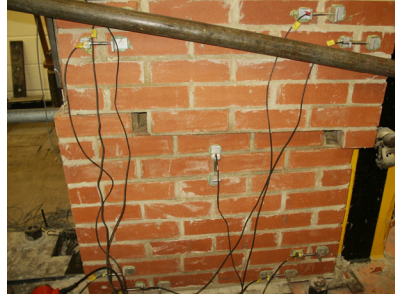
Figure 7: Failure of specimens (a) CT-I; (b) CT-II

The next specimens that were tested were two collar jointed walls with ties (CT-I and CT-II). The walls failed at 35.19 kN and 37.42 kN respectively following a sliding failure mechanism at the 5th bed joint and at the 6th bed joint, as illustrated in Figure 7. No separation between the two leaves occurred.

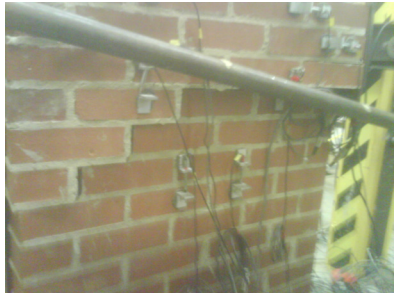
Figure 8: Failure of specimens (a) NCT-I; (b) NCT-II

Finally, two specimens were tested that included only steel ties (NCT-I and NCT-II). In both cases failure involved the development of a diagonal crack (from the 3rd bed joint to the 6th bed joint) following the separation of the two leaves (Figure 8). The failure load of NCT-I was similar to the rest of the results (30.11 kN). However, this was not the case with NCT-II, which failed at a very low load (12.5kN). After close inspection of the test specimen, it was found that the installation of the wall ties had not been performed correctly (they were loose, indicating that they may have been disturbed post installation and before the mortar had set sufficiently). This possibly explains the lower failure load.

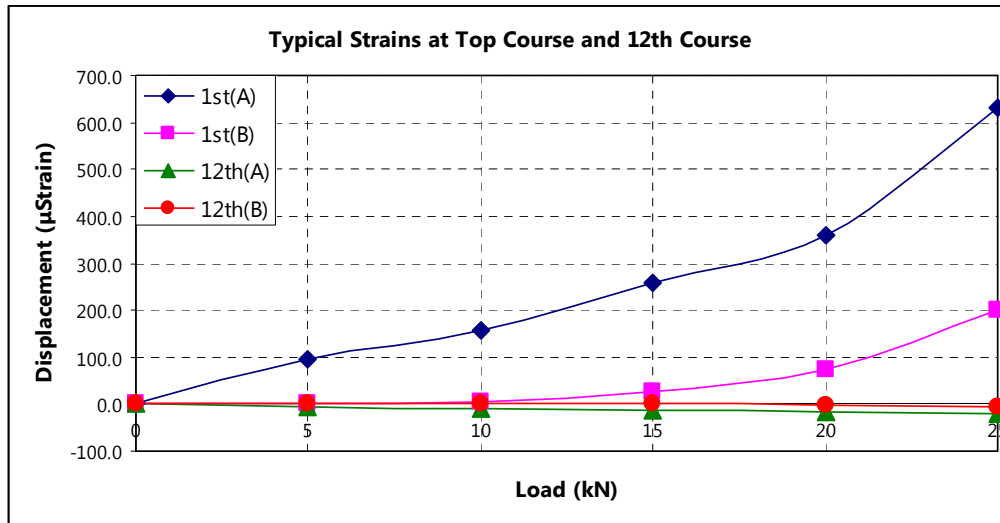
Figure 9: Strain vs Load for CNT-II recorded at the top course (1st course) and at the 12th course; (the letter A indicates a transducer placed on the free, loaded wall and B indicates a transducer placed on the restrained panel)

The failure mechanisms observed during the preliminary experiments are all similar to the five possible failure mechanisms of an infill panel as reported in [10]. In all cases though, the failure was contained between the first seven courses from the top of the wall; below this level the strains recorded were insignificant (see Figure 9). Based on this, it was decided to monitor only the top part of the walls. The transducers were placed on diametrically opposed positions on the two leaves, so as to investigate the influence of the bond between the two leaves on the stress pattern. The region of failure and the failure mechanisms observed in these tests also meant that verifying the location and development of the commonly proposed corner-to-corner diagonal crack failure mechanism [5] was discounted. Finally, a visual inspection of the ‘degree of fullness’ of the cavity in the collar joint walls (CNT-II, CNT-III, CNT-IV, CT-I and CT-II) illustrated that the cavity was generally 55-65% full, except wall CNT-III where the cavity was

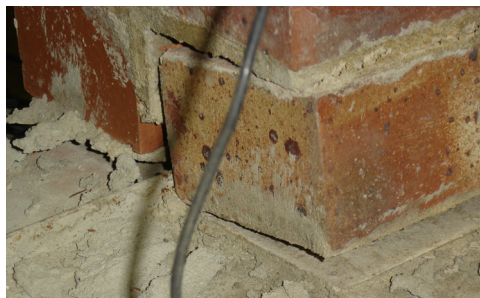
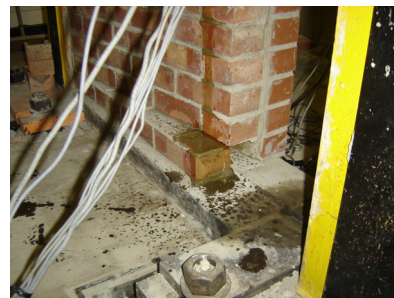
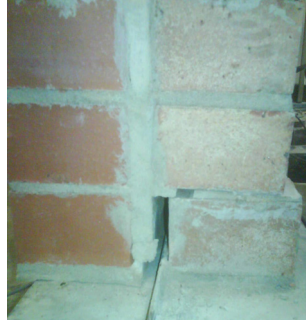
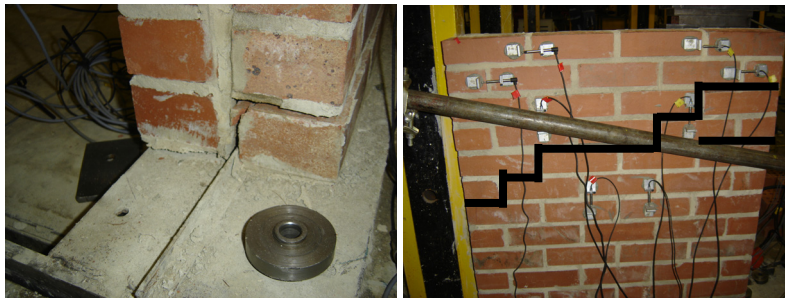
Figure 10: Failing mechanisms of (a) CNT-200b; (b) CNT-1000a; (c) CNT-1000b; (d) and (e) CNT-200a

During these eight preliminary tests, some localised crushing of the top of the vertical mortar joint, at the opposite end of the test specimen to where the load was applied, between the restrained panel and the frame (see Figure 3) was apparent. In practice (see Figure 2) it is possible that this would not occur. It was therefore decided to investigate the influence of this vertical mortar joint and tests were performed with full height mortar joints (as before) and with 200mm high vertical mortar joints which better represent the contact lengths of the typical frame-panel interaction theoretically found at this point (see Figure 2). For these four walls (walls CNT-200a, CNT-200b, CNT-1000a and CNT-1000b, where 200 and 1000 represent the height of the mortar joint), a university employee, who has been trained as a bricklayer, was used instead of the contractor used previously. Figure 10 illustrates the failure mechanism of these 4 walls.

All of the four specimens developed a sliding failure mechanism; the plane of failure being at the base (between the bedding mortar and the steel base) on the loaded wall (Engineering bricks) and then extending vertically up the collar joint for one course and then laterally across between the first and the second courses from the bottom of the restrained (Fletton) panel. Failure began just after 20 kN in all specimens, and collapse occurred between 26.5-34.5 kN (CNT-200a at 34.09 kN, CNT-200b at 32.18 kN, CNT-1000a at 26.40 kN and CNT-1000b at 34.37 kN). However, although failure initiated at the base in Wall CNT-200a (Figure 5d), final collapse was due to the separation of the two panels and the development of a diagonal crack on the loaded leaf (Figure 5e). Tests on the mortar confirmed that there was no difference in the properties of all the mortar mixes used for the construction of these four walls. Also, the testing procedure remained the same. However, a visual inspection of the ‘fullness’ of the collar joint after each test showed that for CNT-200b, CNT-1000a and b walls the collar joint was around 90-95% full. Whereas, a similar inspection of wall CNT-200a showed the collar joint to be only approximately 80% full. From the results of these last 4 tests it appears that if the collar joint is filled to a similar degree, there is, on initial inspection, no influence on the failure load with respect to the height of the vertical mortar joint between the restrained panel and the pylon. However, this conclusion is complicated as it may be affected by the ‘fullness’ of the collar joint and therefore requires further investigation.
