## IN-SITU TESTED BRICK MASONRY WALLS STRENGTHENED WITH HORIZONTAL CARBON STRIPS AND FRP MESH

M. Jarc Simonič<sup>1</sup>, S. Gostič<sup>2</sup> and R. Žarnić<sup>3</sup>

**KEYWORDS:** masonry, FRP, strengthening, in-situ test, shear strength, ductility

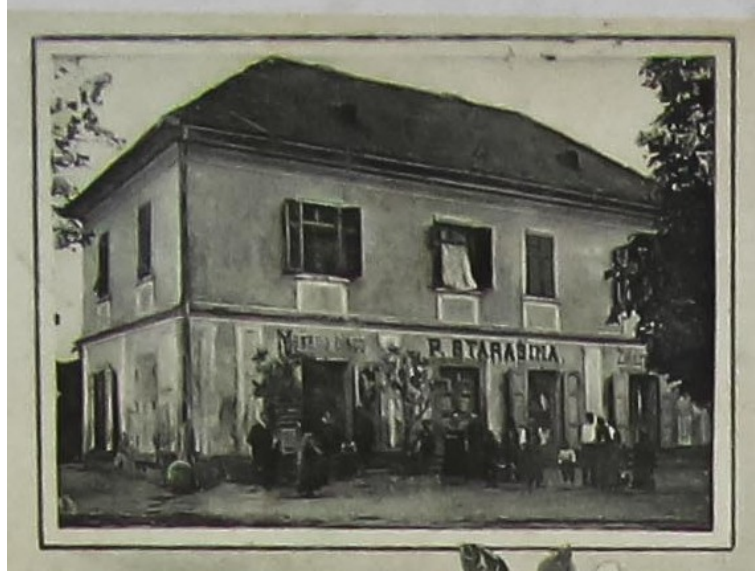
In-situ tests were performed on an old masonry building dated from 1874 with low seismic resilience due to poor connection and low shear strength of load bearing walls (Figure 1). As such it is similar to masonry box-type cultural heritage buildings. Building had two stories: ground floor and first floor, each 3,2 m high. Load bearing masonry walls were made with solid clay bricks (in average roughly  $30 \times 12 \times 6$  cm) and weak lime mortar. The same materials are common for cultural heritage buildings from that period. The thickness of the masonry wall was 52 cm. Six undamaged specimens were isolated by cutting from the walls: two reference unreinforced specimens (marked as R), two strengthened with narrow horizontal stripes (S) and two with GFRP mesh (M) placed over entire surface (Figure 2). Narrow CFRP stripes were glued to surface with epoxy based resin while GFRP mesh was laid into modified cement mortar. Specimens' height was 2.1 m and width 1.0 m. To get the basic information about existing masonry a compression test was also performed where the compressive strength and modulus of elasticity were determined.

**Figure 1 : Tests were performed on an old building**

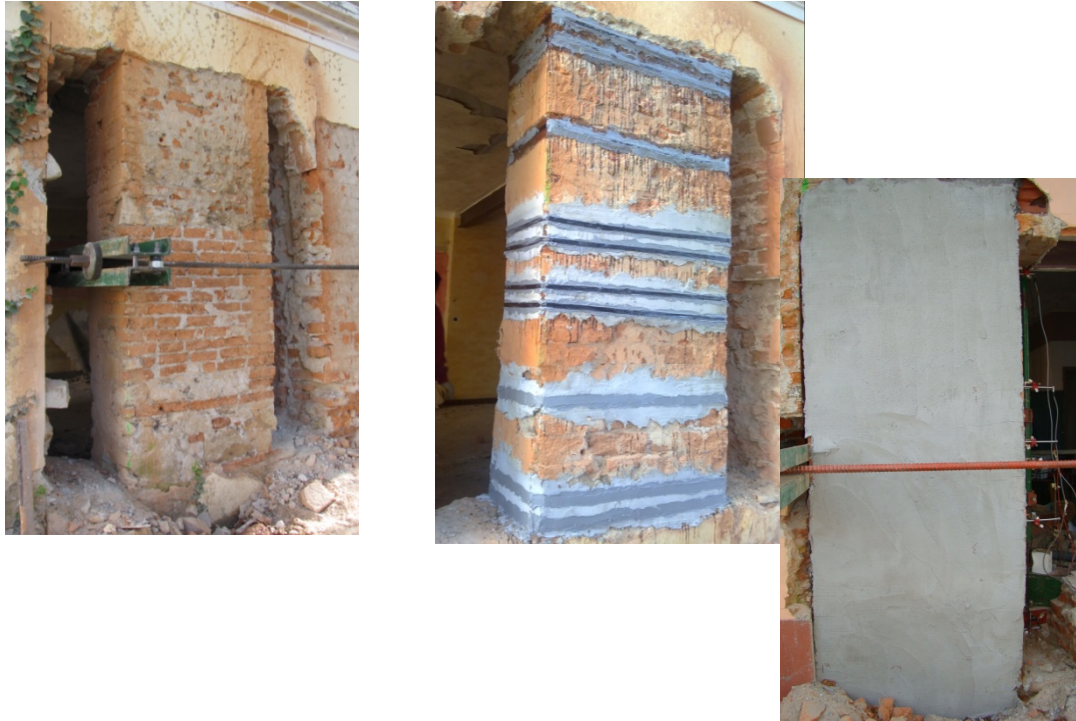
Surface of the wall area designated for gluing was prepared by removing plaster and grinding the loose parts. In the case of narrow stripes the edges were rounded on appropriate places to avoid CFRP fibers bend cracking. Unevenness of the surface was corrected with cement mortar (class CS III according to EN 998-1) in thickness up to 5 mm. A thin layer of epoxy resin mixed with fine sand was placed under CFRP stripes and then the CFRP stripes were placed with wet lay-up technique. Stripes Carboniar 1,5 cm wide with weight of  $800 \text{ g/m}^2$  were used. Stripes were placed horizontally forming the confinement around the wall specimens on 10 levels. Two of them in each compression loaded areas and one in the middle of each half of specimen (Figure 2, b with upper and lower half of specimen).

**Figure 2 (a, b, c): Three configurations (un-strengthened R, with horizontal stripes S and mesh M) were prepared for shear testing**

GFRP meshes (Sika WrapGrid 350G) were installed in surface applied modified cement mortar (Sika MonoTop 722 Mur with declared compressive strength 27,13 MPa) in common thickness of 1 cm (Figure 2, c). The strengthening was carried out by the company GRAS from Ljubljana.

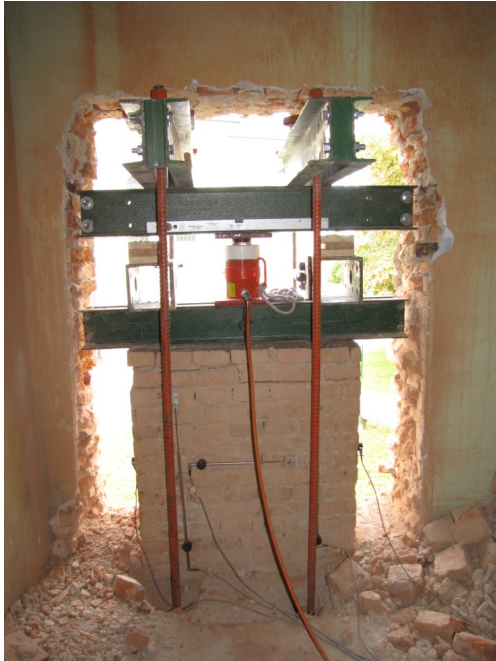
To determine the compressive strength and modulus of elasticity a test on brick wall sample was performed. Dimensions of the specimen were (width/height/thickness) 100 x 100 x 48 cm. In-situ compression tests were carried out with a hydraulic jack of 1300 kN capacity (Figure 3). With the system of steel ties and displacement controlled hydraulic jack the sample was tested in-place. Due to limitations of available equipment (and time) a steel profile on the top of the wall did not cover entire cross section but only 101 cm x 28 cm. This provoked a splitting crack through the middle of the wall thickness. Vertical and horizontal deformations were measured with LVDTs mounted on one side of the wall (verticals E1, E2 and horizontal H1) and H2, H3 were horizontal on the sides. Sample was released at 88% of the maximum load and then loaded again up to failure (Figure 4). Mechanical characteristics gained in the compression tests are presented in Table1. Module of elasticity ( $E_w$ ) was calculated from stresses at 1/3 of maximum divided by average of vertical strains (E1 and E2) at that point.

Figure 3: Compression test set up

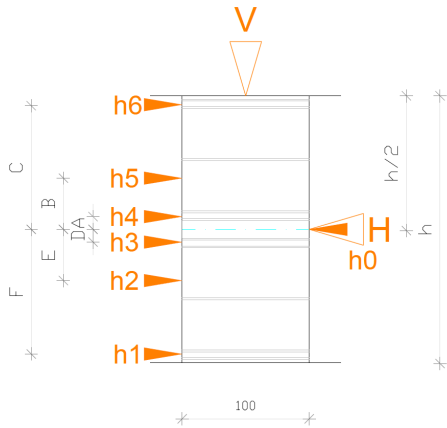
WALL	h	A	B	C	D	E	F
R52A	220	4	37	88	3.5	36	107
R52B	210	3	29	102	3.5	35.5	102
S52A	213	4	36	101	7	36	101
S52B	202	4	35	100	4	34	86
M52A	216	6	38	106	6	44	100
M52B	225	6.5	36	99	6.5	36.5	102.5

**Figure 8 : Position of horizontal LVDTs (h0, h1, h2, h3, h4, h5 and h6)**

Displacements and deformations were measured with linear variable differential transducers (LVDTs; exact positions are on Figure 8). Horizontal load was measured with load cell. Loading during tests was displacement controlled and it was progressing in steps to 0.5 mm, 1.0, 1.5, 2.0,

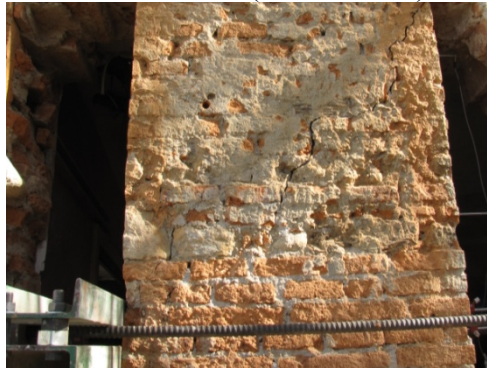
**Figure 9: Failure by diagonal cracking**

Un-reinforced specimens R52A and R52B started to show first cracks at 2 mm of horizontal displacement that was at max load for R52A (103,5 kN) and 80% of max load for R52B. They failed by propagation of diagonal cracks to width of 17 mm (R52B, Figure 9) at ultimate displacement of 12 mm (R52B). Both un-reinforced specimens fail by diagonal tensile mechanism.

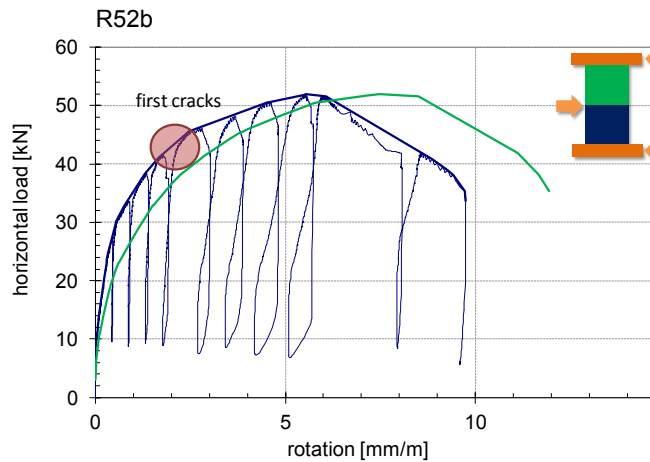
**Figure 10: Envelope of rotation vs. load and occurrence of first cracks**

On the Figure 10 the rotation versus horizontal load for lower part of wall with its envelope is presented. An envelope for upper part of the tested wall is also presented for comparison. Due to test setup the horizontal load from the hydraulic jack is distributed half to bottom part of wall and half to upper part. The forces on two halves of the wall were thus assumed identical but the deformations were different (as measured).

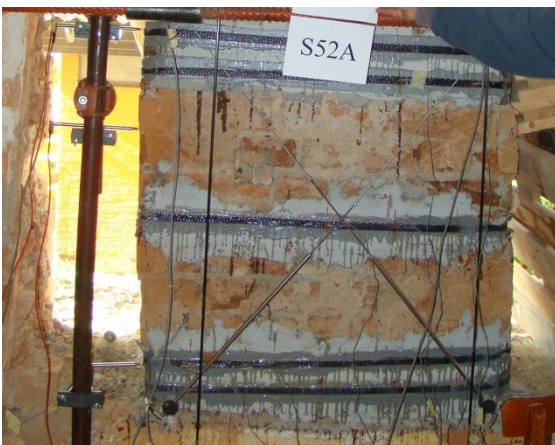
**Figure 11: Failure by diagonal cracking and crushing of comp. toe**

Cracks propagation was efficiently obstructed by the CFRP strips, which resulted in formation of many minor shear cracks for specimens S (Figure 15). First diagonal cracks occurred at 65% of max load for S52A (or about 2 mm of horizontal displacement) and 77% of max load for S52B (or about 4 mm of horizontal displacement). Maximum width of crack was 5 mm (S52A) at 18 mm of horizontal displacement and 9 mm (S52B) at 25 mm displacement (Figure 11). FRP stripes haven't detached from the surface because they were well connected around the masonry pier. Load during test S52A reached 162,8 kN at max displacement of 10 mm while S52B reached 181,3 kN at displacement of 14 mm (Figure 12). Failure mechanism exhibited diagonal cracking together with crushing of compression toe. Ultimate displacements were 25 mm and 30 mm (S52A and S52B) respectively.

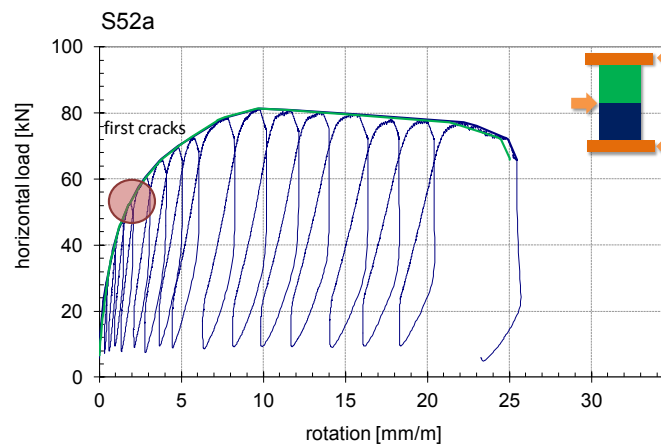
**Figure 12: Envelope of rotation vs. load and occurrence of first cracks**

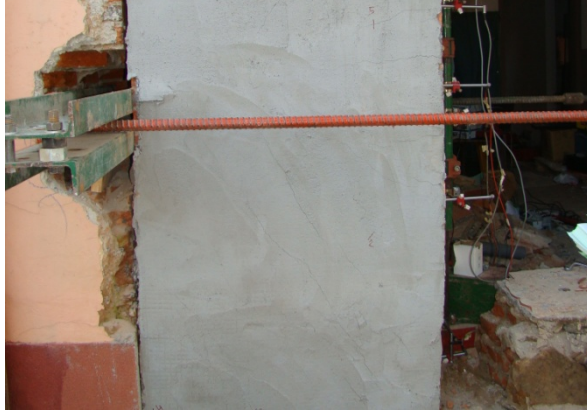
**Figure 13: Failure by detachment of GFRP mesh in mortar from the surface**

GFRP meshes in mortar also exhibit increment of maximum load and ultimate displacement comparing to un-reinforced specimens. Maximum load of specimen M52A was 162 kN (at 8 mm displacement) and ultimate displacement 16 mm. Specimen M52B reached maximum load 203 kN at 10 mm and failed at ultimate displacement of 16 mm (Figure 14). Cracks appeared earlier: at 1 mm (53% of max load) for M52A and at 1,5 mm (79 % of max load) for M52B. Noticing cracks earlier might be attributed to easier spotting of cracks on smooth surface. Cracks started with horizontal pattern at zones in tension and diagonal cracks. At maximum load (or at 8 mm of horizontal displacement) the detachment of coating in compression zones (Figure 13) occurred. Both specimens failed at 16 mm displacement due to overall detachment of GFRP mesh coating. Maximum width of cracks observed on the plaster was 0,8 mm (M52A) and 1,9 mm (M52B).

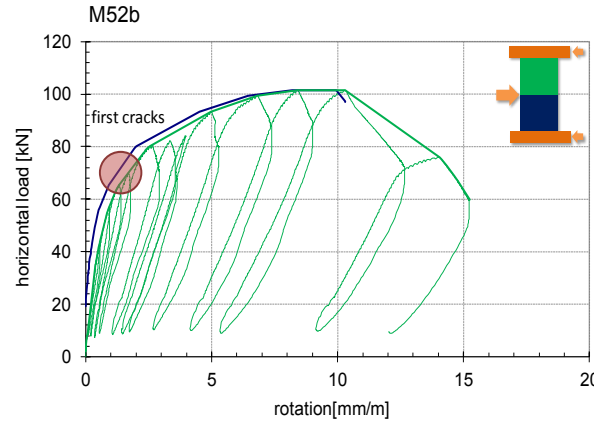
**Figure 14: Envelope of rotation vs. load and occurrence of first cracks**

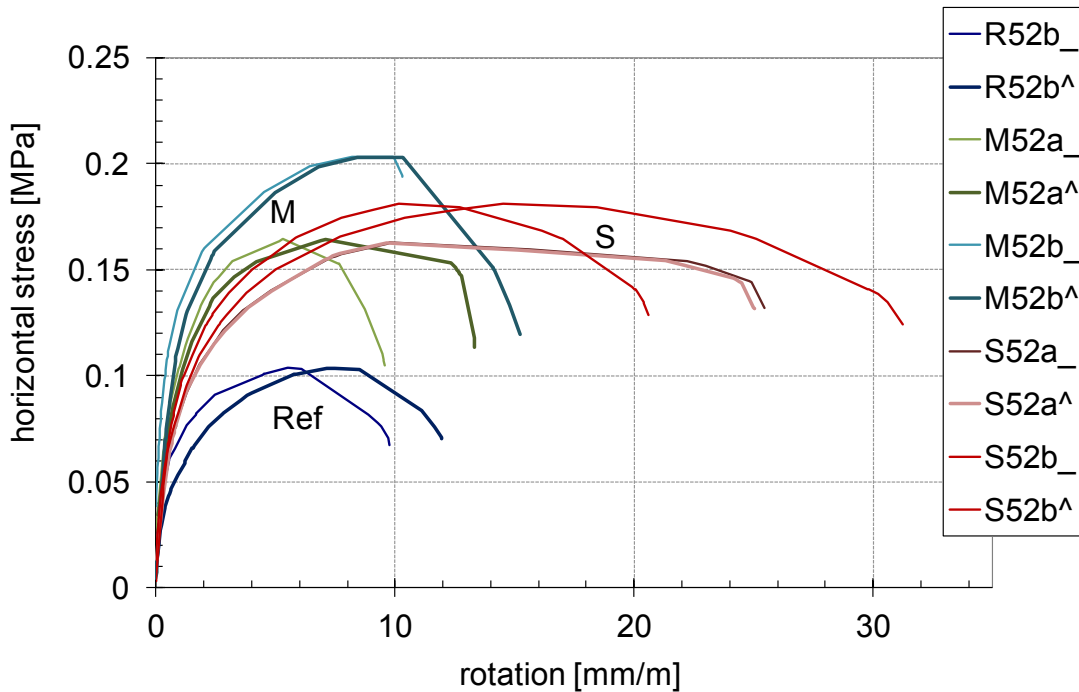
Envelopes of results for all specimens are compared on Figure 16. For those envelopes horizontal load was divided by the horizontal cross section of the wall. There can be seen a certain variation of results for different specimens (a or b) or deformations of upper (marked with ^) and bottom (marked with \_) part of each specimen.

The best results both in terms of strength and ductility were gained with S configuration of horizontal stripes (red lines). Strength increased on 170 % and ultimate rotation capacity on 250 % of unreinforced specimens (blue lines).

Load bearing capacity was almost doubled (180 %) with M configuration (green line). In case of M52B specimen peak load was even 196% of the reference one, but on average gained very little in increasing ultimate rotation capacity (110 %).

**Figure 16: Hysteresis envelopes for all shear tested walls**

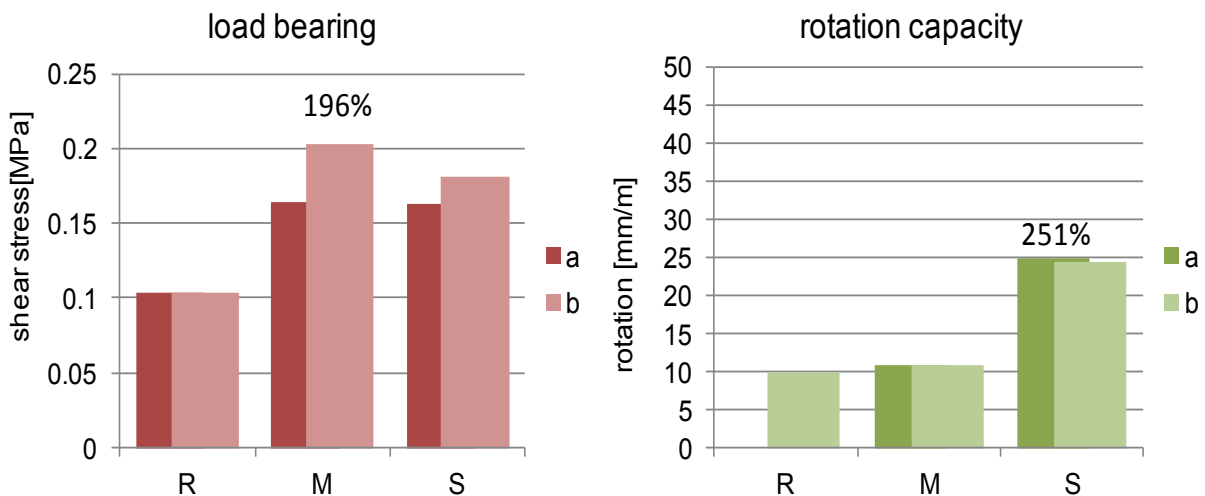
For study of effectiveness the average values of strengthening configuration was compared to average values of URM walls. The biggest increase of shear strength and ultimate rotation capacity was achieved by configuration S (Figure 17). Narrow stripes S were thus the most effective configuration despite their relatively small size.

**Figure 17: Effectiveness of FRP strengthening configurations M(ash) and S(trips) comparing to R(eference) specimen**
