13<sup>TH</sup> CANADIAN MASONRY SYMPOSIUM  
HALIFAX, CANADA  
JUNE 4<sup>TH</sup> – JUNE 7<sup>TH</sup> 2017

ICA CATHEDRAL, PERU: SAFETY ASSESSMENT AND STRENGTHENING

Ciocci, Maria Pia<sup>1</sup>; Sharma, Satyadhrik<sup>2</sup> and Lourenço, Paulo B.<sup>3</sup>

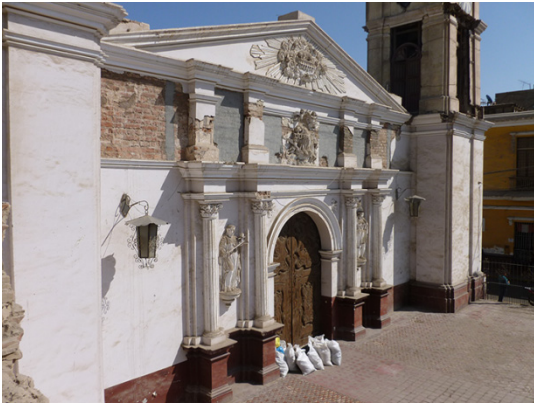
**Figure 1: Ica Cathedral. (a) Eastern front façade; (b) overall structural scheme [5]**

Located at the corner of an urban block in the historic centre of Ica, the one story cathedral has a rectangular plan that consists of a main entrance with a choir loft, a main nave, two lateral aisles, a transept, an altar and two chapels. A series of spaces including a sacristy, a reception and offices is present to the west, while a concrete portico and a square cloister are located towards its southern side. Figure 1 shows the overall structural scheme of the cathedral. The fired brick

front façade is flanked by two bell towers which are composed of timber frames resting on fired brick bases. The thick lateral walls are constructed with adobe masonry over a fired brick base course and rubble stone foundations. The internal timber frame is composed of a series of pillars which support a complex vaulted timber roofing system including a main dome, barrel vaults and small domes. In general, the pillars are composed of numerous posts braced by means of horizontal and diagonal elements, while the domes and the barrel vaults are constructed with wooden ribs and arches. These timber members are connected to the adjacent members by means of different types of timber joints and are covered by *quincha* layers.
