OUT-OF-PLANE PERFORMANCE OF FULL-SIZE UNREINFORCED BRICK WALLS RETROFITTED WITH EXPANSIVE EPOXY

A. El-Zeiny¹ and J. Larralde²

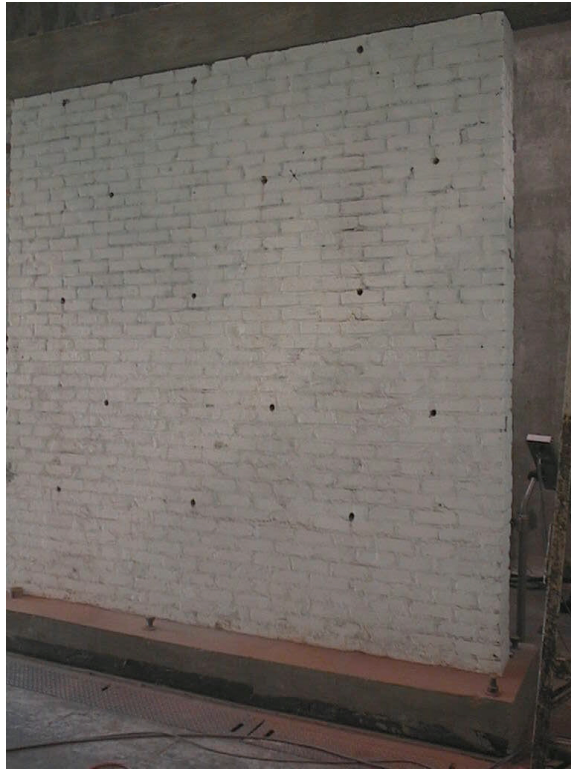
Figure 1: Distribution of Holes on the Wall

construction, holes are drilled in the outside bricklayer to reach to the 2-inch gap to pump the expansive epoxy in a liquid form. The holes are drilled in a diamond shape distribution as shown in Fig. 1 with 2 feet spacing on center. Expansive epoxy is pumped at about 70°F temperature in the lowest row of holes till it leaks out from neighbor holes showing that this particular section of the wall is full of epoxy as shown in Fig. 2. Then after few minutes, the foam starts to expand and hardens. The expansion ratio varies depending on thermal characteristics and confinement of the surrounding. In this test, the expansion ratio for all walls is estimated to be 1:3.8. The necessary time for the foam to cure is seven days. The method can also be implemented for brick walls with single layer of brick. The approximately 2 inch of void area can be created by the use of common plywood and drywall.

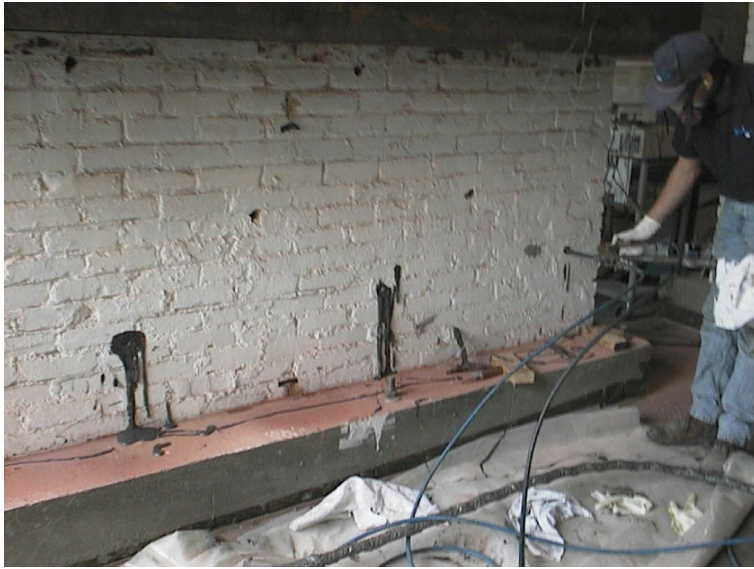
Figure 2: Pumping of Expansive Epoxy in the Wall

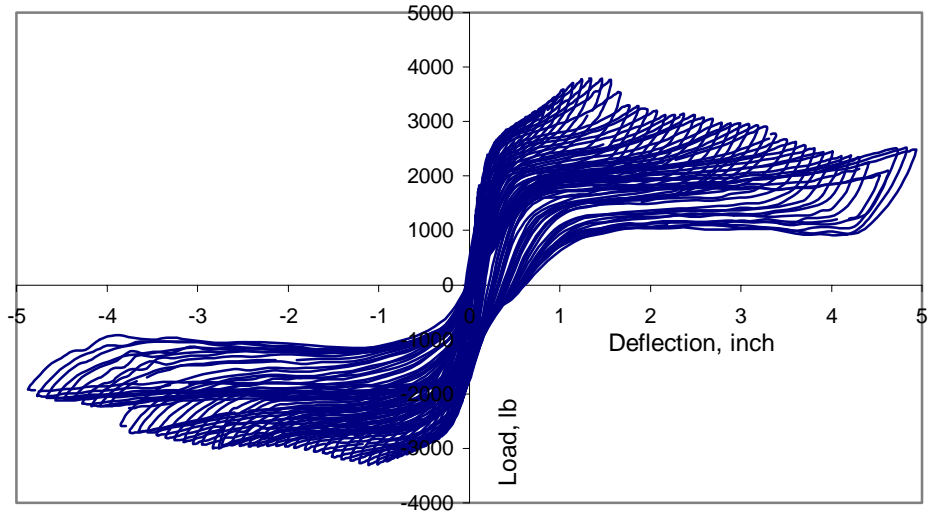
Figure 6: Load-Deflection Curve of the Repaired Wall, (Phase II: Full Deflection Range)

The repaired wall was then tested under cyclic displacement control condition. The period of the cycles was 10 seconds. The amplitude of the first cycle was 0.02 inches and then was increased by 0.02 inch per cycle. This test was done in two phases. In phase I, the wall was pushed to a total deflection of one inch. In phase II, the wall was pushed to the full stroke range of actuator (± 5 inch). Fig. 5 and Fig. 6 show hysteresis loops for both phases. The wall has reached to a deflection of five inches in both directions without catastrophic failure as shown in Fig.7. Two horizontal cracked sections were observed: one right above the horizontal steel beam connected to the actuator and the other at the bottom of the wall near the foundation. At each horizontally cracked section, a plastic hinge was formed with a length equal to the length of the wall. Such ductile plastic hinges were not possible to form without the foam. In addition, the maximum load observed in the foam-retrofitted wall was approximately 25% higher than the maximum load observed in the plain wall. This indicates that the injection of the foam not only restored the strength of the cracked wall by sealing all previous cracks, but also increased the strength by 24%. Add to that the added ductility and damping due to the formation of the plastic hinges.

Fig. 5 shows the ultimate strength of the repaired wall at a value of 4500 lbs, which is 1500 lbs more than the plain brick wall. Fig. 6 shows that the wall is very ductile because it took a deflection up to five inches without collapsing. This ductility is attributed to the formation of the plastic hinges in the middle and at the bottom of the wall. One may argue that the wall was prevented from catastrophic failure because the actuator laterally braced it. Such an argument is not valid because the load did not reverse sign. In other words, if the wall is prevented from collapsing by the actuator, then the force in the actuator will be tension instead of compression in one direction, or compression instead of tension in the other. But the shown load deflection curve in Fig. 6 is showing that up to five inches of deflection, the actuator had to push/pull the wall with a force of 2100 lbs to produce a five inch deflection, i.e. the wall still has a resistance of 2100 lbs at five inches of deflection. If the applied actuator force of 2100 lbs is removed, then the wall will return to a position close to the at rest position. This magnitude of deflection is very ample to prove a very ductile behavior of the originally very brittle brick wall keeping in mind that the maximum deflection allowed by the actuator used was plus or minus five inches, i.e. the test was stopped at 5 inches because of the limitations of the testing equipment not because of the wall reaching its ultimate capacity. It was not possible to see such ductile plastic hinges in the wall without the foam. A catastrophic failure would have taken place because the portion of the wall above any of the two horizontal cracks may slide out of the plane of the wall causing the wall to suddenly lose the ability of carrying vertical loads.
