# POST FAILURE REPAIR OF SELF-REINFORCED CONCRETE BLOCK PRISMS

KEYWORDS: concrete block, confinement, ductility, masonry, repair, seismic performance

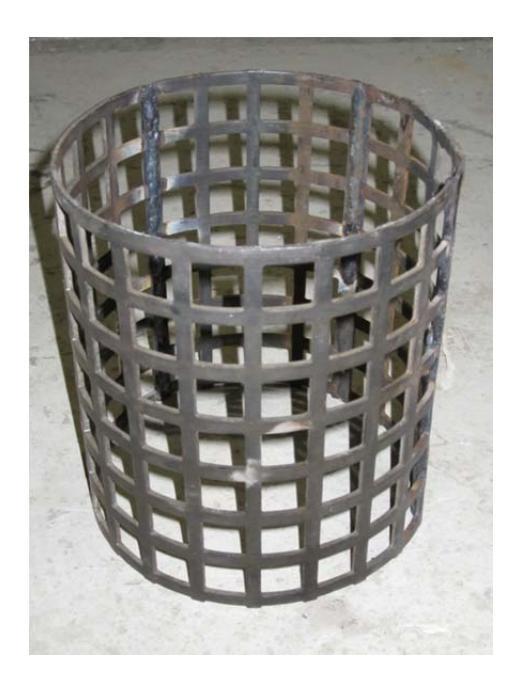
Figure <u>1</u>: Lateral Confining Device

The SR Blocks were fabricated as <u>20 cm</u> splitter blocks with <u>a 142 mm</u> diameter cell. The confining devices were inserted into the mold of an automated block-making machine. <u>As indicated earlier [1]</u>, for blocks with smaller cells, placement of the devices and full compaction of the concrete in the molds were accomplished very satisfactorily. As displayed in Figure 1, the confining devices were manufactured from <u>11</u>-gauge steel. The <u>designed</u> device is 164 mm in diameter (centre-to-centre), 184 mm in height and has 19.1 mm openings spaced 6.3 mm apart in all directions. The yield strength of the steel was measured as <u>401 MPa</u>.

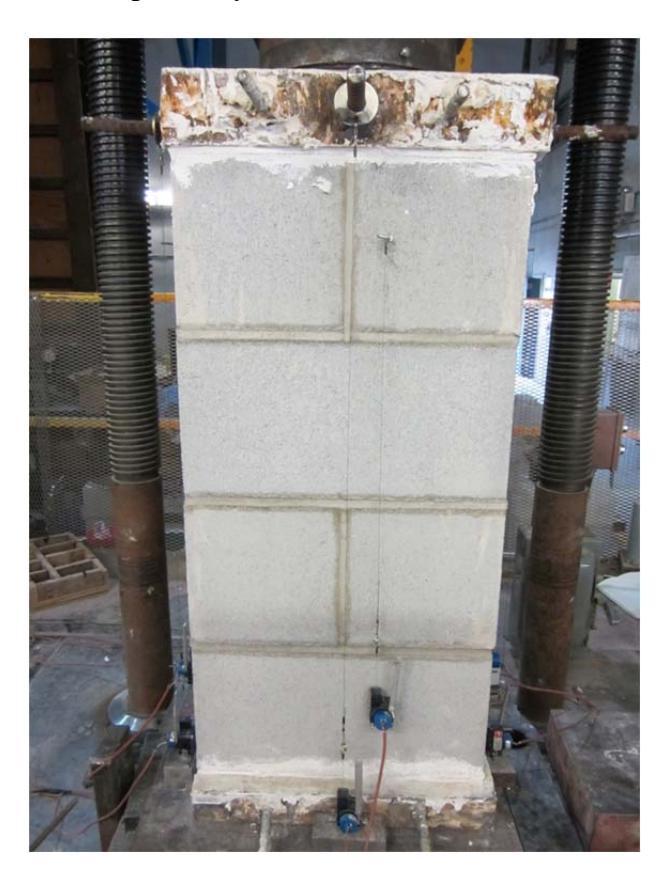
**Figure 2: Typical Prism Specimen**

The SR Block prisms were built on site by a qualified mason in the Applied Dynamics Laboratory of McMaster University. As shown in Figure 2, the prisms were four courses high and one block long, with a one-half running bond. Each prism was grouted with fine grout mix prepared in the laboratory having a slump of 270 mm. The material properties and mixes are given in Tables 1 and  $2_{2}$  respectively. Prisms one and two were grouted with mix -#1, while prism three was grouted with mix # 2. Subtracting 1.64 times a minimum coefficient of variation of 10 percent from the average values shown in Table 1 results in specified block, grout cylinder, and mortar cube strengths [5] respectively of 23.9 MPa, 20.6 MPa, and 11.5 MPa.

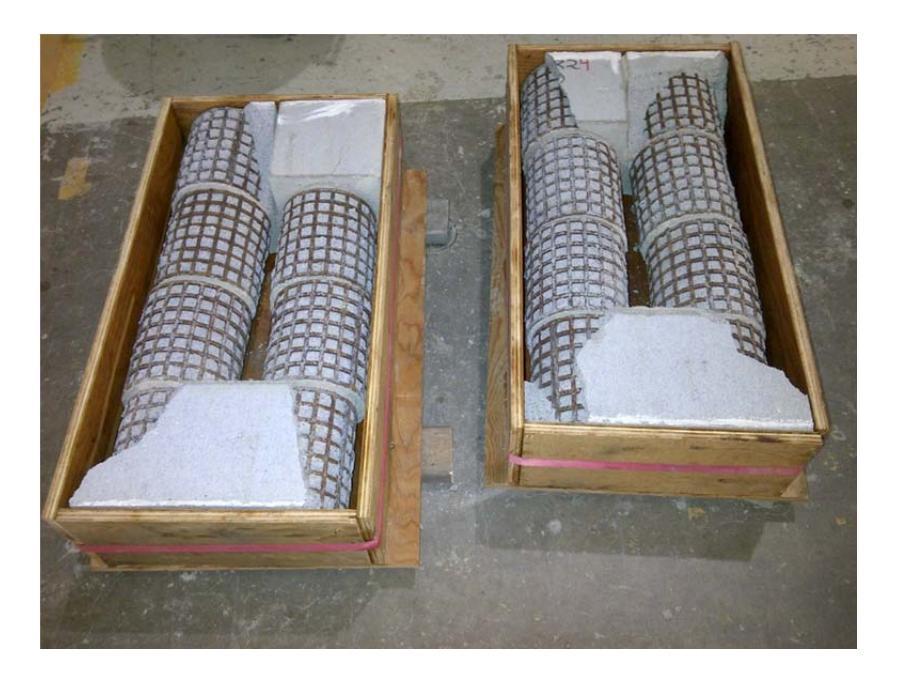
(a) Tested SR Block Prisms Positioned in Forms in Preparation for Repair

Each prism was then carefully removed from the test setup. The steel <u>loading plates</u> were <u>removed</u> along with any concrete that could be easily <u>freed</u>. The resulting specimens were then laid flat <u>in a plywood form sized</u> to the dimensions of the original <u>thickness</u> and length <u>of the prism</u>. The displaced height <u>after the first test was</u> preserved. The specimens are shown <u>in the forms</u> in Figure <u>3(a) prior to repair grouting</u>. This photograph also indicates the typical degree of spalling associated with having achieved a compressive strain of near 2%.

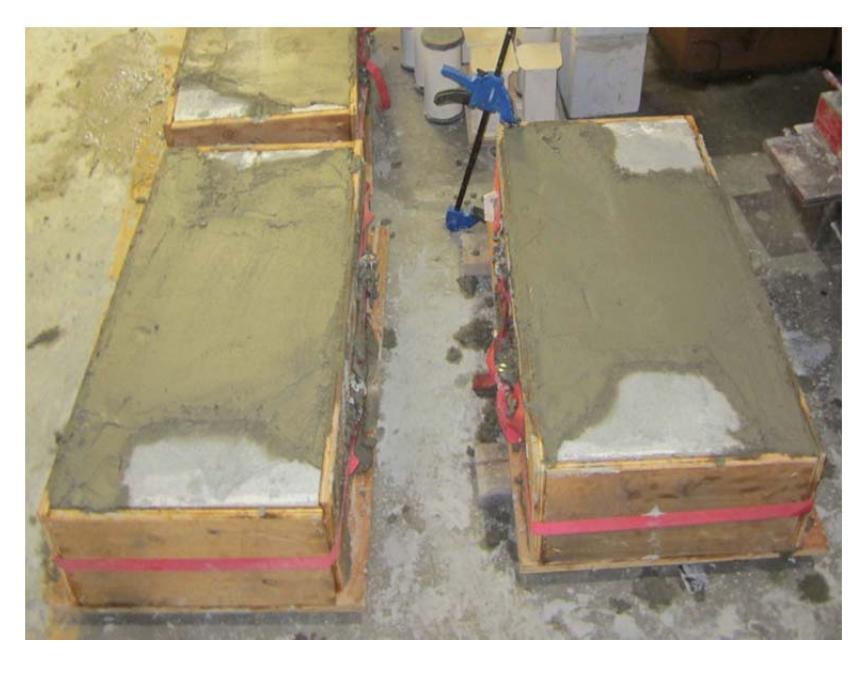
(b) Prisms Shown After Completion of Repair Grouting

Previous work by Atkinson and Schuller <u>documented</u> the use of expansive admixtures to ensure minimal plastic shrinkage <u>of repair grout</u> [6]. Consequently, Type GU cement was replaced with Type K expansive cement to compensate for drying shrinkage. <u>Additionally</u>, Sika Intraplast-N admixture was used, in the amount of <u>1%</u> by\_weight of cement. <u>The admixture</u> contains fluidizing agents to ensure thorough filling of the forms and around the spalled specimens. This admixture also included an expansion agent to compensate for plastic shrinkage of the grout. As shown in Figure 3(b), the three specimens were repaired on the same day with the above mentioned grout mix <u>having an average cylinder compressive strength of 22.1 MPa</u>. The repaired prisms were tested to the same specifications as the original prisms, except <u>that loading was continued to extremely high strains</u> until <u>complete failure occurred</u>.

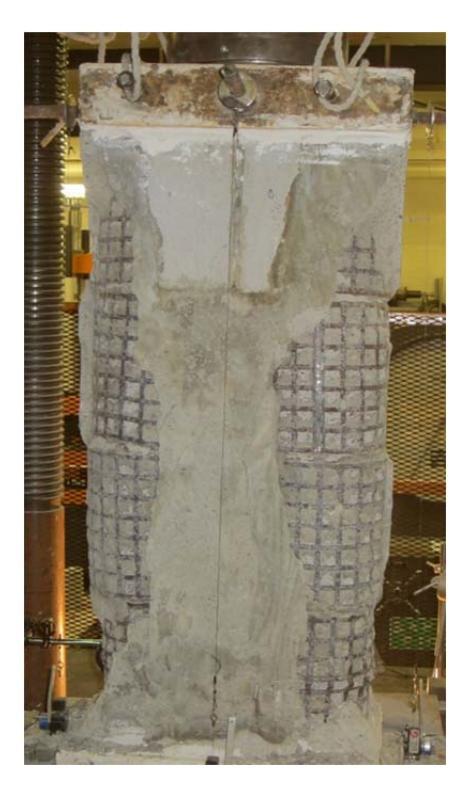
Figure 4: <u>Repaired Prism #2 at</u> Midtest

Failure of each repaired prism was observed to start with vertical cracks forming in the cent<u>re</u> two courses, <u>but this cracking propagated to span nearly the entire prism height as the prism was</u> subjected to the increasing vertical strain. The sides of the prisms were the first <u>zones where</u> the repair concrete/grout began to spall, exposing the confining device underneath. As seen in Figure 4, some areas of repair remained intact along the faces of the prisms even at very high strains corresponding to evident bulging of the confining devices.

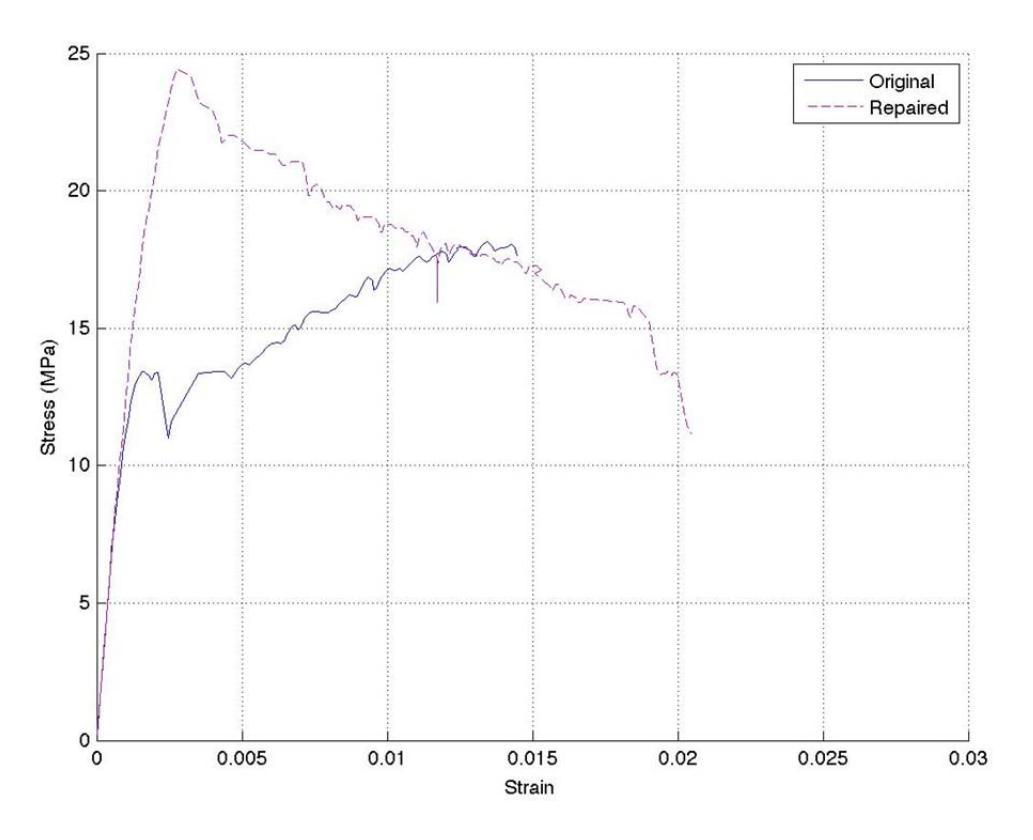
Figures 5, 6, and 7 contain plots of the stress-strain curves for tests before and after repair for the three test prisms. As can be seen in all cases, the repairs effectively restored the initial high stiffness of the grouted concrete block prisms under compression loading. The repaired prisms consistently were able to exceed the capacity of the original prisms and maintain equally large strains. This improved behaviour was unexpected. The average strength of the repaired prisms was approximately 50% greater at initial failure compared to initial failure of the original prisms. As can be seen in Figures 5 to 7, the strength of the repaired prisms gradually decreased until they converged with the stress-strain curves of the original prisms. This occurs at an average strain of about 1.6% corresponding to the second peak point at which original testing of the prisms was terminated. This intersecting phenomenon corresponding with the very high spalling strains indicates that the repaired prism has returned to its original damaged condition sustained at termination of the original tests. However, it should be pointed out that at the end of the original tests, the residual compression strain in these prisms averaged 1.4% so that total accumulated compression strain is the value shown in the figures plus the residual strain. The ability of the prisms to be repaired and remain stable again following application of new high compression strains is attributed to the lateral confining devices within the blocks continuing to effectively confine the enclosed parts of the cross-section.

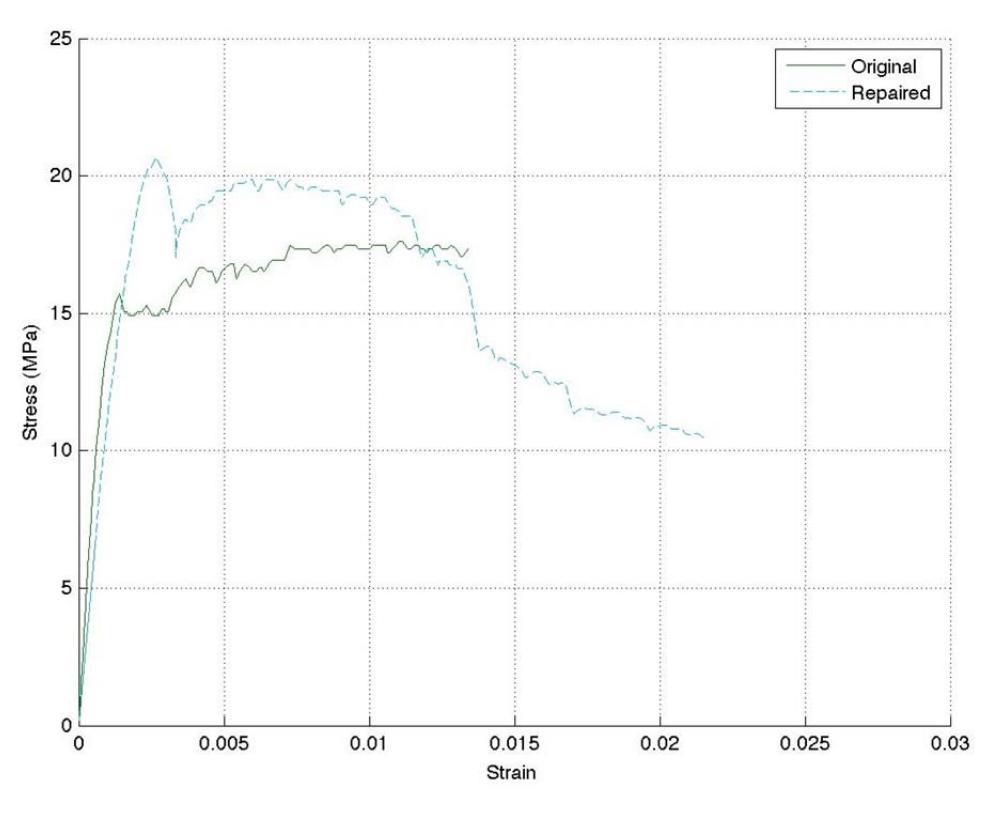
Figure 7: Stress-Strain Curves for Prism #3
